Report of Investigation into
Sinking of Hong Kong Registered
Bulk Carrier “Trans Summer” at
Position 21°55.3’N, 113°40.4’E
West of Dawanshan Dao, China
on 14 August 2013

The Hong Kong Special Administrative Region
Marine Department
Marine Accident Investigation Section

16 March 2015

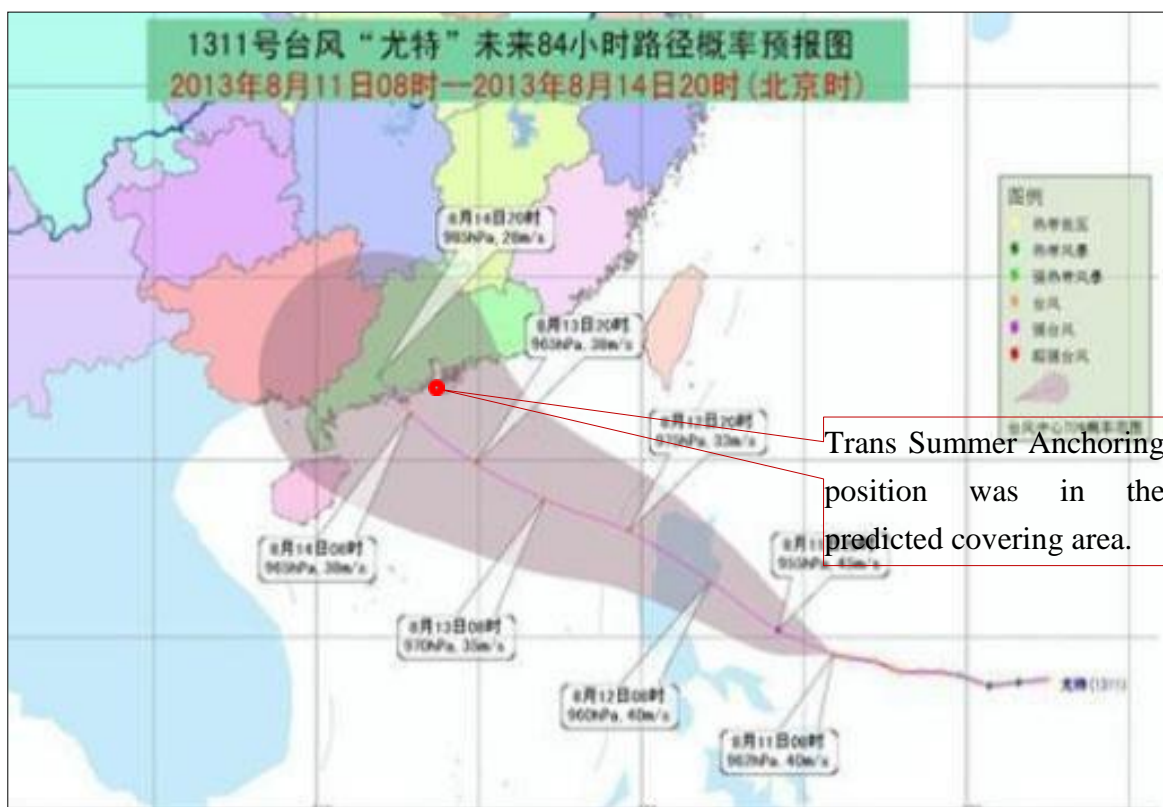
Fig. 2 – The predicted track of Typhoon “Utor” on 11 August 2013.

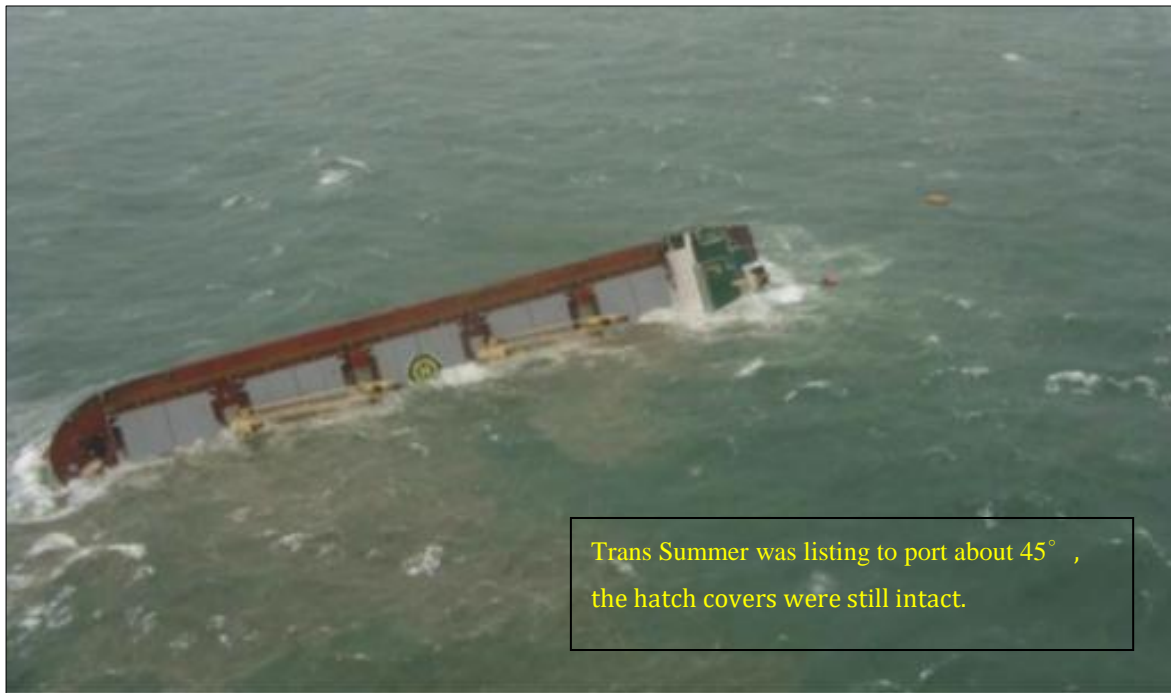
- 4.17 At about 1000 on 14 August 2013, wind force was intensified to about force 10 on Beaufort scale, and waves up to 7 m high. At 1010, a very high wave rushed from starboard side caused *the vessel* heeled to port side more than 20 degrees with the deck edge immersed in water. *The vessel* rolled back and stayed at a listing to port of about 10°. The starboard anchor was then dropped with 5 shackles of anchor chain in water. The listing to port was aggravated to 15 degrees soon afterward and persisting. The management company suggested the master to put ballast water into double bottom ballast water tanks to low the height of gravity centre of the vessel. The master followed the instruction but the ballast water was wrongly pumped into No.3 starboard topside ballast tank.

Fig. - 3 Trans Summer listed to port more than 45° (View from Rescue Helicopter)

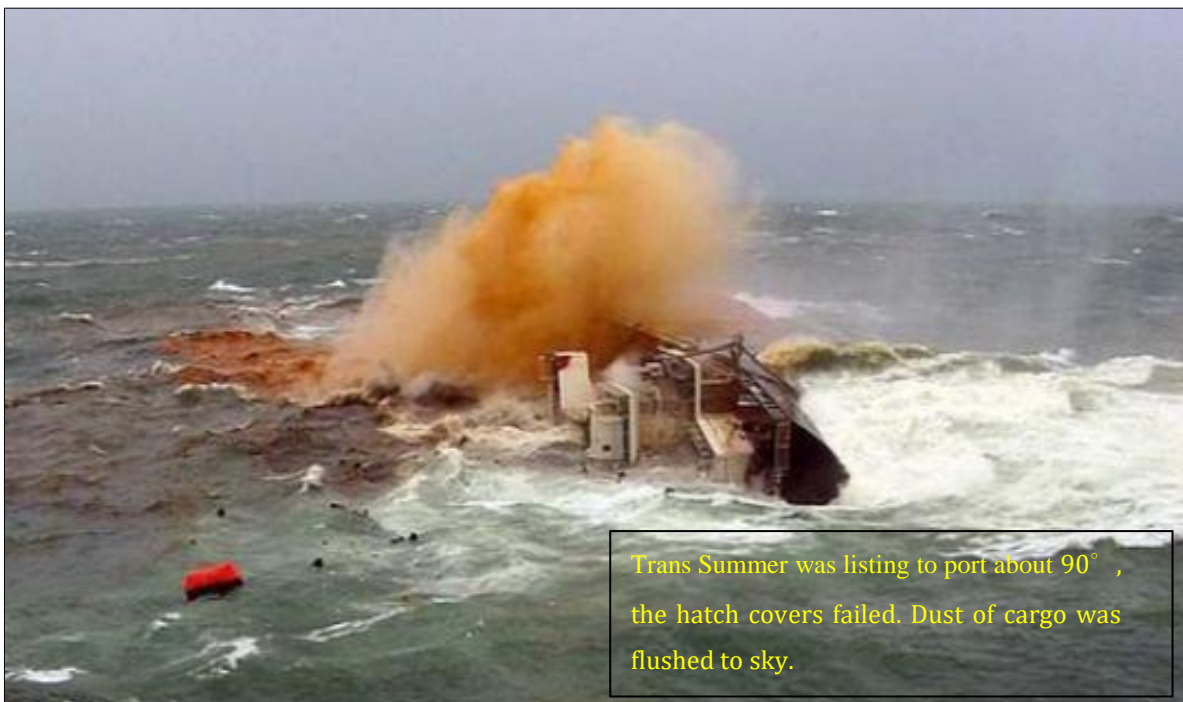
Fig. - 4 Trans Summer listed to port about 90° (View from Rescue Helicopter).

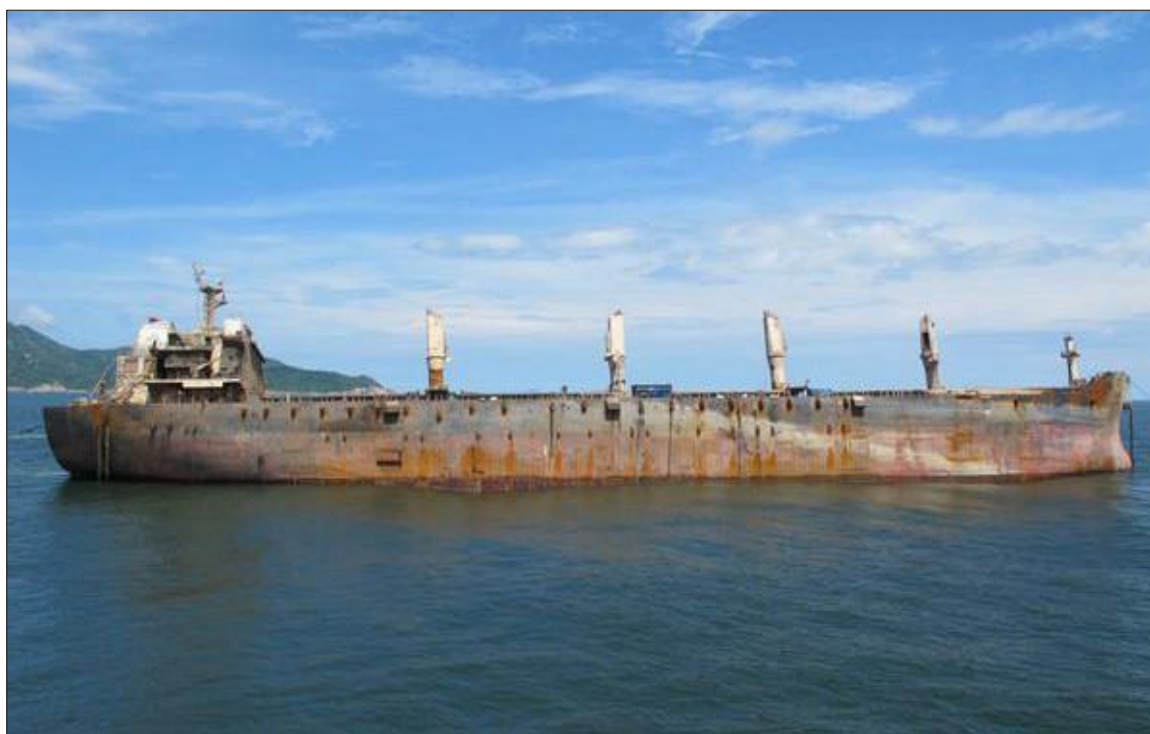
Fig.5 – “*Trans Summer*” refloated after one year of the accident.

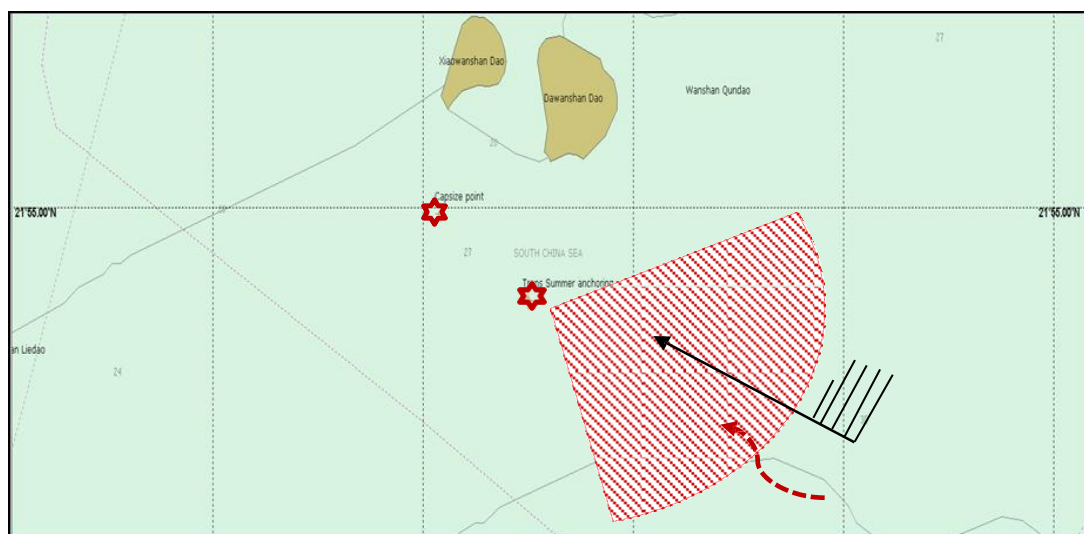
- 5.11 The master dropped anchor at 21°53.42'N, 113°42.31'E about 2 n.m south of Dawanshan Dao of Wanshan Quandao for sheltering from the typhoon. It was about 100 n.m to Yangjiang, China (Fig.6, 7).
- 5.12 Investigation into the topography of the anchorage south of Dawanshan Dao revealed that the islands of Wanshan Quandao could shelter the wind from the north only. *The vessel* was in the right semicircle of the typhoon while she was moving northwesterly and passed south of *the vessel*. The prevailing wind was easterly to southeasterly while the typhoon moved closer and passed on south of *the vessel*. It was obviously that *the vessel* could not be sheltered from the southeasterly strong wind and waves.

Fig.6 - Anchoring area of “Trans Summer”, strong southerly wind and seas.

- 5.13 On the evening of 13 August 2013, strong wind of force 9 and 10 on Beaufort scale and heavy waves 7 to 8 m from southeast in the anchorage was prevailing. After extending the anchor chain to 9 shackles in water, with running of main propulsion at slow-ahead, *the vessel* was still experienced anchor dredging. It was obviously *the vessel* could not hold her position by anchor and running of engine at slow-ahead under this severe weather condition.
- 5.14 At 1100 hours on 14 August 2013, the center of “Utor” was about 103 n.m west of *the vessel*, the southerly wind intensified to force 9 to 10 in the area and wave at sea about 9 to 10 m high. At the time of the accident, the anchorage gave no sheltering benefit from the wind and waves.

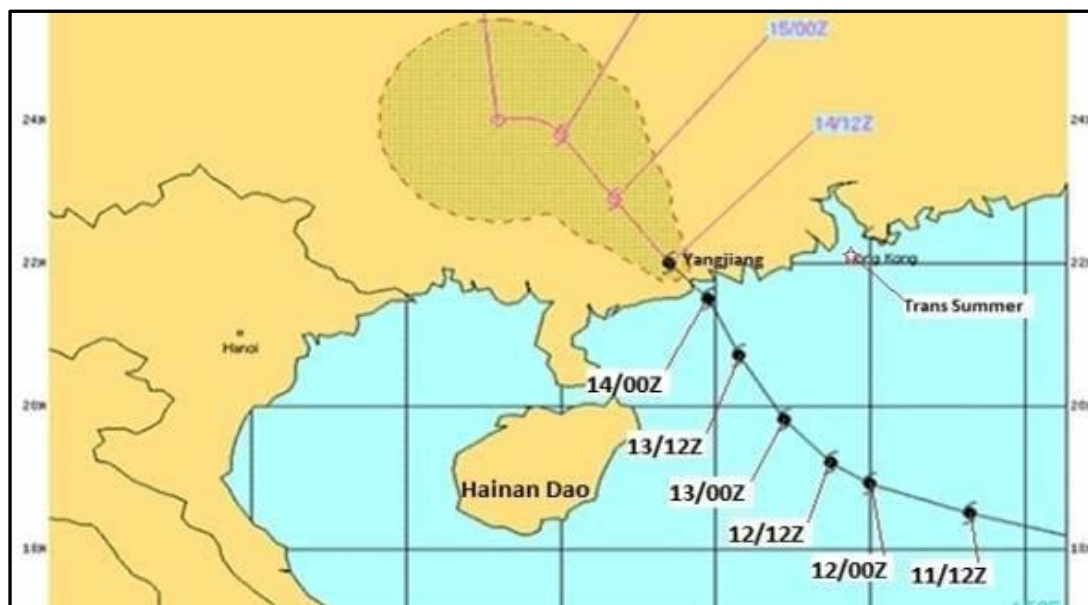
- 5.10 Super typhoon “Utor” took a northwesterly track over the northern part of the South China Sea to the south of Hong Kong after crossing over Luzon, the Philippines on 12 August 2013 (Fig.2 & Fig.7). It was predicted to land at Yangjiang, China.

Fig. 7 – Track of “Utor” on 14/1200 hours, the real track in black line. Predicted track in red
