**Report of investigation
into the explosion of the
diving cylinder on board
local cruiser (24949) at Sai
Kung Shelter anchorage
on 18 October 2013.**

Marine Accident Investigation Section
Marine Department
The Hong Kong Special Administrative Region

16 May 2017

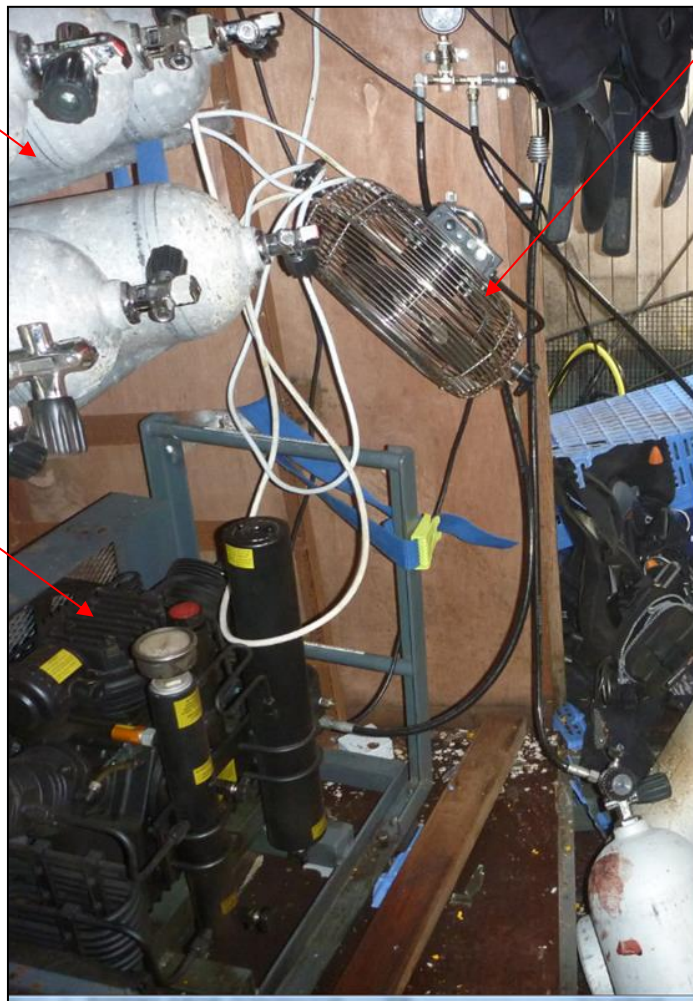
Figure 2: Air Compressor in the cylinder storage space

- a) On the *Vessel*, two air charging systems were fitted for charging the diving air cylinders. One of the air charging systems was driven by an electric motor and the other one was driven by a diesel engine.
- b) One major criteria for the air compressor to produce quality compressed air into the diving cylinders was that the air compressor should not be situated against a wall in an inadequately ventilated small room on board. As this might result in producing compressed air with high level of carbon monoxide or moistures into the cylinders causing internal corrosion. From the picture (Figure 2) taken from the scene, it appeared that, the environment was not suitable to produce good quality of compressed air.

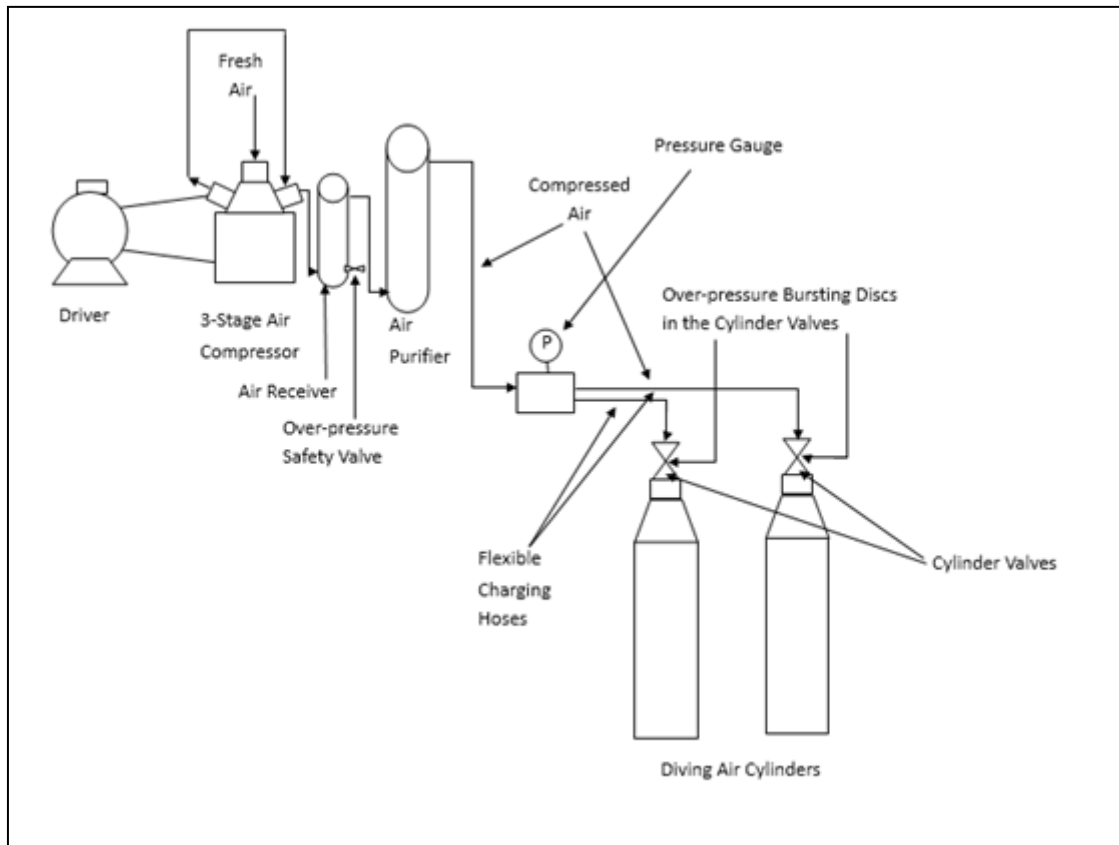
Figure 3: Configuration of the air charging system

- Safety devices in the system for high pressure:
 - There was an over-pressure safety valve at the outlet of the final stage of compression, the safety valve was installed on the air receiver.
 - There was a bursting disc installed in each cylinder valve.
- j) The control system was in manual mode only. There was no pressure switch fitted. The filling systems were not able to stop the air compressors when reaching the required pressure.

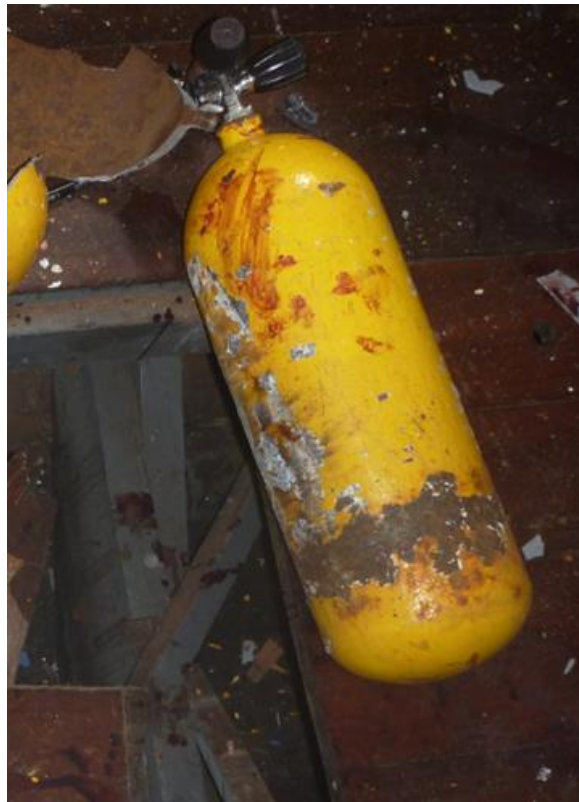
- m) Before the filling-up, it was important to examine the cylinder externally for any defects such as sign of wear-down, deformation, and the condition of the burst disc.
- n) The coxswain failed to carry out this inspection properly before filling the defective cylinder with compressed air. The picture below (Figure 4) shows one of the defective cylinders which was not charged yet with corroded external shell lying on the floor.

Figure 4: Corroded air cylinder

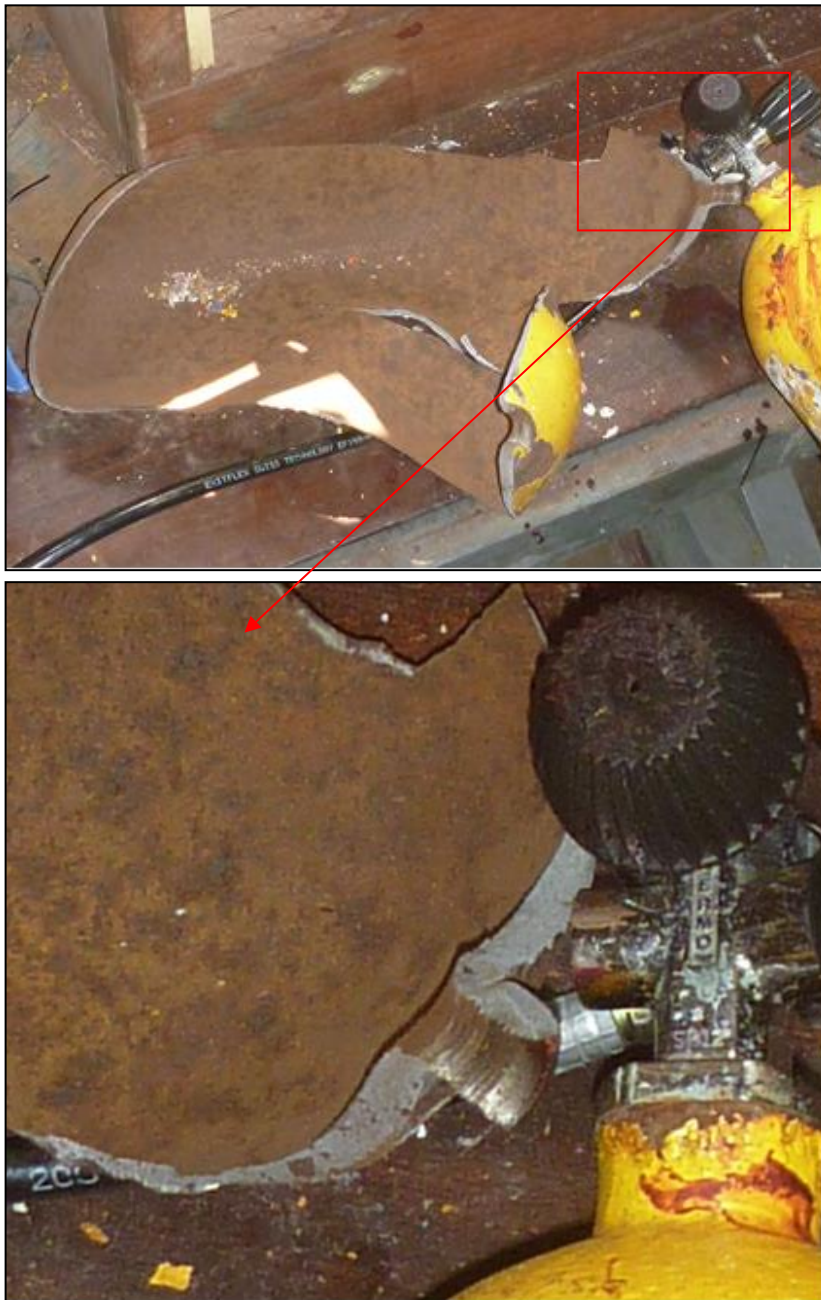
- o) The coxswain reported that the compressed air pressure of the exploded diving cylinder was still far below the normal working pressure (180 bar) at the time of the explosion.
- p) The exploded cylinder was made of aluminum. Corrosion rate of aluminum by water was largely dependent on the composition of the water. In sea water with heavy metals, the durability of the aluminum cylinder would be reduced greatly.
- q) Aluminum was subjected to stress cracking. Corrosion accelerated by the high pressure of the air in the cylinder led to critical weakening of the cylinder shell. The exploded cylinder was inspected in October 2012 with stamping on the cylinder.

- r) The fragment of the exploded cylinder shell indicated the following defects (Figure 5):
- General internal and external corrosion;
 - localized internal pitting; and
 - stress corrosion cracking formed through the simultaneous action of applied stresses and a corrosive environment.
- s) The above defects on the cylinder reduced the material strength, and led to large flaws that eventually resulted in structural failure. The cylinder exploded below the normal working pressure.

Figure 5: Internal surface of the exploded cylinder was corroded with pitting holes

- The exploded cylinder was corroded internally and externally.
 - The exploded cylinder was made of aluminum which was subjected to stress cracking. Corrosion was accelerated by the high air pressure inside the cylinder that led to weakening of the cylinder shell.

- The general corrosion and scattered pitting holes on the cylinder shell reduced the material toughness, and led to large flaws that eventually resulted in structural failure.

- 6.1. A copy of this report should be sent to the coxswain, advising him the findings of this incident.
- 6.2. Only the approved diving air cylinders that were properly maintained and tested according to manufacturer's instructions should be carried on board.
- 6.3. A copy of this report should be sent to the Dangerous Goods and Prosecution Section of Marine Department, Fire Services Department and the Boilers & Pressure Vessels Division of Labour Department, advising them the findings of this incident.
