**Report of Investigation
into the Collision between
the Hong Kong registered container ship
OOCL Southampton and the Chinese
Mainland-registered coastal vessel *Hang
Sheng 18* off east of
Ninepin Group, Hong Kong
on 5 November 2013**

The Hong Kong Special Administrative Region
Marine Department
Marine Accident Investigation Section

9 Jan. 2015

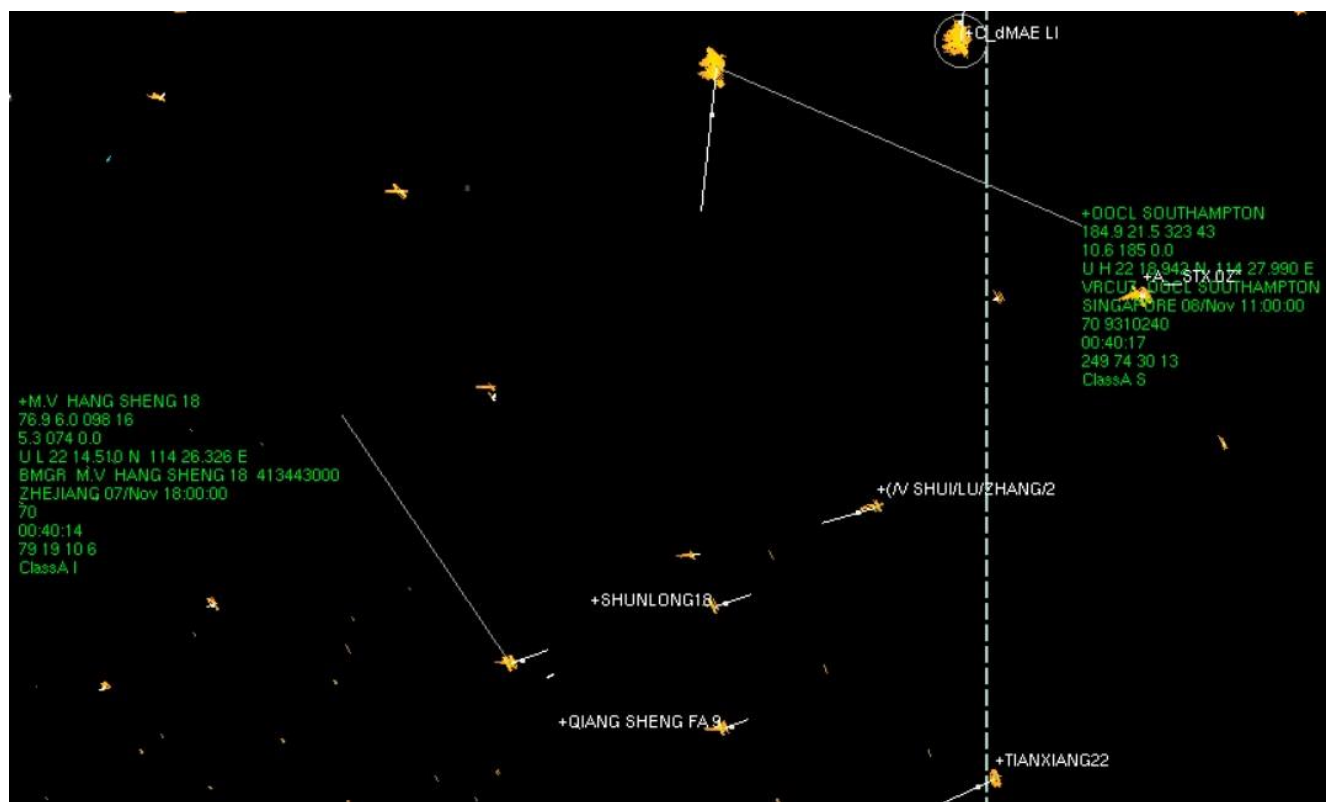
- 4.1.5. At around 0040, the master returned to the bridge, he monitored the X-band radar while the second officer was monitoring the S-band radar. Several vessels included HS18 were crossing over from both sides at forward of OSN (figure 2). HS18 was at a distance of 4.7 nautical miles on starboard bow 2 points (about 23°) and the CPA was still keeping 1 cable.

Figure 2 – at 0040 on 5 November 2013, the traffic condition viewed from VTC Radar, the distance between OSN and HS18 was about 4.7 nm

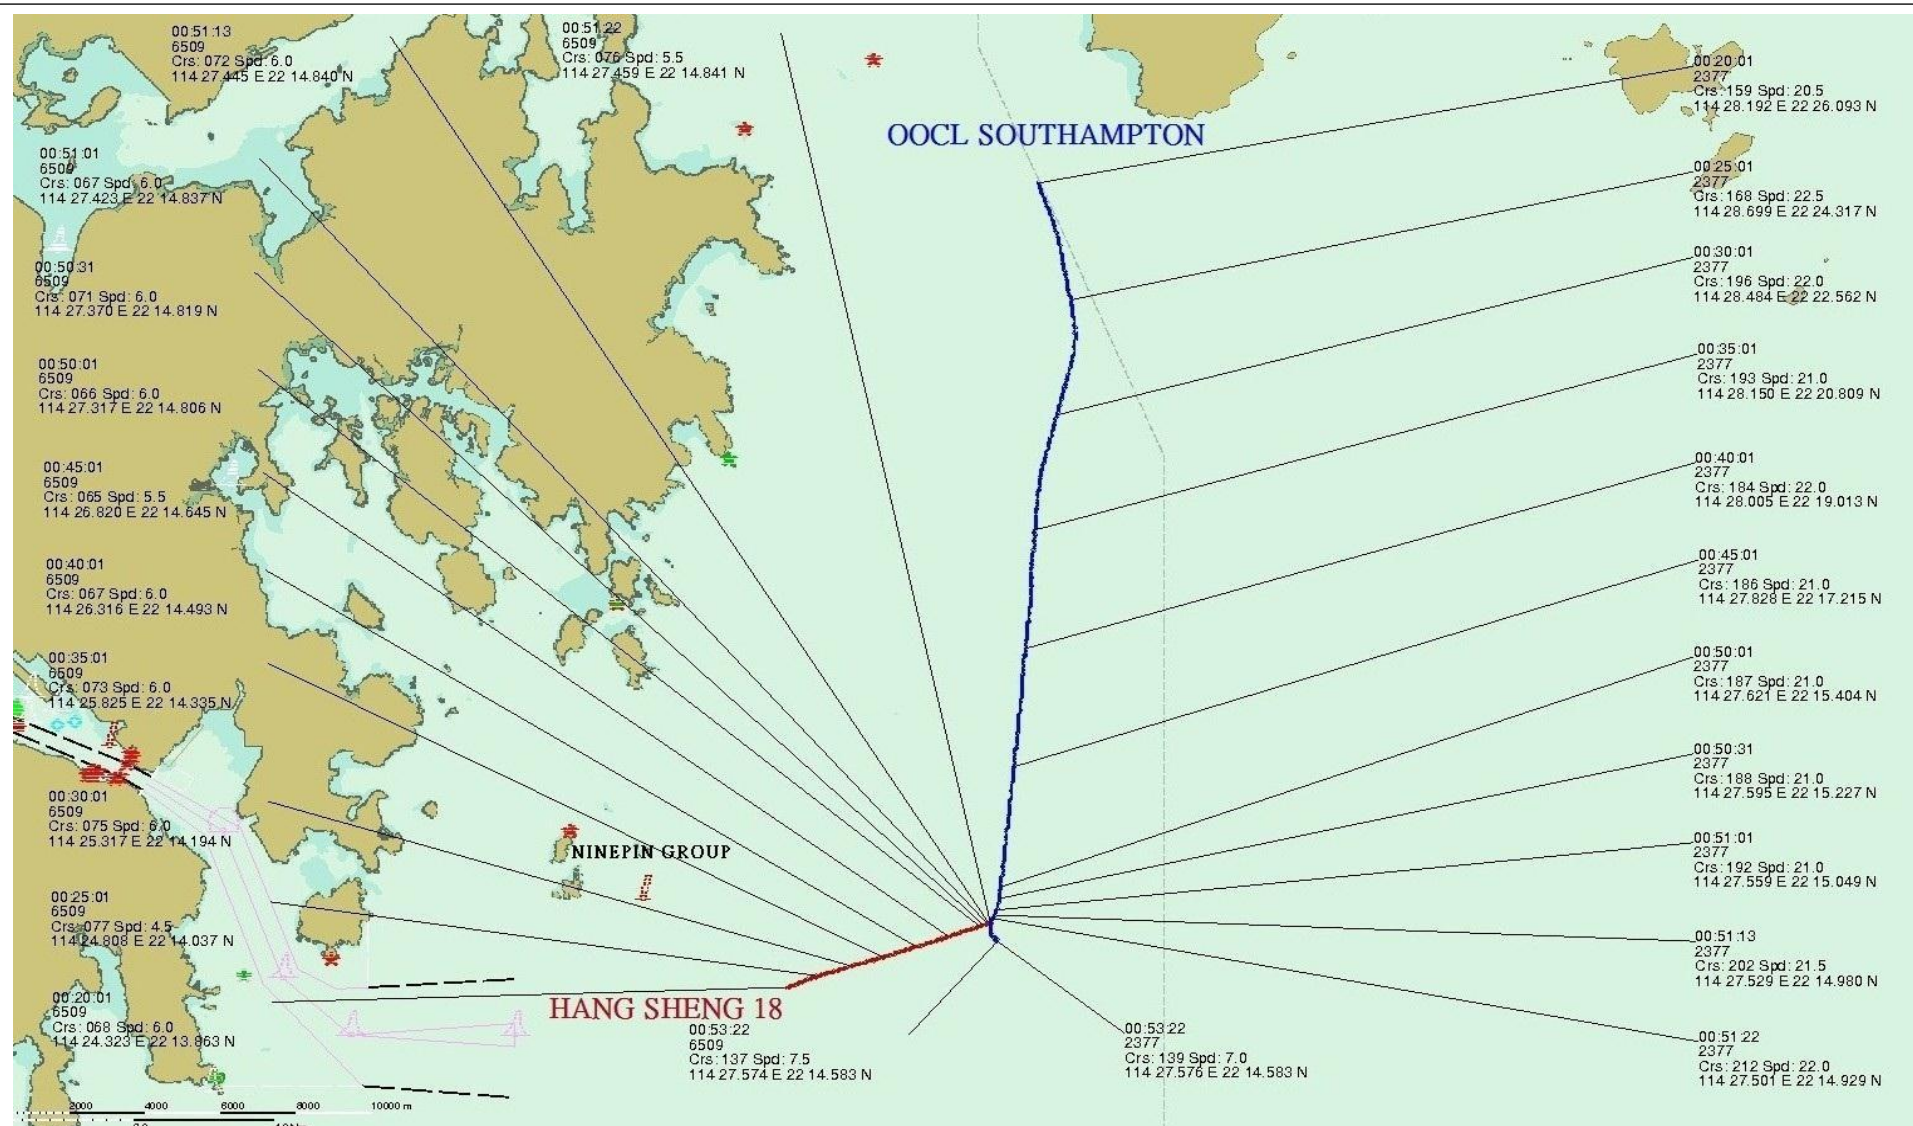
Figure 3 - the Radar Plot of the two vessels before the collision (off east of Ninepin Group, Hong Kong)
