**Report of Investigation
into the fatal accident
on board Hong Kong
Registered Ship “*Sainty
Vanguard*” at sea 30nm west
off Hadera of Israel on
19 December 2013.**

Marine Accident Investigation Section
Marine Department
The Hong Kong Special Administrative Region

9 February 2015

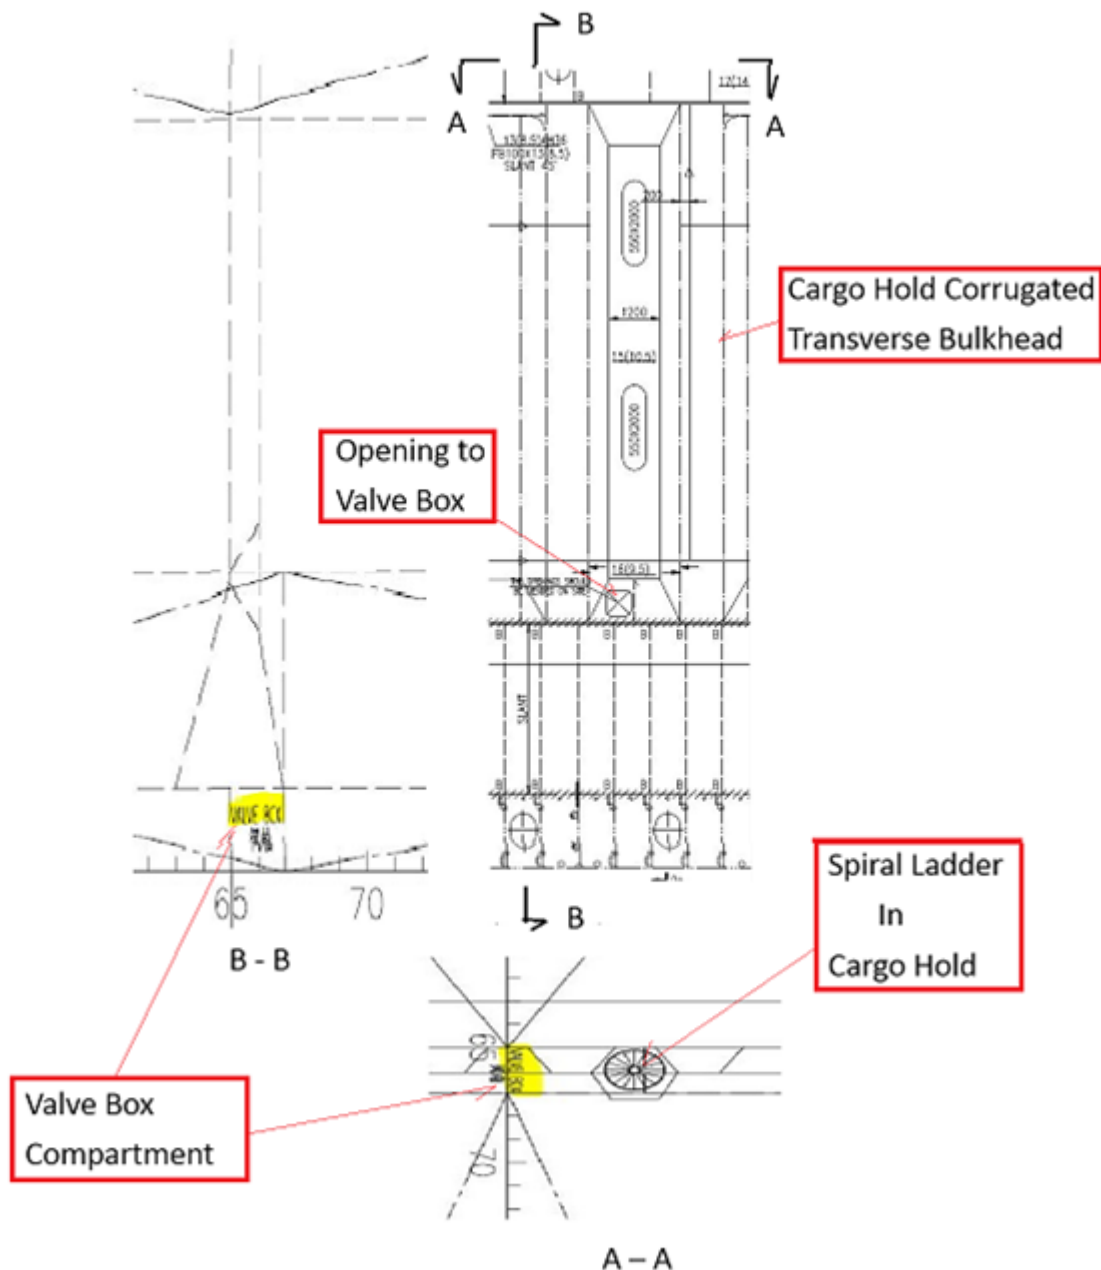
Fig. 2: No.6 Cargo Hold, Aft Section

- 5.7 The ballast water valve control transmitters were located inside the valve box compartments in double bottom under the respective cargo hold lower stools. The access cover of each valve box compartment was adjacent to the bottom end of the spiral ladder in each cargo hold (Fig.2).

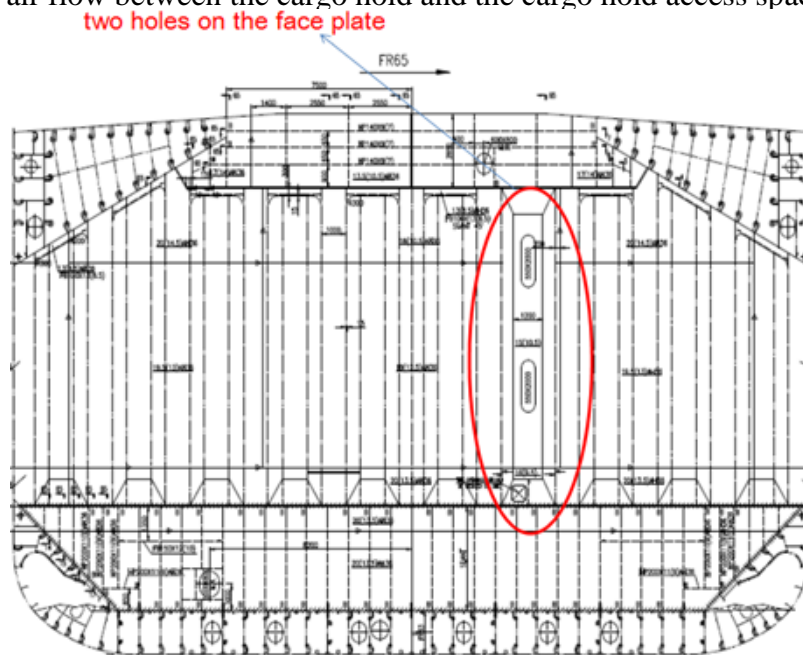
Fig. 3: The two holes on the face plate of the cargo hold access space

- 5.13 To reach the access cover of each Valve Box Compartment, the crew must climb down from the cargo hold access hatch through the spiral ladder except for the access cover of the Valve Box Compartment for No.7 cargo hold which was located in the Engine Room. The spiral ladder was fixed in the corrugated cargo hold transverse bulkhead and was protected from any potential mechanical damage during the cargo operations by one steel face plate at the front of the ladder and two steel web plates at either sides of the ladder throughout the depth. The face plate had two big holes (Fig.3) allowing natural air flow between the cargo hold and the cargo hold access space.

- 5.16 Regarding the incident in No.7 cargo hold, the lower hole on the face plate had been shielded by the cargo “Coal”. The cargo hold access space was then intermittently contaminated by toxic and flammable gases emitted from the cargo “Coal”, the atmosphere was therefore unstable and was subject to change under natural ventilation. The cargo hold access space could not be considered as safe for entry.
- 5.17 The entry to the cargo hold access space in No.7 cargo hold should therefore not be permitted. However, in case any entry that is absolutely necessary, for example: for emergency/ rescue purpose, only properly trained and experienced crew equipped with breathing apparatus (Fig.5) may consider entry for the purpose.

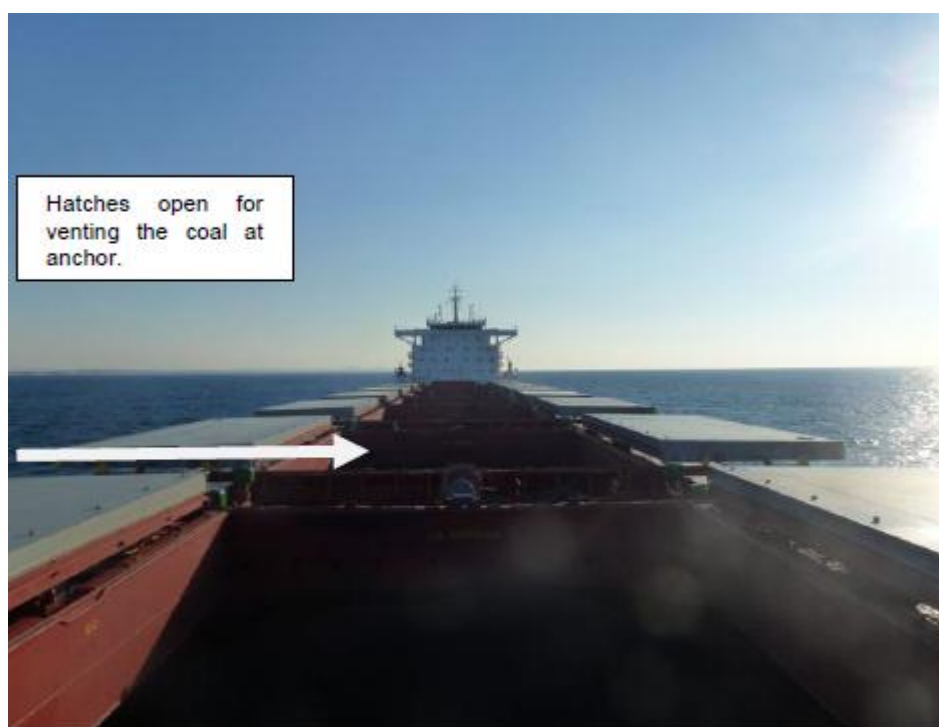
Fig. 4: All the cargo hold hatches and the access hatches were opened

- 5.14 Toxic gases such as carbon monoxide were odorless in nature. It could be emitted from the cargo “Coal” and accumulated amply in the cargo holds during the voyage from the loading port Ust-Luga, Russia to the discharge port Hadera, Israel.
- 5.15 Although all the cargo hold hatches were opened (Fig.4) when the fatal accident happened on 19 December 2013, the air pockets within the cargo holds including the cargo hold access spaces could be trapped with toxic and flammable gases.

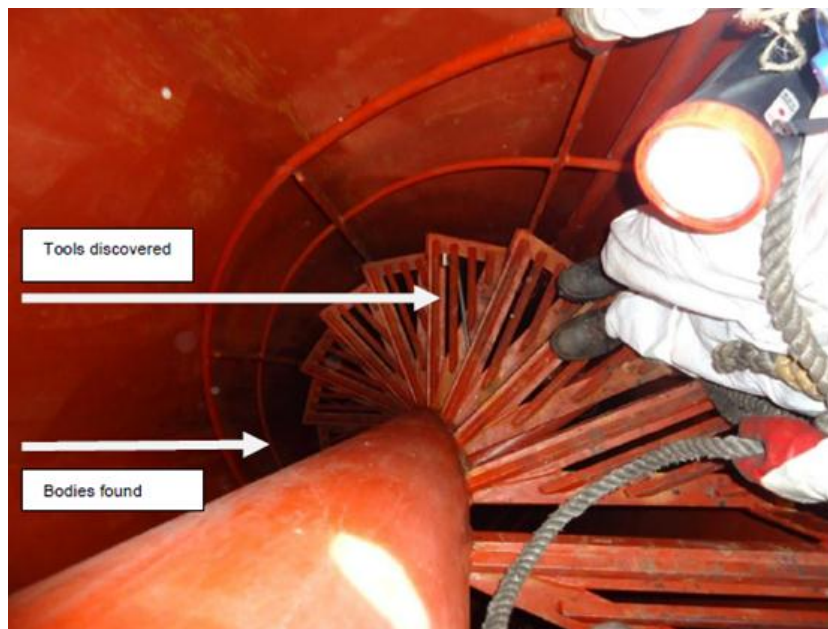
Fig. 6: No.7 cargo hold forward access space where the Bosun was found

- 5.22 The atmosphere of No.7 cargo hold access space was unsafe for entry. The lack of oxygen at that moment in the space caused the Bosun to collapse within a few minutes and to fall down from the spiral ladder with the head going first (Fig.6), since it was reported that the Bosun sustained additional head injury before his death.
