Report of investigation
into the death of the fitter and
injury to the chief engineer onboard
the Hong Kong registered bulk carrier
“*Liberty Prrudencia*” at Taiwan Strait
on 20 February 2014

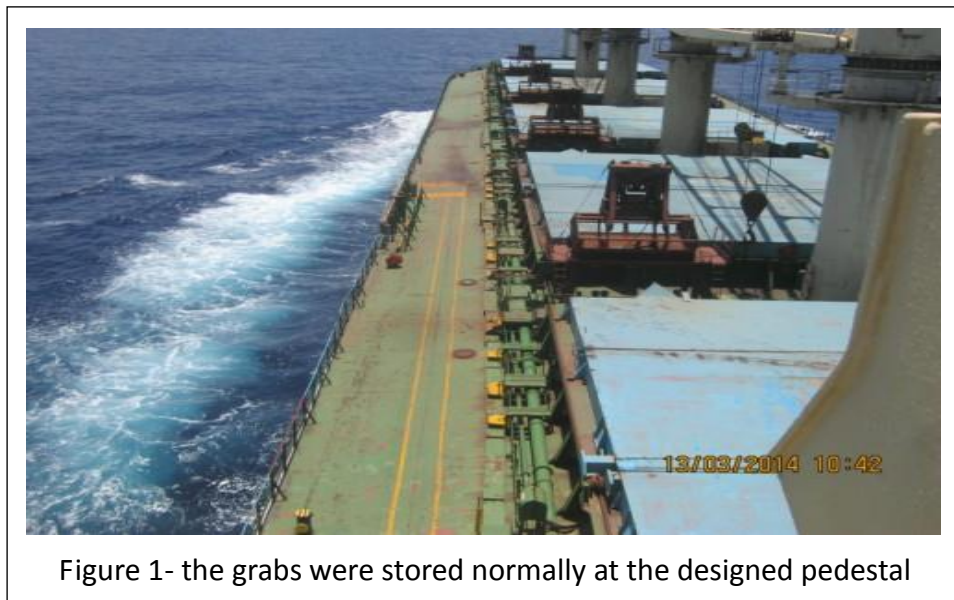
- 4.2 While the vessel was loading iron ore fines at the port, the steel wire (luffing and running wire) of No.1 crane was to be renewed. Before the work started, the No.1 grab had been moved and secured by belts and chain blocks on the main deck near the No. 5 cargo hold on the starboard side from its normal stowage position on the pedestal located between the No.1 and No. 2 cargo hatch on the port side (Figure 1).

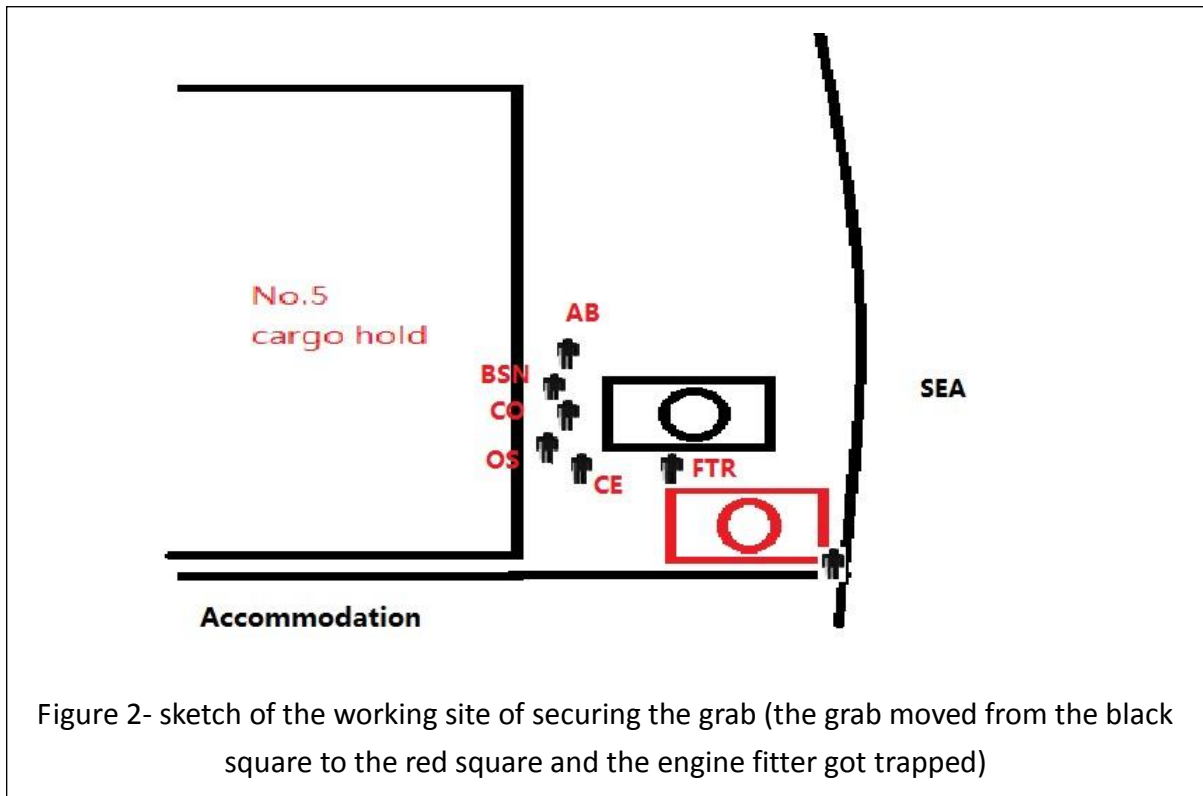
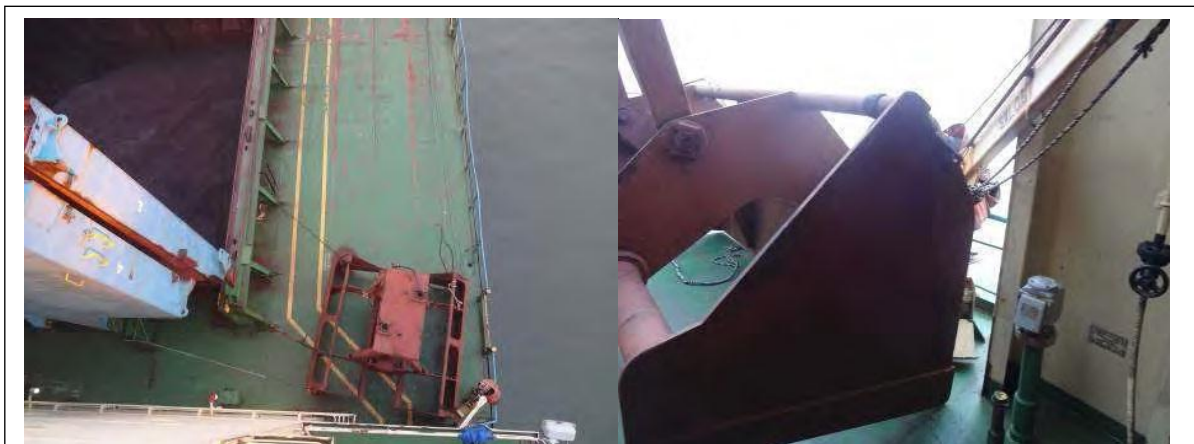
Figure 3- after the accident, the grab was temporarily secured at the accident site
