Report of investigation into the  
listing and grounding of  
Vietnam registered vessel  
*Sunrise Orient* in Hong Kong  
waters on 21 February 2014

The Hong Kong Special Administrative Region  
Marine Department  
Marine Accident Investigation Section

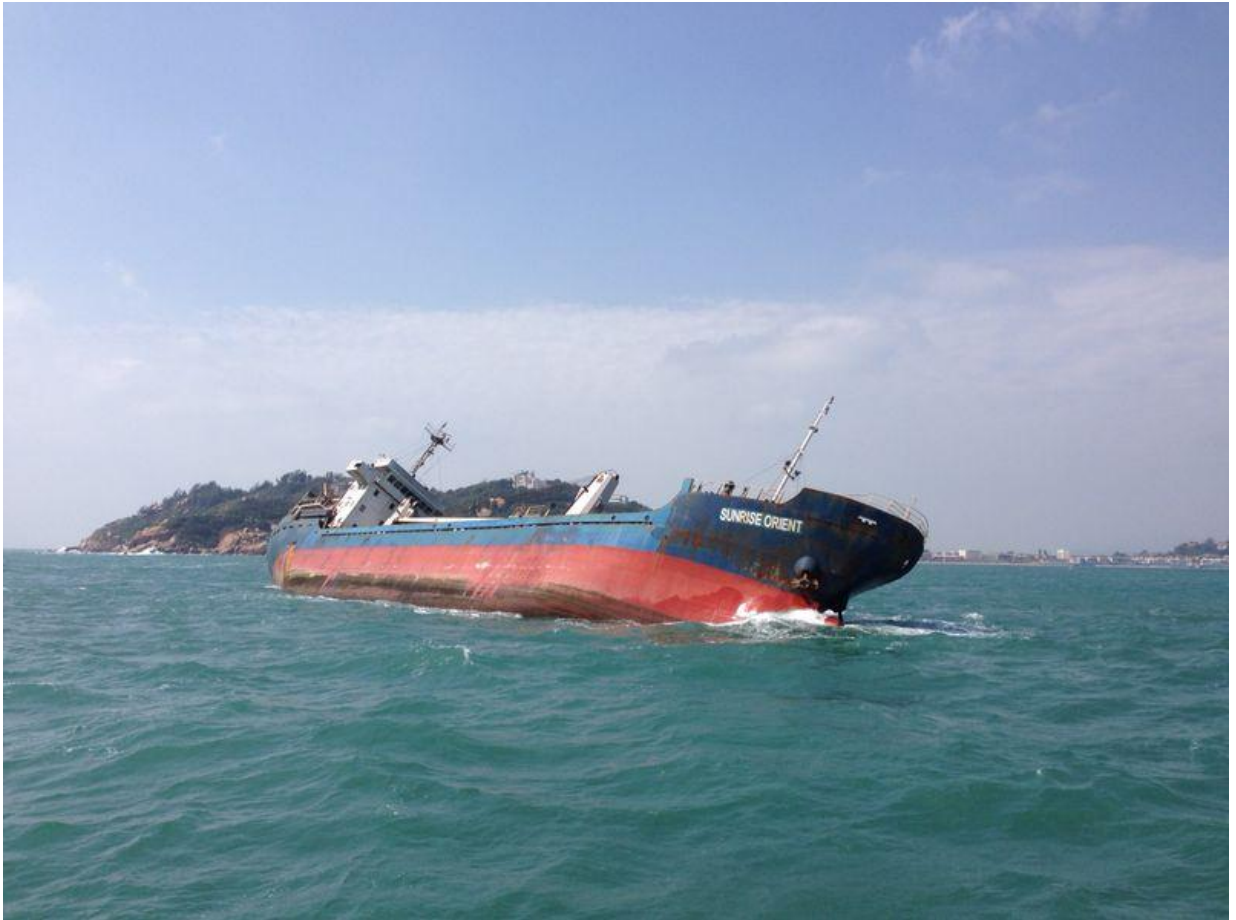
Fig.1 – Vietnam registered vessel *Sunrise Orient* listed to the port.

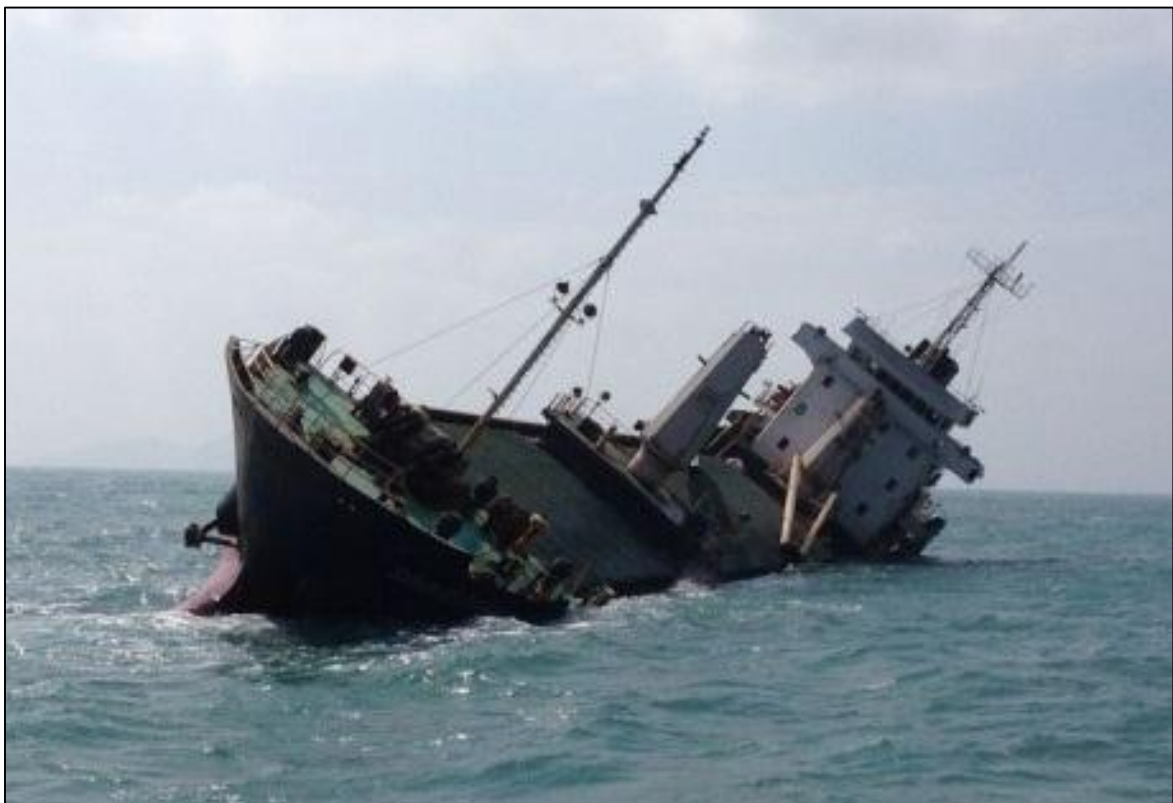
- 4.5 At about 1010, *the vessel* suddenly listed more than 50 degrees to the port side and was not able to return upright (Fig.2). It caused the 3/O to fall down on the floor. The master immediately turned the rudder hard port and ordered to press VHF distress button for transmission of distress signal. The master activated the general alarm to alert all crew to evacuate. The master, the 3/O and the AB evacuated from the bridge to the starboard muster station immediately. However, they did not switch off the propulsion engine.

Fig.2 – *The vessel* listed to port and lost control.

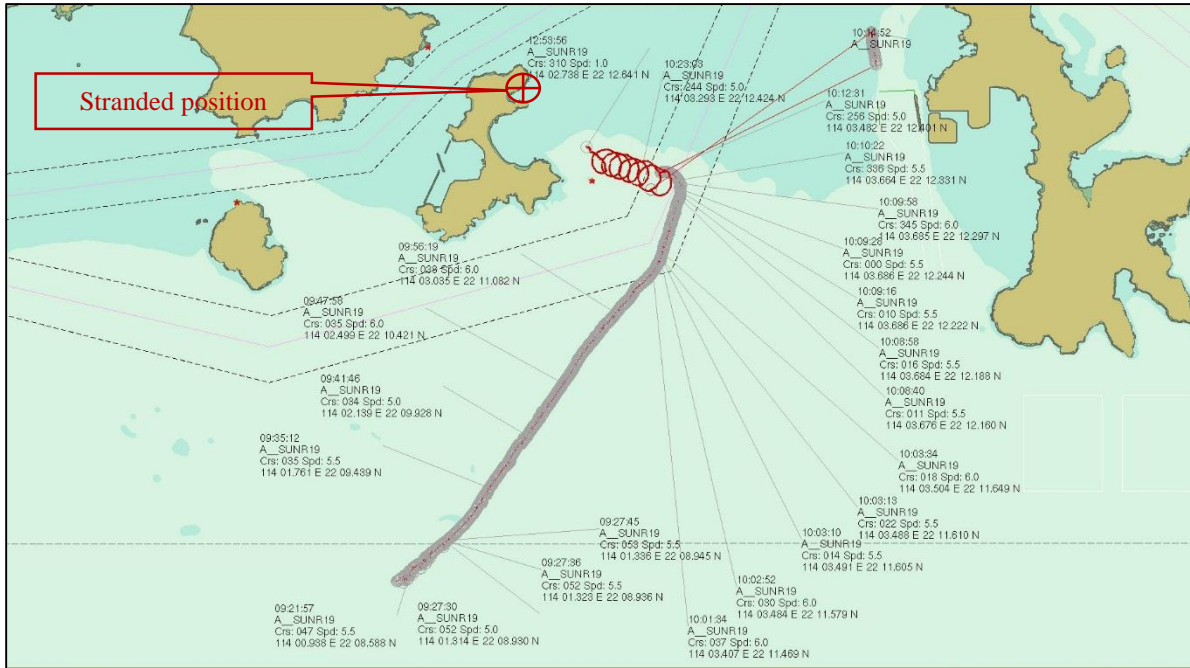
Fig. 3 - The vessel was moving in circular motion after being abandoned and finally grounded at Tung Wan Tsui, about 1.6 n.m away from the position of abandon ship.

- 5.9 The bridge team members evacuated from the wheelhouse without having stopped remotely of ship propulsion. On the other hand, the engine crew also evacuated from the engine room without having shut down fuel oil supply to the engines. When the vessel was abandoned with engines still running, she was still moving at a slow speed at sea and made many circular turns until it finally grounded at Tung Wan Tsui, Cheung Chau. It was dangerous to the other vessels in the vicinity, and increased the difficulty in salvage and rescue operation. The master, officers and crew on board did not follow the ship procedure for abandoning ship.

- 7.1 A copy of the investigation report into the accident should be provided to the management company and the master of *Sunrise Orient* advising them of the findings of the investigation. The management company should issue a safety circular instructing the master, officers and crew of *Sunrise Orient* to strictly follow:
- a) cargo securing arrangement in accordance with the cargo securing manual; and
  - b) the company procedure in abandoning of ship.

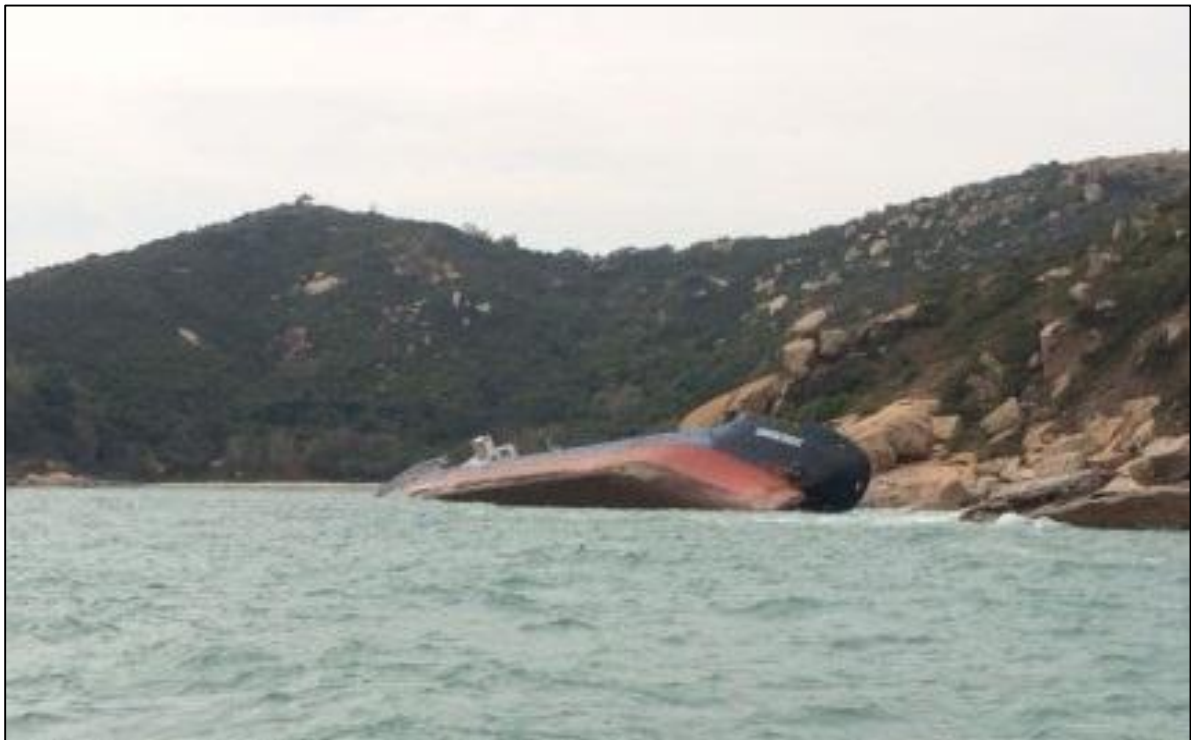
- 4.9 After the accident, the vessel was refloated on 20 May 2014. Series crack damage on the port side hull due to stranding on the rock was found.

Fig.4 – The vessel grounded at northeast of Tung Wan Tsui, Cheung Chau.

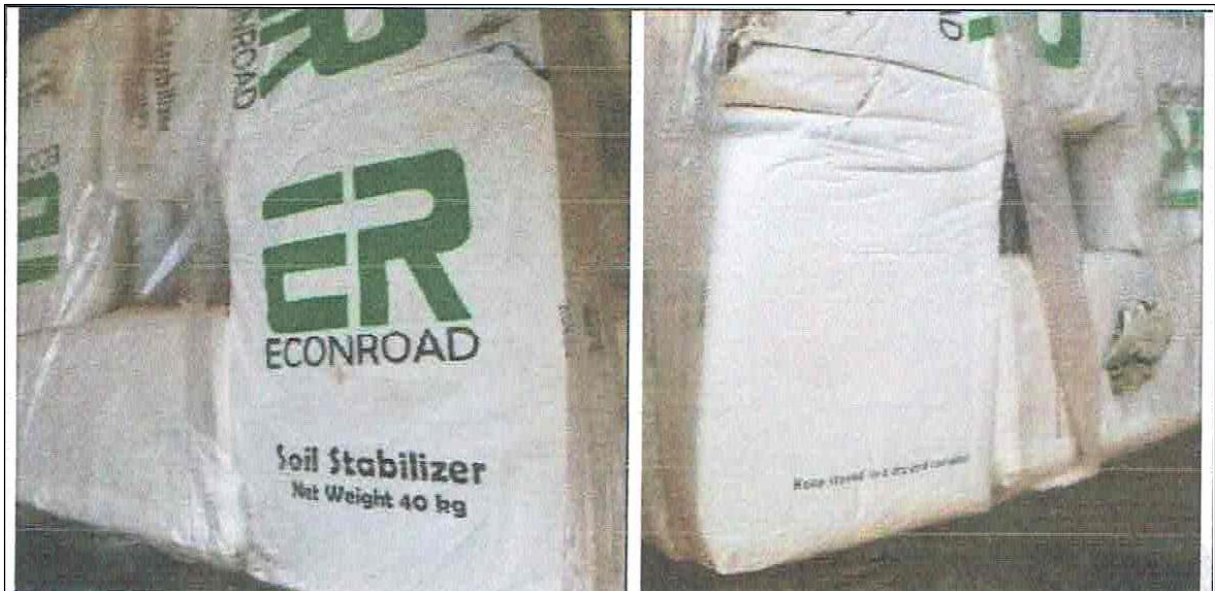
- 5.3 At the port of Nansha, Guangzhou, China, the cargo of soil stabilizer was packed in paper bags and stowed on wooden pallet. The weight of each bag was 40 kg and a total of 40 bags were stowed on each pallet. Each pallet was then wrapped by plastic film (Fig.5). The gross weight of each pallet was 1628 kg and the volume was about 1.83 m<sup>3</sup>. Shore cranes were used to lift the pallets into the cargo holds of the vessels. There were a total of 1738 pallets (total number of bags equal 69520).

Fig.5 – The begs of soil stabilizer were stowed on the pallet

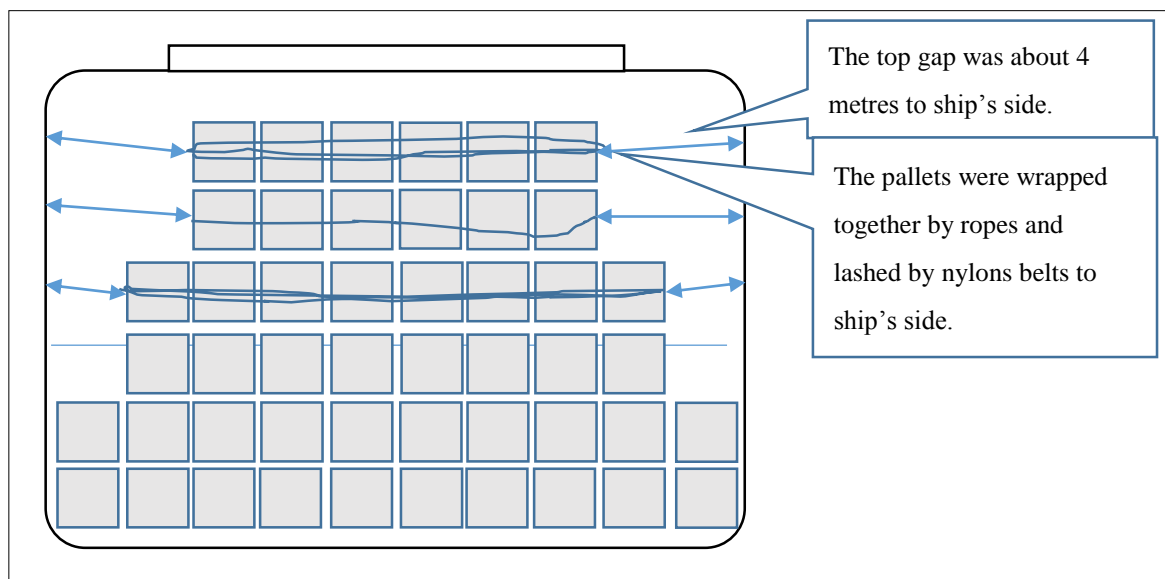
Fig.6 - illustration of pallets stack in cargo hold. Maximum gap was about 4 m.

5.5 There were free spaces on both sides of the cargo holds. For instance, at the top tier, the free space between the sides of the cargo and the ship's sides were about 4 m wide (Fig.6).

5.6 According to the cargo securing manual, the unit loads should be stowed without any free spaces between the unit loads and the ship's sides to prevent the unit loads from racking during ship sailing. Also, lashing wires with grating and plywood should be used for securing of the cargo stack. Timbers should be used to transform any irregular shapes inside cargo holds into rectangular shapes. However, at the time of

the accident, the upper tiers pallets of cargo were only lashed by ropes and secured to the ship's structure by nylon belts. There was no proper support (i.e. use of timbers or steel bars) to prevent cargo from shifting despite the 4 m wide free space emerging between the cargo and the ship sides. As such, it was evident that the cargo securing arrangement did not comply with the ship's cargo securing manual. The crew also admitted that the cargo was not stowed satisfactory.
