Report of investigation into the
fatal accident on board Hong
Kong registered chemical tanker
“Alpine Maya” at Fujairah, UAE
on 18 April 2014

The Hong Kong Special Administrative Region
Marine Department
Marine Accident Investigation Section

03 June 2015

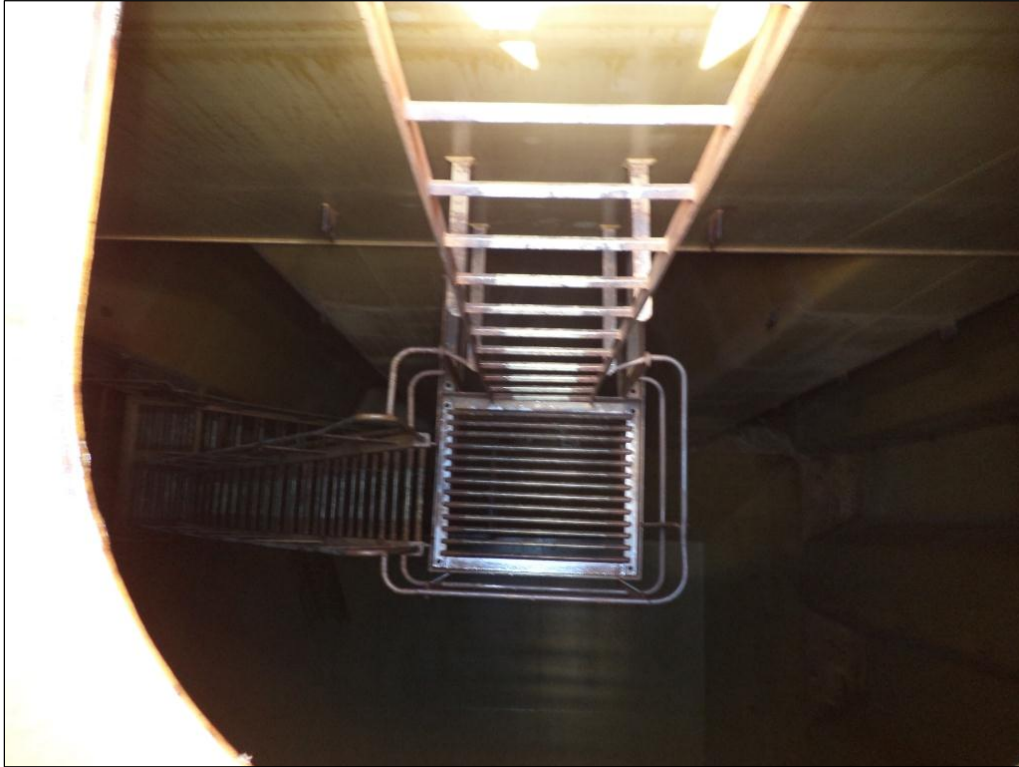
Fig.2 – Access ladder inside 4S COT

5.18 The access ladder into 4S COT, which was typical in other cargo oil tanks of the vessel, is shown in figure 2. The height from deck to the bottom of 4S COT was about 17.50 m. The length of the vertical ladder, which had no guard-rings, was about 3.9 m. It ended at the landing platform the size of which was about 950 mm by 1000 mm.

5.19 After the accident, it was confirmed that there was no damage to the vertical ladder.

- 5.27 From the analysis, based on the evidence and information available, it was deduced that the main contributory factors to the accident was that the superintendent who might have suffered from heat exhaustion that caused him losing his grabbing on the vertical ladder while he was entering into 4S COT in the afternoon under high ambient temperature. The vertical ladder without guard rings could not prevent him from falling sideway after he lost his grabbing on the ladder.

5.21 After the accident, the management company revised the relevant procedures and instructed the crew on board the vessel and all other vessels under its management to use fall arrestor when climbing a vertical ladder of 2.5 m in length or above. Also, the company would consider fitting guide rings on the vertical ladders inside cargo oil tanks of all similar vessels managed by the company during dry docking in order to prevent re-occurrence of similar accident.

- 7.2 The ship management company should consider fitting guard rings on the vertical ladders inside cargo oil tanks on all vessels under the management in order to prevent re-occurrence of similar accident.
