Report of investigation into the
fatal accident of Hong Kong
registered cargo ship “*Great
Immensity*” in Kohsichang
anchorage, Thailand
on 26 April 2014

The Hong Kong Special Administrative Region
Marine Department
Marine Accident Investigation Section

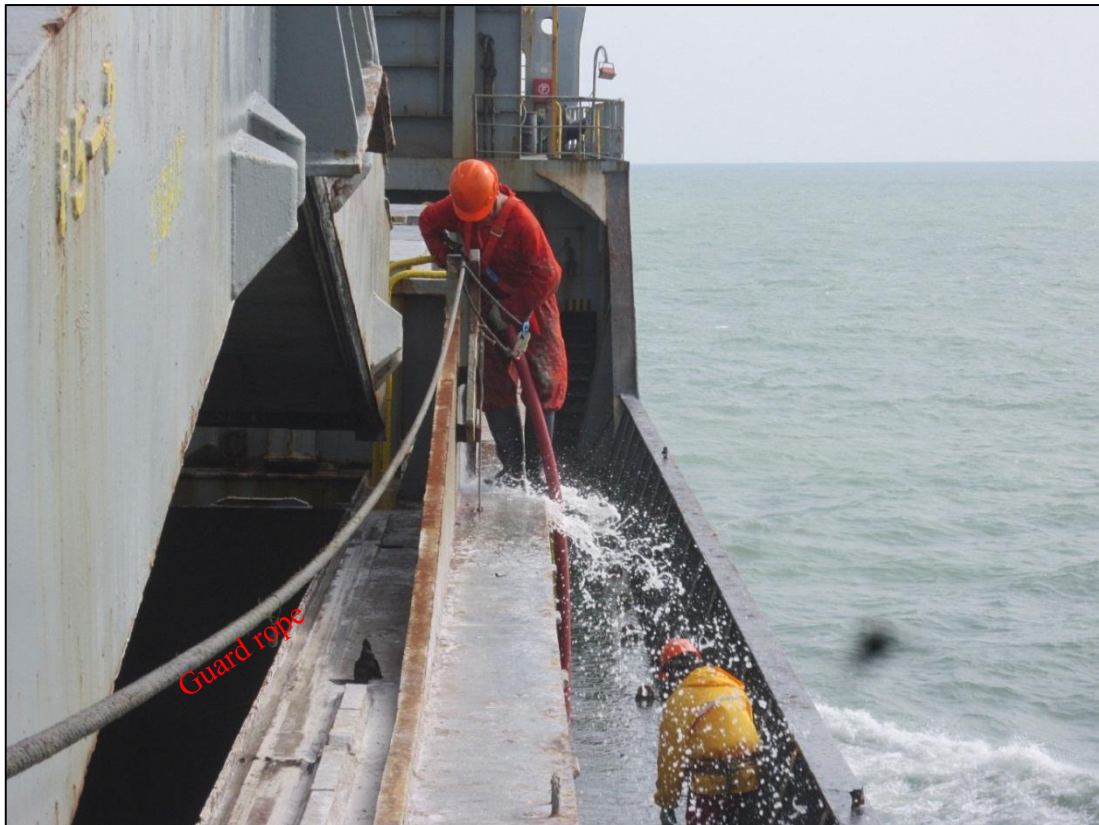
- 4.3 Before resuming the work, a safety briefing was conducted by the bosun attending by 3 ABs and a cadet. 2 ABs (AB1 and AB2) were assigned in one team to cleanse the coaming gutter way and hatch covers of the No.4 cargo hold (Figure.2).

- 4.4 The safety measures for the work were applied extensively by having a guard rope fastened to the ends of the coaming; and attaching the crew’s safety harnesses to the guard rope while working on the gutter way.

Fig.2 – Arrangement for working on the gutter way of coaming.

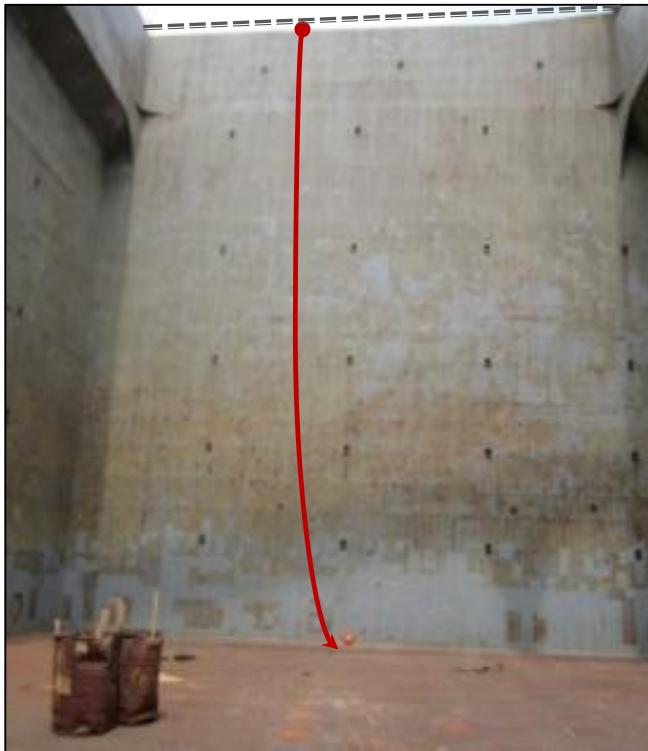
- 4.5 At about 1540 on 26 April 2014, AB1 was standing at the middle of the gutter way in way of No.4 hatch port side coaming. The hose was flattened as the hose was bent and hence blocked the water flow. AB1’s safety harness was tangled with the flattened water hose. He unhooked his safety harness from the guard rope and tried to free it from the water hose. AB2 assisted to release the bends on the hose. Suddenly, the flattened water hose under the foot of AB1 was inflated and stretched or jerked when water pressure built up inside the flattened hose after the bends had been unfolded. AB1 lost his balance and fell down to the bottom of the No.4 cargo hold from a height of about 16 m. He was seriously injured and unconscious.

Fig.3 – Cargo hold No.4, the red arrow indicating the fall of AB1.

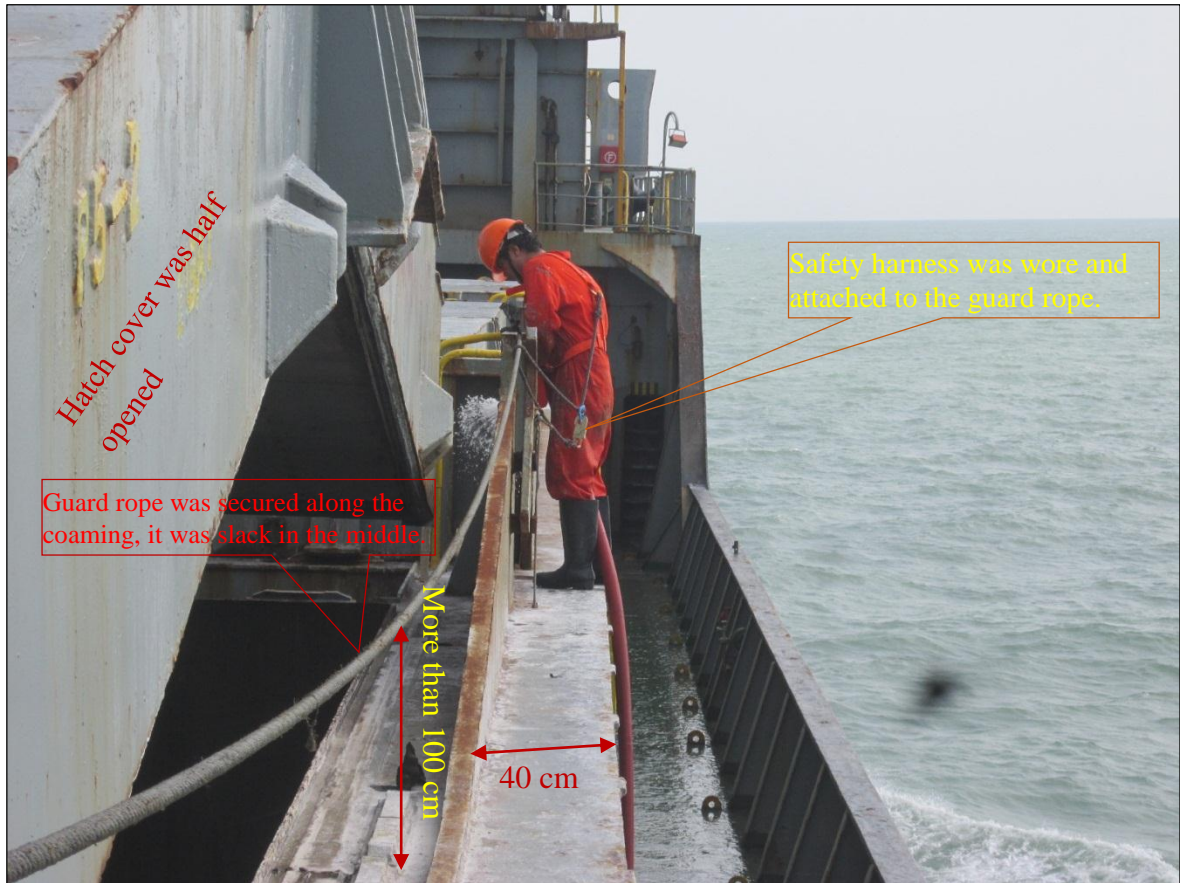
- 5.6 As a general practice on board the vessel, a guard rope was secured on the coaming for such operation. The gutter way of the coaming was about 40 cm in width. The hatch cover was half-opened for the convenience of cleansing. The crew wore safety harness with a safety lanyard attaching to the guard rope while working on the gutter way.

Fig. 4 – One crew was cleansing the hatch coaming on the gutter way.

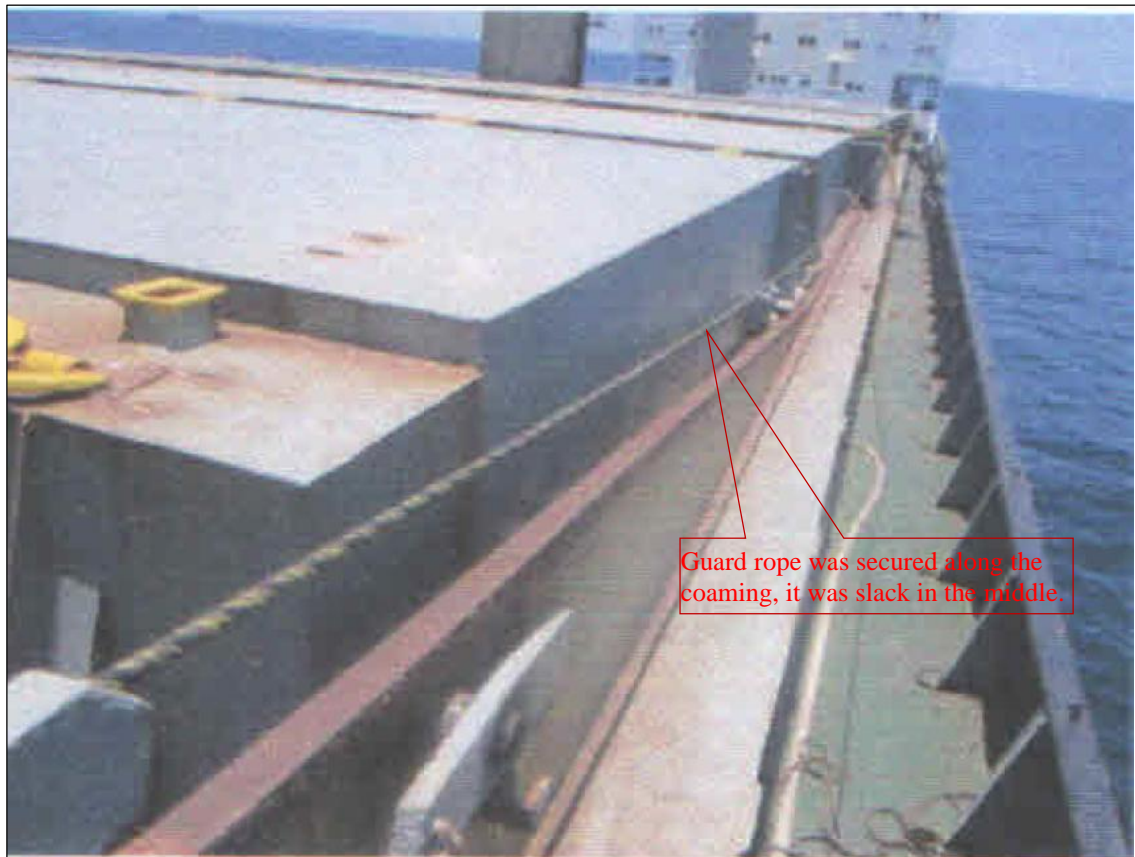
- 5.7 Normally, the gutter way would become wet and slippery during cleansing. The guard rope should not be regarded as a guard rail. The gap between the rope and the hatch coaming was about 1 metre at the midway. It was more than 1 metre in other areas. The guard rope connecting to the safety harness must be maintained by the crew at all times to prevent falling at height.

- 5.8 At the time of the accident, AB1 was standing in the middle of the hatch coaming. He disconnected the connecting lanyard of his safety harness from the guard rope in order to release his safety harness from tangling with the flattened water hose. After the bends of the water hose had been unfolded by AB2, the flattened water hose under the foot of AB1 inflated suddenly when pressure built up inside the hose. Under the circumstance, the hose which was under the foot of AB1 stretched or jerked. It was probable that it caused AB1 to lose his balance. As his safety harness was not attached to any strong point and both of his hands were occupied (one hand holding the lanyard of his safety harness and the other hand holding the nozzle), he was unable to grab the guard rope in time and consequently fell down to the bottom of the No.4 cargo hold about 16 m below the coaming

Fig.5 – view from forward, a guard rope was secured along the coaming.
