Report of investigation into the death
of a Bosun onboard the Hong Kong
registered bulk carrier *Jumeirah
Beach* in the Yellow Sea

at position 33⁰35.9'N 123⁰16.4'E
on 2 June 2014

The Hong Kong Special Administrative Region
Marine Department
Marine Accident Investigation Section

30 June 2015

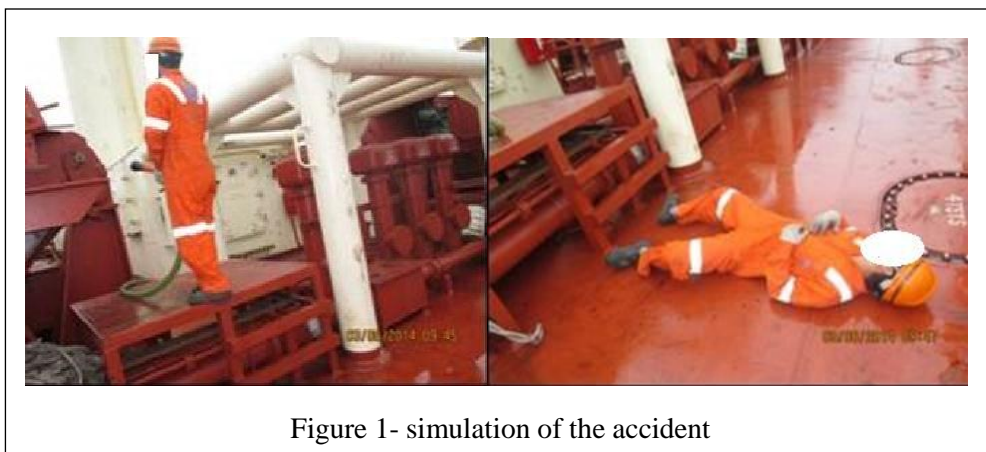
- 4.4 The bosun was found to have fallen down from the platform onto the deck with the back of his head hitting against the deck (Figure 1). The OS working in the vicinity immediately came up to help the bosun when he saw him lying on the deck. At that moment, the bosun did not give any response. The OS removed the safety helmet of the bosun and tried to wake him up but was in vain. No sign of wound or blood was seen on the bosun's head, but he was unconscious.

Figure 1- simulation of the accident

- 5.5 There was no witness to the accident. Before the accident, the bosun was on the stepping platform, which was about 0.85 meter in height above the main deck, holding a water hose to wash the hatch coaming of No.2 cargo hold. While concentrating on his work and with his back facing the side of the platform, the bosun might not have been aware that he was already standing near the edge of the stepping platform and was prone to losing his footing and eventually fell.

- 5.7 As witnessed by the crew, he was lying down with his back on the deck after the accident. It indicated that, probably due to losing of his footing, the bosun had fallen backwards from the platform with the back of his head hitting against the deck. He sustained serious injury to the back of his head, which was consistent with the findings in the certificate of death.

- 7.1 A copy of the investigation report into the accident should be provided to the ship management company and the master of the vessel informing them of the findings of the investigation.
- 7.2 The ship management company should issue safety circular and/or instructions to the fleet of vessels under the management in order to:
- a) disseminate the lessons learnt from the accident; and
 - b) instruct all crew on board to always maintain their alertness even when they are working only on a low-rise stepping platform.
- 7.3 Hong Kong Merchant Shipping Information Note should be issued to promulgate the lessons learnt from this accident.

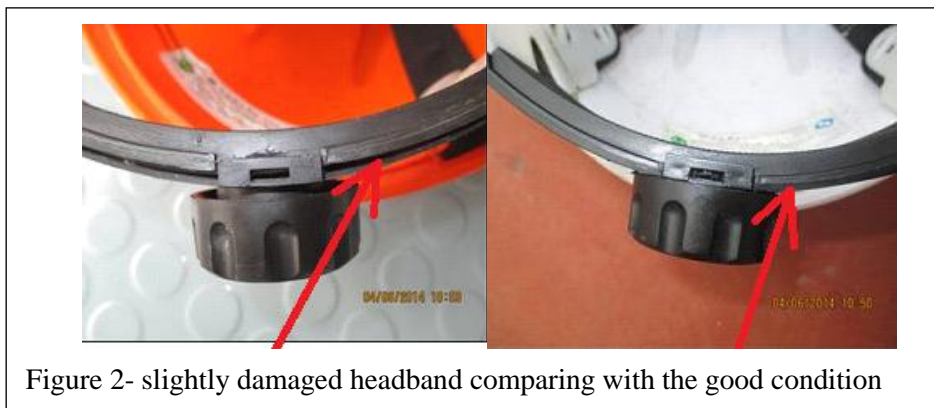
- 5.3 The bosun wore a safety helmet with the manufacturing date of September 2013 stamped on it. The validity would normally be 2.5 years (i.e. needs to be replaced in March 2016). Inspection of his safety helmet after the accident revealed that the adjustable headband of the safety helmet was slightly damaged (Figure 2). Except the said damage, there was no damage to the shell and the harness (Figure 3). The damage to the helmet was most probably caused by the impact force when the bosun fell down from the platform onto the deck.

Figure 2- slightly damaged headband comparing with the good condition

- 5.8 The adjustable headband of the safety helmet used by the bosun was found slightly damaged in the accident. It was probably caused by the impact force subsequent to the bosun falling backward down from the stepping platform. The design of a safety helmet was not meant to protect a person from injury at the back of his head due to such falling at height.

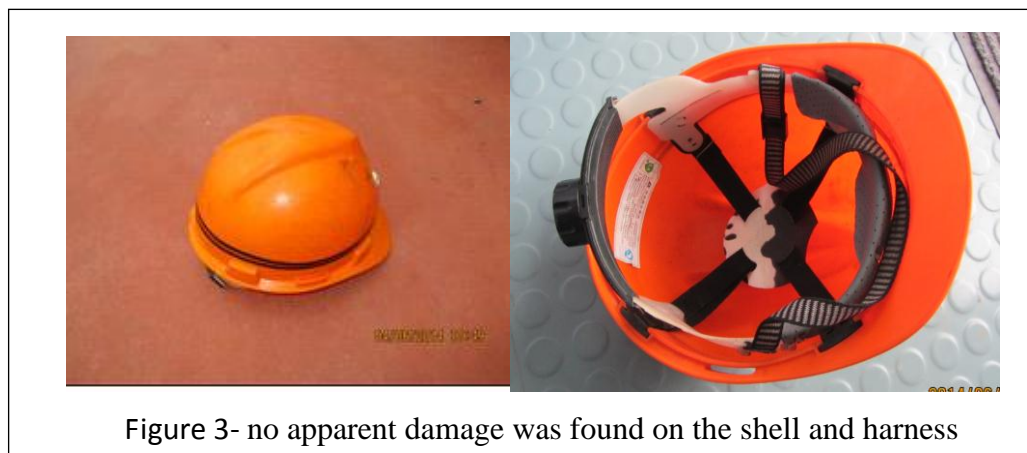
Figure 3- no apparent damage was found on the shell and harness
