Report of investigation into the
fatal accident of an Able-Bodied
Seaman on board Hong Kong
registered bulk carrier *Tuo Fu 8*
on 10 June 2014

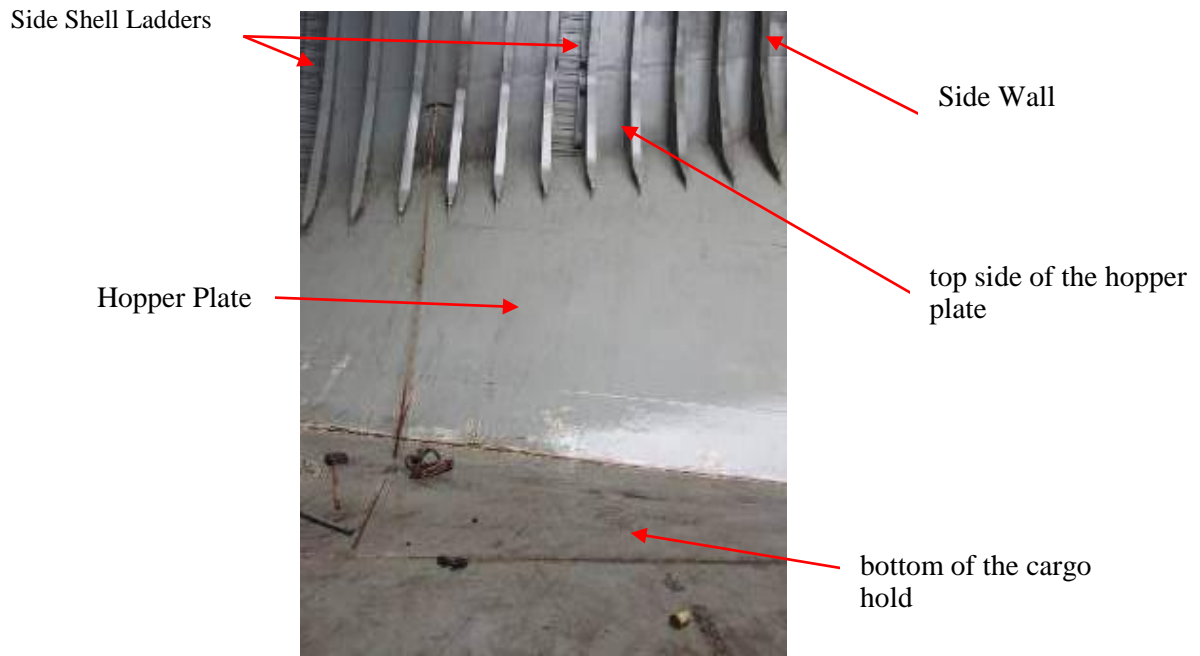
Fig.2 No.1 Cargo Hold, port side

- 4.6 One by one, they climbed a portable aluminum ladder to reach the top of the hopper plate, thence they continue to climb the vertical ladders (Figure 2 and 3) to reach the upper part of the side wall. There were four such vertical ladders on the side wall. The OS and the CDT were at the bottom of the cargo hold responsible for shifting and securing the portable aluminum ladder for the Bosun and the Able-Bodied seamen.

- 5.12 The top of the hopper plate joining the side wall of the cargo hold was an acutely inclining surface and probably was wetted by washing water during cargo hold cleansing. It was not safe for crew to stay at that position without using a safety belt.

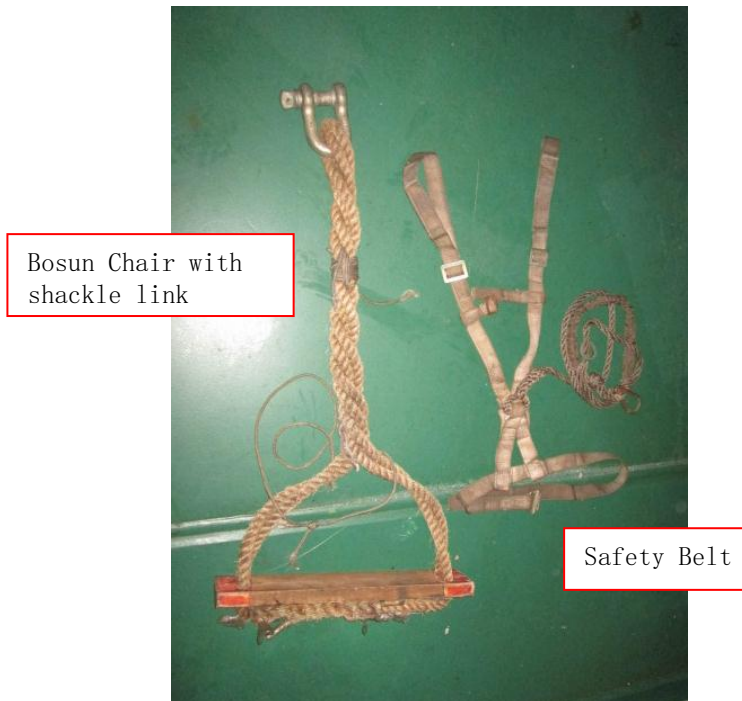
Fig. 4 Bosun chair and safety belt

4.7 Each crewmember moved up and down along the vertical ladder for cleansing the side wall at different heights. When they stopped at a position for cleansing, each of them would secure the bosun chair with shackle link and the safety belt (Fig. 4) to the vertical ladder. During the cleanse, they sat down on the bosun chairs and used the extension rods fitted with rags to mop the wall. If the dirt on the wall could not be removed by mopping, they would request the OS and CDT to wet the surface with a high pressure water hose.

- 5.9 After the accident, it was found that the bosun chair and safety belt used by the

deceased AB were intact.

- 5.11 The deceased AB wore the safety belt anchored to the vertical ladder when he was working aloft. However, after he had finished his work, came down and stayed at the top of the hopper plate while waiting for the OS and CDT, his safety belt was detached and was not anchored to the vertical ladder.
