Report of investigation into

the fatal accident of a stevedore on board the container vessel "NYK Orpheus" at Berth No.7 of Kwai Chung Container Terminals, Hong Kong on 14 June 2014

The Hong Kong Special Administrative Region
Marine Department
Marine Accident Investigation Section

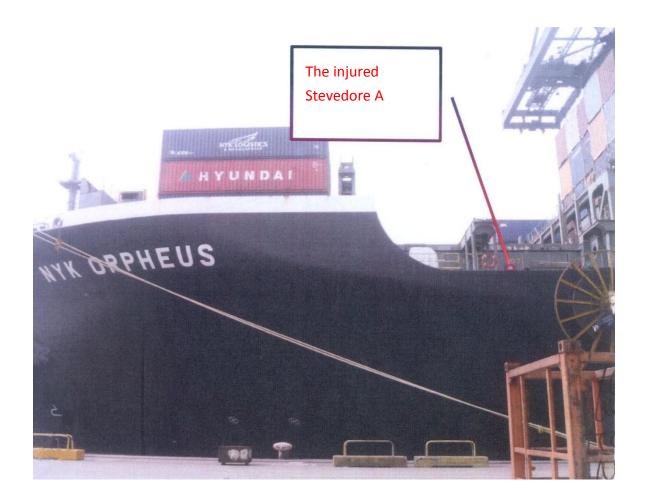
- 4.5 At about 1050, the crane operator using the shore crane lifted and suspended a container over the wharf while waiting for a truck to arrive for receiving the container. Inside the control cabin, the crane operator saw a person (Stevedore A) lying on the deck passage in the vicinity of bay No.7.

Fig. 2 - The location of the injured Stevedore A

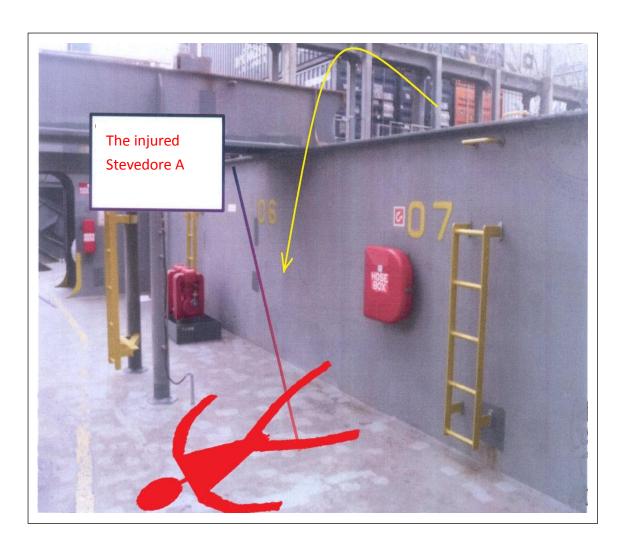
- 4.8 Stevedore A was seen vomiting. His forearm and eyeballs were swollen with blood coming out from the eyes. The posture of his body lying on the deck was head pointed to the wharf and slightly to the aft of the *vessel*; feet pointed to bay No.7 and slightly to the fore of the *vessel* (Fig. 3). His helmet was seen located at the left side of his head. His safety shoes and reflective vest were on his body.
- 4.9 At about 1115, an ambulance arrived at the scene and took the Stevedore A to hospital for treatment. He was certified dead in the hospital on 18 June 2014.

Fig. 3 - Stevedore A fell down from hatch cover onto the deck passage

- 5.6.2. Stevedore A was seen lying unconsciously with his face up on the deck passage. The body posture suggested he fell backward from the hatch cover onto the deck passage.

- 5.6.3. Stevedore A had worn safety helmet. However, it appears that the safety helmet could not protect him from head injury.
- 5.6.4. It was highly probable that, at 1035 on 14 June 2014, Stevedore A tripped and lost his balance while walking in the vicinity of the edge of the hatch cover thus causing him falling down backward from a height of about 2 metres onto the deck passage. He sustained fatal head injuries at the back of his head.

- a) works supervisors and stevedores should always be cautious when staying or working at height with a risk of falling down; and
  - b) as far as practicable, works supervisors and stevedores should not work alone on board ships.
