Report of investigation

into the fatal accident of an Ordinary
Seaman falling into the cargo hold
onboard the Hong Kong registered bulk
carrier *Tian Bai Feng* at Lanoraie
anchorage, Montreal, Canada
on 2 July 2014

Marine Accident Investigation Section
Marine Department
The Hong Kong Special Administrative Region

21 August 2015

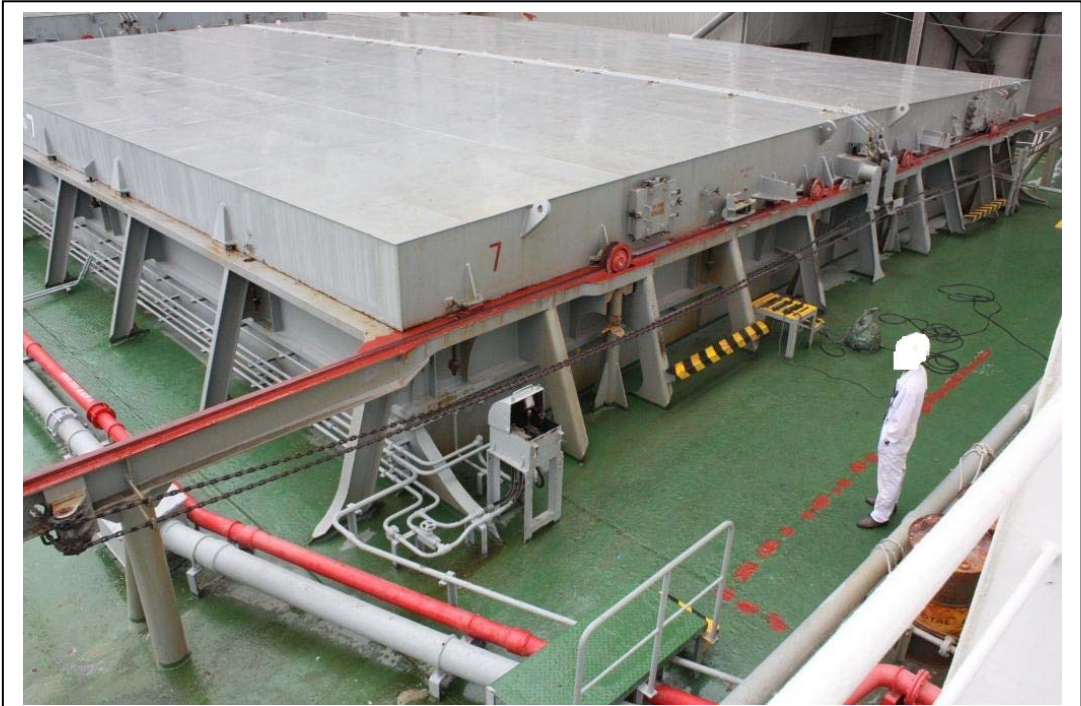
Figure 2- hatch covers type, chains driving system

The vessel has seven cargo holds with hatch covers in the type of MacGregor hydraulic to confirm side rolling (Figure 2).

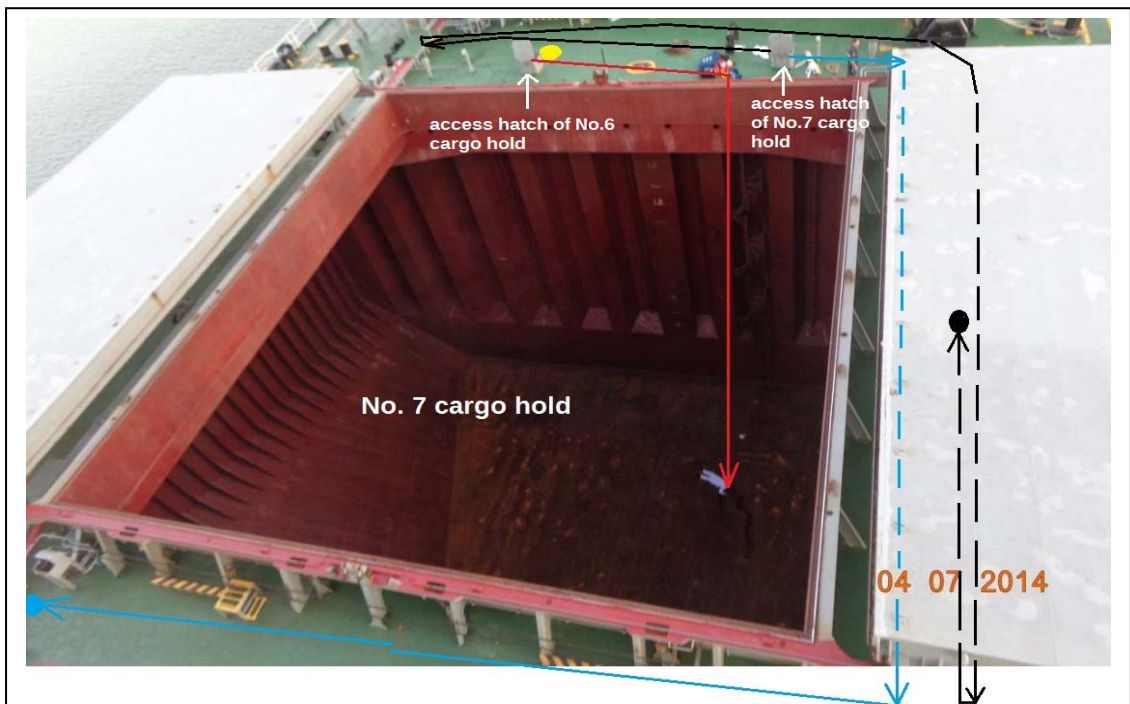
Figure 3- Top view of the No.7 cargo hold, looking forward, each person's route and location in the incident:

4.4 At about 1910, the chief engineer and oiler B finished their work and came out from the access hatch at starboard forward of the cargo hold No.7. A safety check was then conducted along the hatch coaming by the oiler B and the chief engineer (Figure 3 - each person's route and location in the incident). The oiler B inspected the port side forward, starboard forward and the starboard aft respectively. He found that everything was normal and walked forward and at the time of incident, he was at about the half way of his passage along the No.7 hold at the starboard side.

and the oiler B went out of the cargo hold and proceeded to do a safety check in preparation to close the hatch covers (Figure 3). They found that everything was normal and the chief engineer proceeded to the control station. His vision being blocked by the hatch cover, the chief engineer was not able to see the OS standing on the chains and he started the operation of closing the hatch covers (Figure 6). At that time, oiler B was situated on the main deck about the half way along the No.7 hold on the starboard side. The chief engineer who was the highest ranked officer in the teams, had failed to take overall control of the operation.

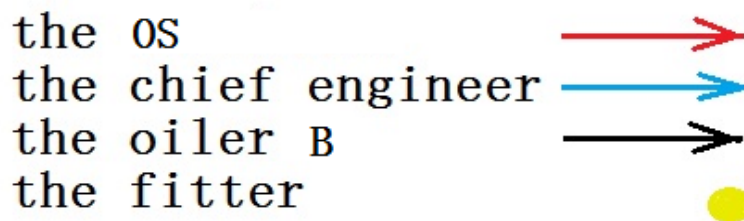
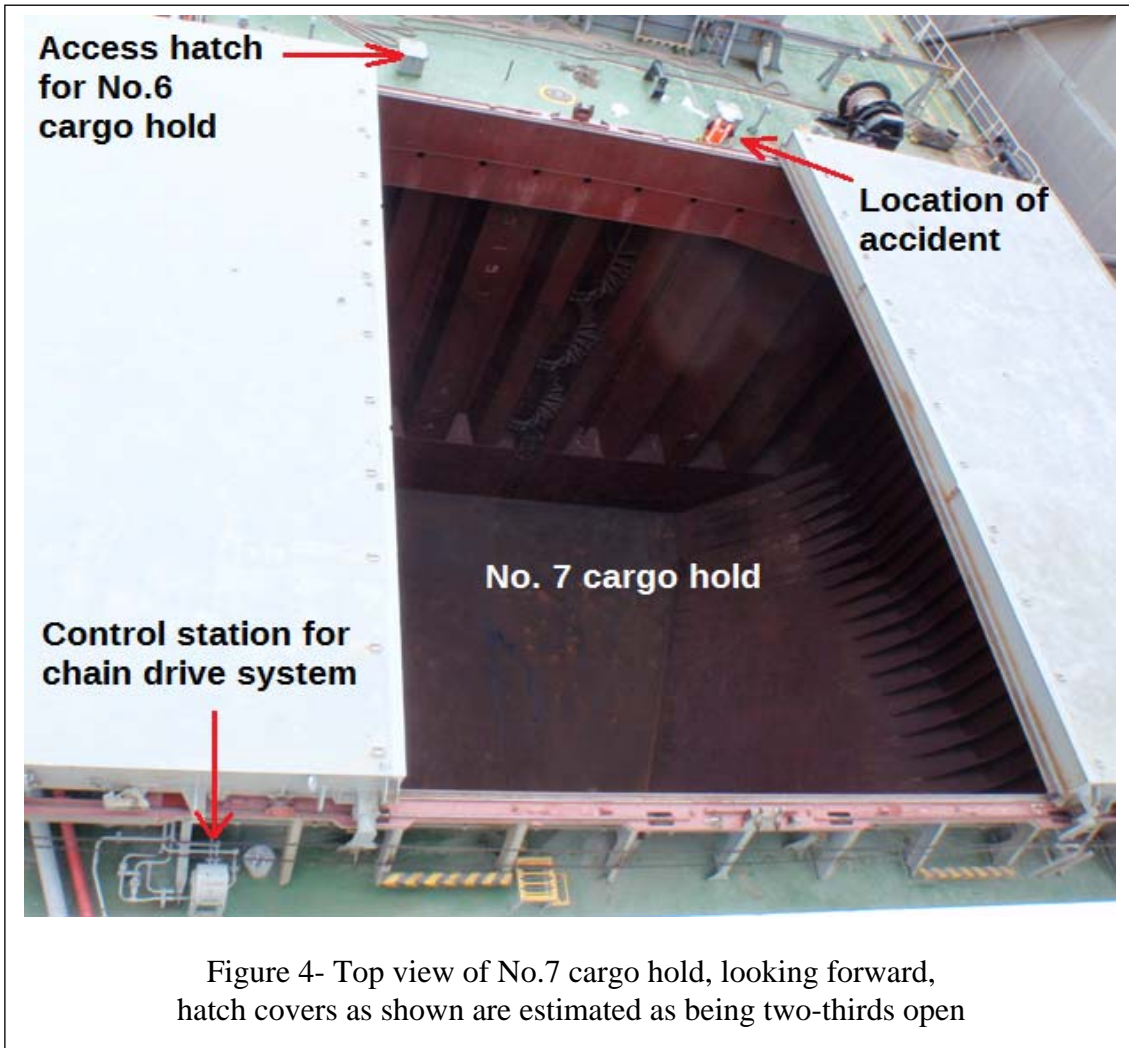
4.5 At the same time, the chief engineer, after having completed the safety check, proceeded to the control station at port side aft of the hatch coaming in order to operate the hydraulic valves to close the hatch covers of the cargo hold No.7, which were approximately two-third open (Figure 4).

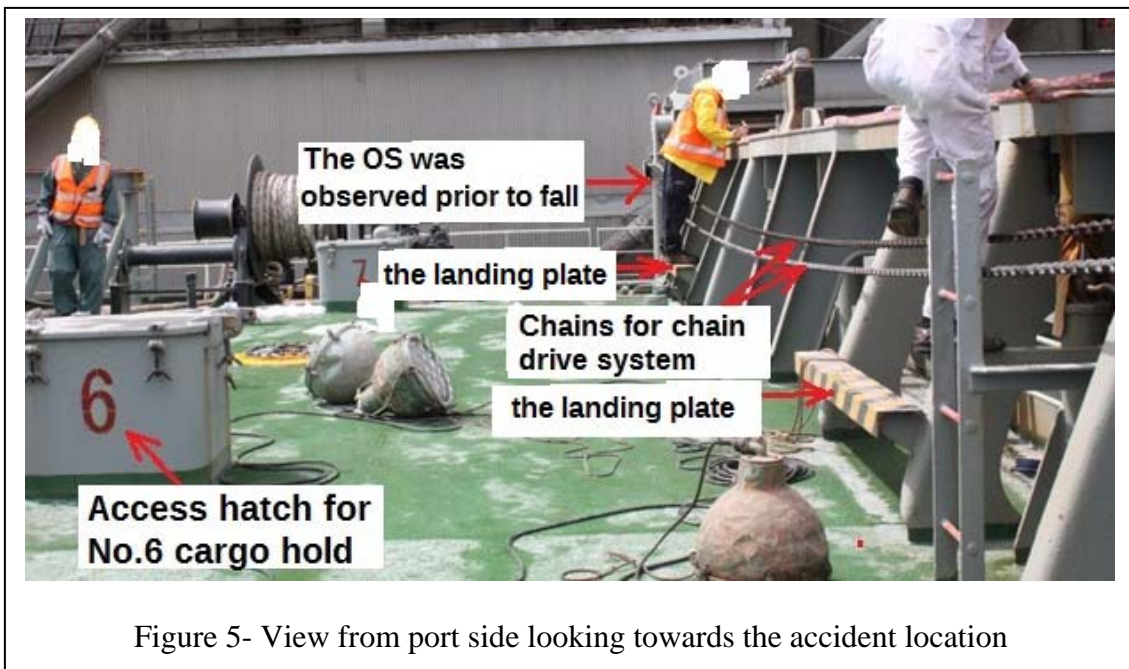
4.6 At that time, the OS and the fitter had also finished their work in the cargo hold No.6 and came out via the access hatch at port side aft of the cargo hold. The OS came out first, followed by the fitter. The OS went to check if anyone was still working in the cargo hold No.7, he stepped on the landing plate (Figure 5) at the forward starboard corner of the hatch No.7. The landing plate was just below the chains used for the hatch cover operating system.

- 5.7 After the OS had come out from the cargo hold No.6, it was not clear why he immediately went to check whether there was anybody still working inside the cargo hold No.7. In order to have a clear view inside the cargo hold No.7, rather than standing on the landing plate, he stepped on the chains which were at a higher position than the landing plate. It was a dangerous act for the OS to stand on the chains as he may lose his balance and resulting in falling into the cargo hold through the hatchway.
- 5.8 At the time of the accident, the chief engineer was just operating the hydraulic motor to pull the chains for closing of the hatch covers of the cargo hold No.7. The sagged chains were tightened and sprung. As a result, the OS was bounced up, lost his balance and fell into the cargo hold.

- 5.9 A banging sound could be heard on the deck when the hydraulic system and the hydraulic motors were running. There was no visual or audible warning signal to indicate that the chains driving system was operating.
- 5.10 The control console for opening and closing of the hatch covers for each the cargo hold was installed at deck level. As the height of the hatch covers was about 3 metres, the view of the operator would be obstructed and rendered him not able to see the opposite side of the cargo hold (Figure 6).
- 5.11 The two chains for the chains driving system located above the landing plates on the forward hatch coaming (Figure 5) and no protect guard or other safety device was fitted to protect personnel standing on the landing plates from being hurt by the running chains during the hatch cover operation.

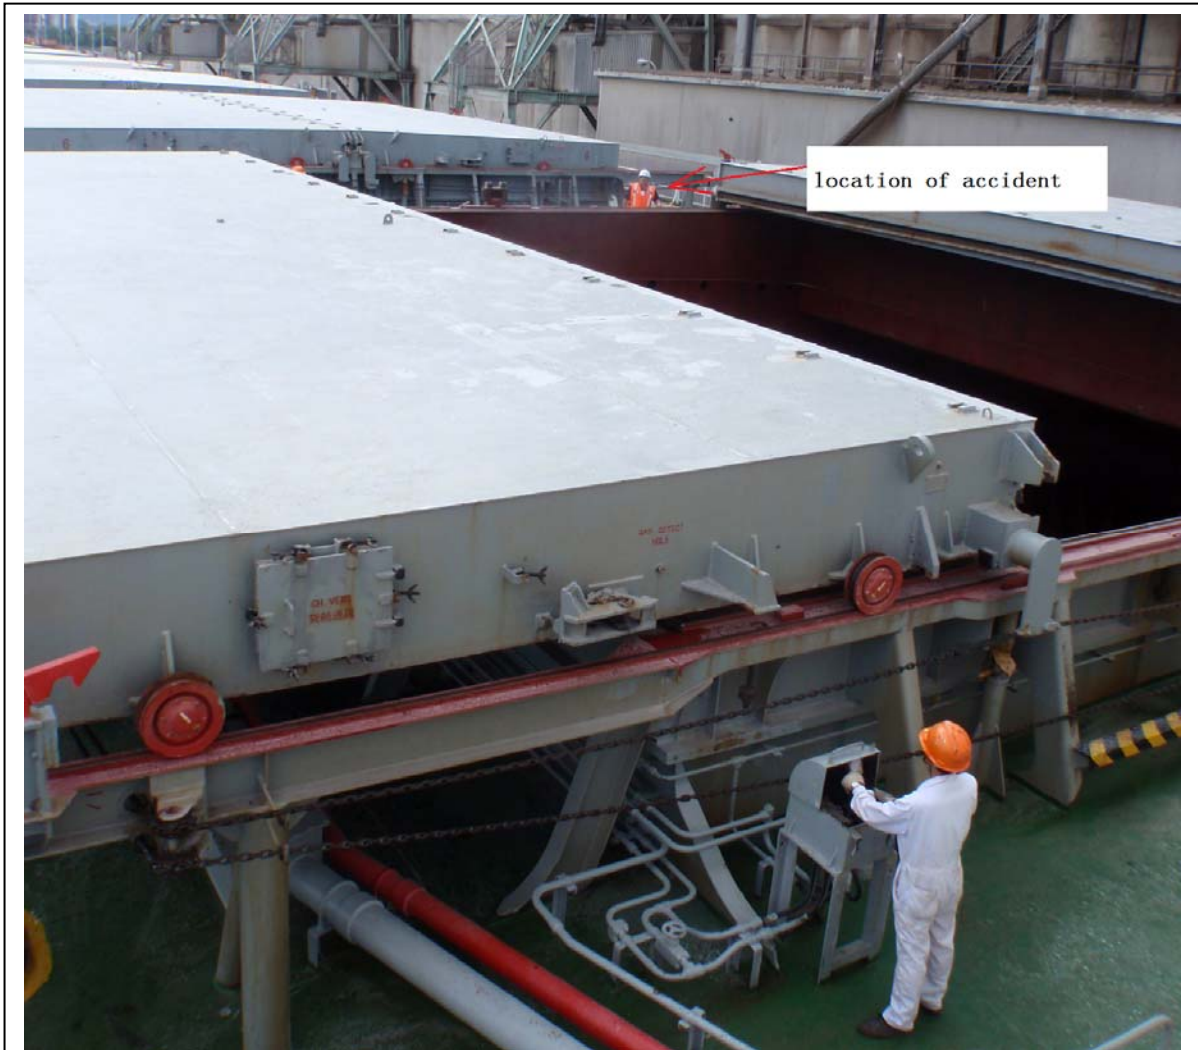
- 5.6 That the chief engineer did not ensure that everyone had cleared from the hatch covers before closing was considered as one of the contributing factors of this accident.

Figure 6- Simulation of the accident:
View of operator was obstructed

- 7.1 A copy of the report should be sent to the master and the management company of the vessel drawing their attention of the findings of this incident and the lessons learnt. The management company of the vessel should ensure that:
- a) The company procedure, “the instruction for opening & closing operation of hatches”, is effectively implemented and crewmembers should be well trained under the procedure;
 - b) Visual and audible warning signals to alert personnel aware of the pending operation of hatch should be fitted; and
 - c) Protective guards should be fitted or other arrangement should be made to prevent crew from being hurt by the running chains.
- 7.2 A Hong Kong Merchant Shipping Information Note should be issued to promulgate lessons learnt from this accident.
