**Report of Investigation into
the explosion onboard the
Hong Kong Registered
chemical tanker *Liang Sheng*
resulting one death and one
injured in South China Sea off
Shanwei, China
on 12 July 2014**

The Hong Kong Special Administrative Region
Marine Department
Marine Accident Investigation Section

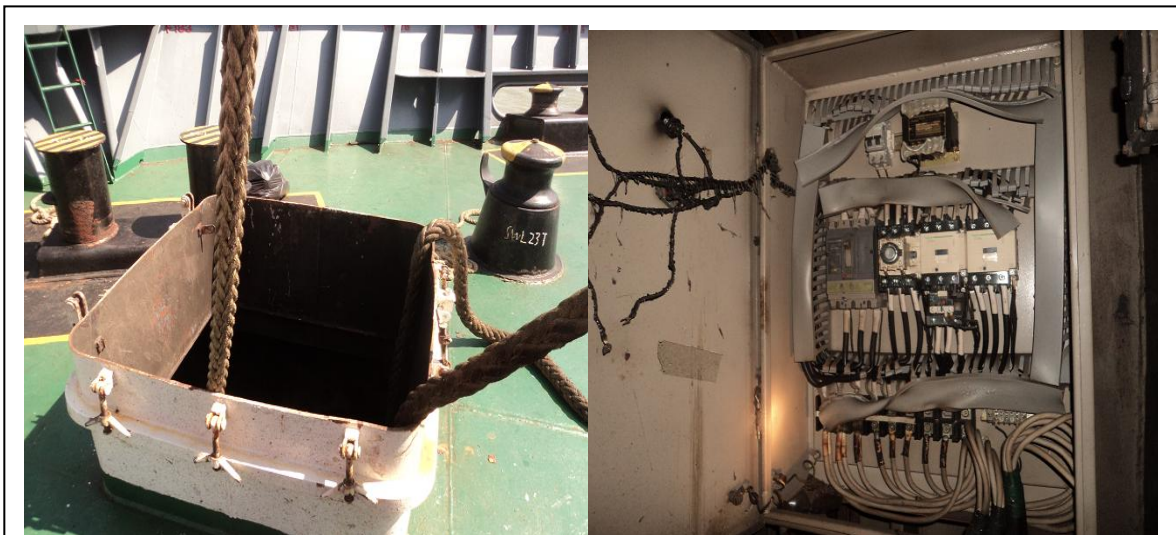
3. The store room and the equipment installed inside including electric control panels and cables, lights and escape hatch cover etc. were badly damaged.

- 4.11 The store room was badly damaged. About 90% of electric cable inside the room was damaged. All electric control panels were burnt. All lights were broken and the escape hatch cover was sheared and blown overboard (Fig. 2 & 3).

Fig.2 Left - the escape hatch cover blown away. Right - electric control panels deformed and burnt

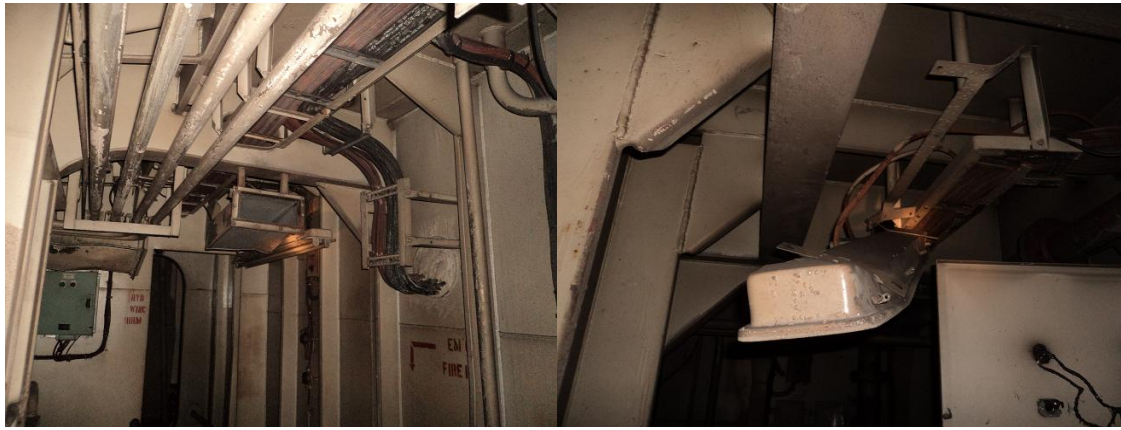
Fig. 3 - Left – 90% of electric cable burnt. Right – all lights broken and damaged

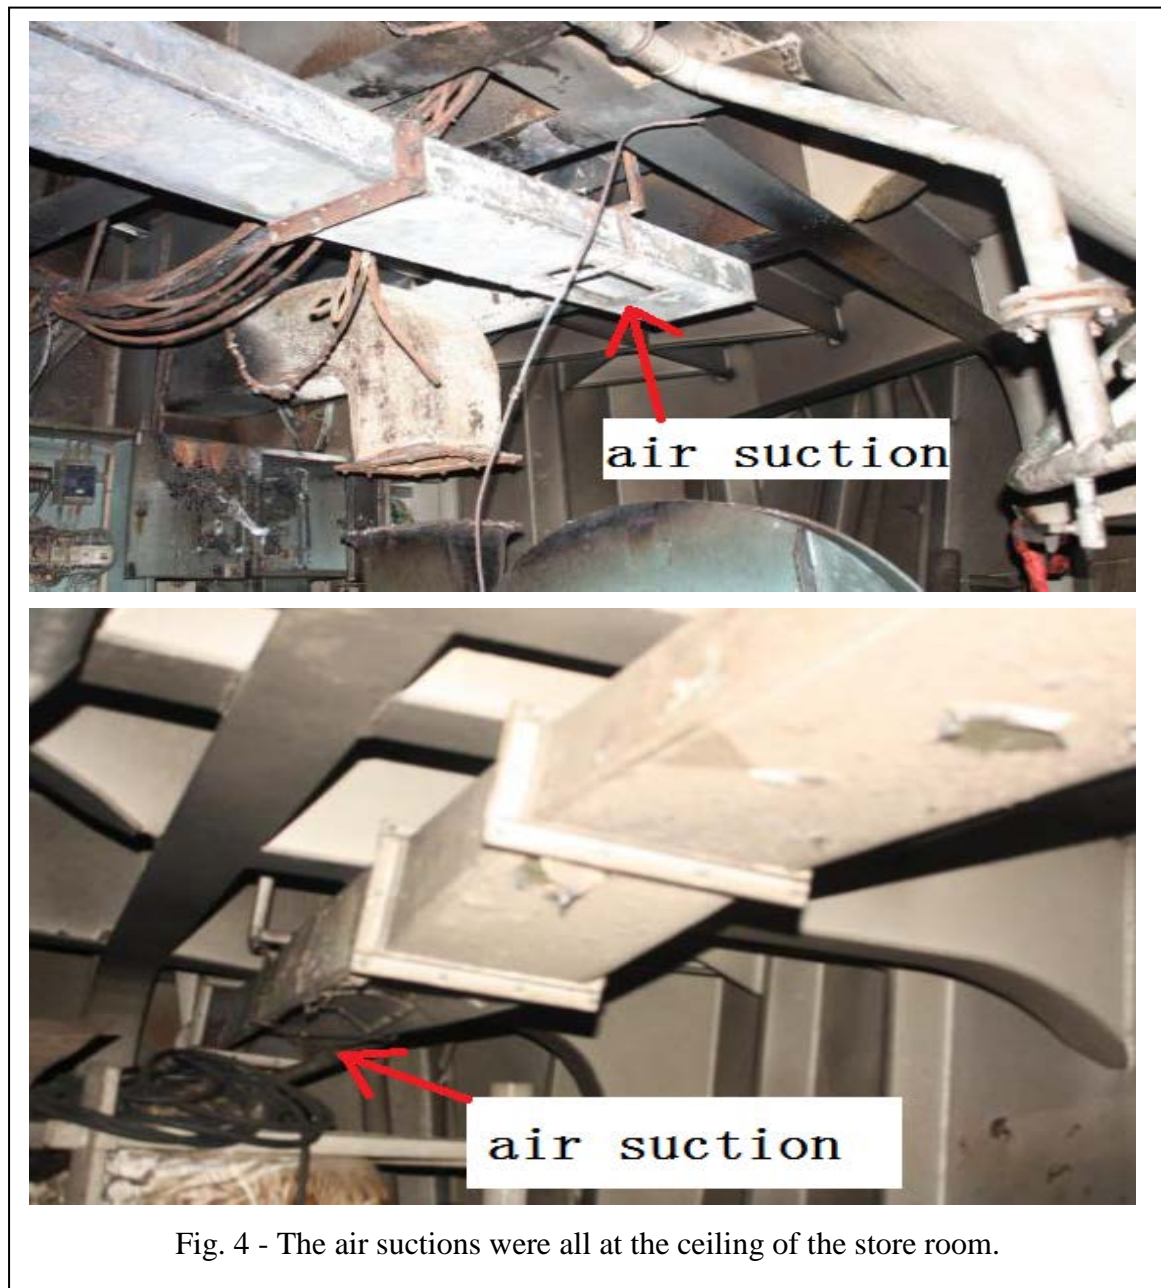
- b. The mechanical ventilation system of the forecastle store room was so designed that all the air suction were at the top of the store room (Fig. 4). Thus the air at the lower part of the store room was exchanged ineffectively. Investigation revealed that the access door of the forecastle store room was kept opened throughout the voyage, including the time when the cargo tank cleansing and gas-free operation were being conducted. The mechanical ventilation system of the store room was maintained at all times, thus, the air was continuously introduced into the store room. Furthermore, the wind was

blowing from the stern of *the tanker* and the crewmembers stated that they sensed a peculiar smell when conducting tank washing on deck. The cargo tank washing and gas-free operation would discharge a lot of LAB vapour. Therefore, it was possible that the LAB vapour would be sucked into the forecabin store room and accumulated at the lower part of the store room due to its density heavier than air.

Fig. 4 - The air suction points were all at the ceiling of the store room.

- 5.11 If the air suction points of the ventilation system in the store room could be installed at different height levels, the ventilation in the store room would be more effective and the LAB vapour might not have accumulated in the store room.

- 5.12 In order to prevent the recurrence of the explosion, the air ducts in the forecastle store room and the emergency fire pump room had been modified to improve the ventilation after the incident.

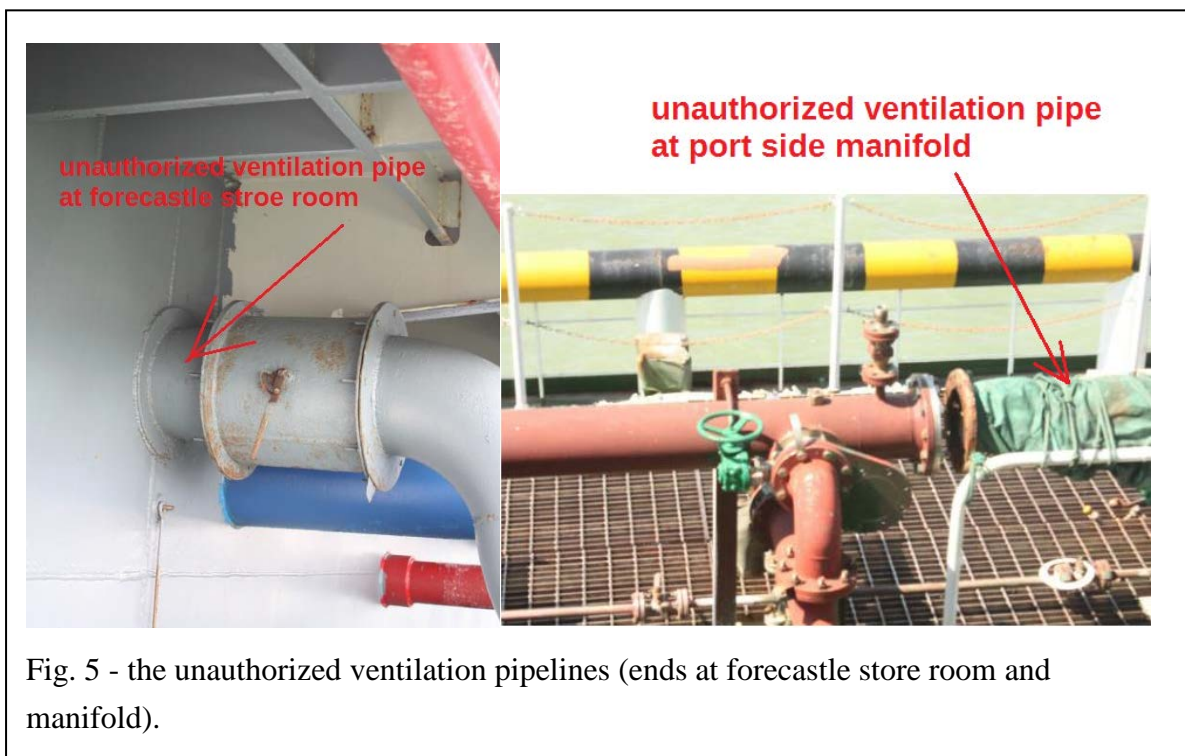
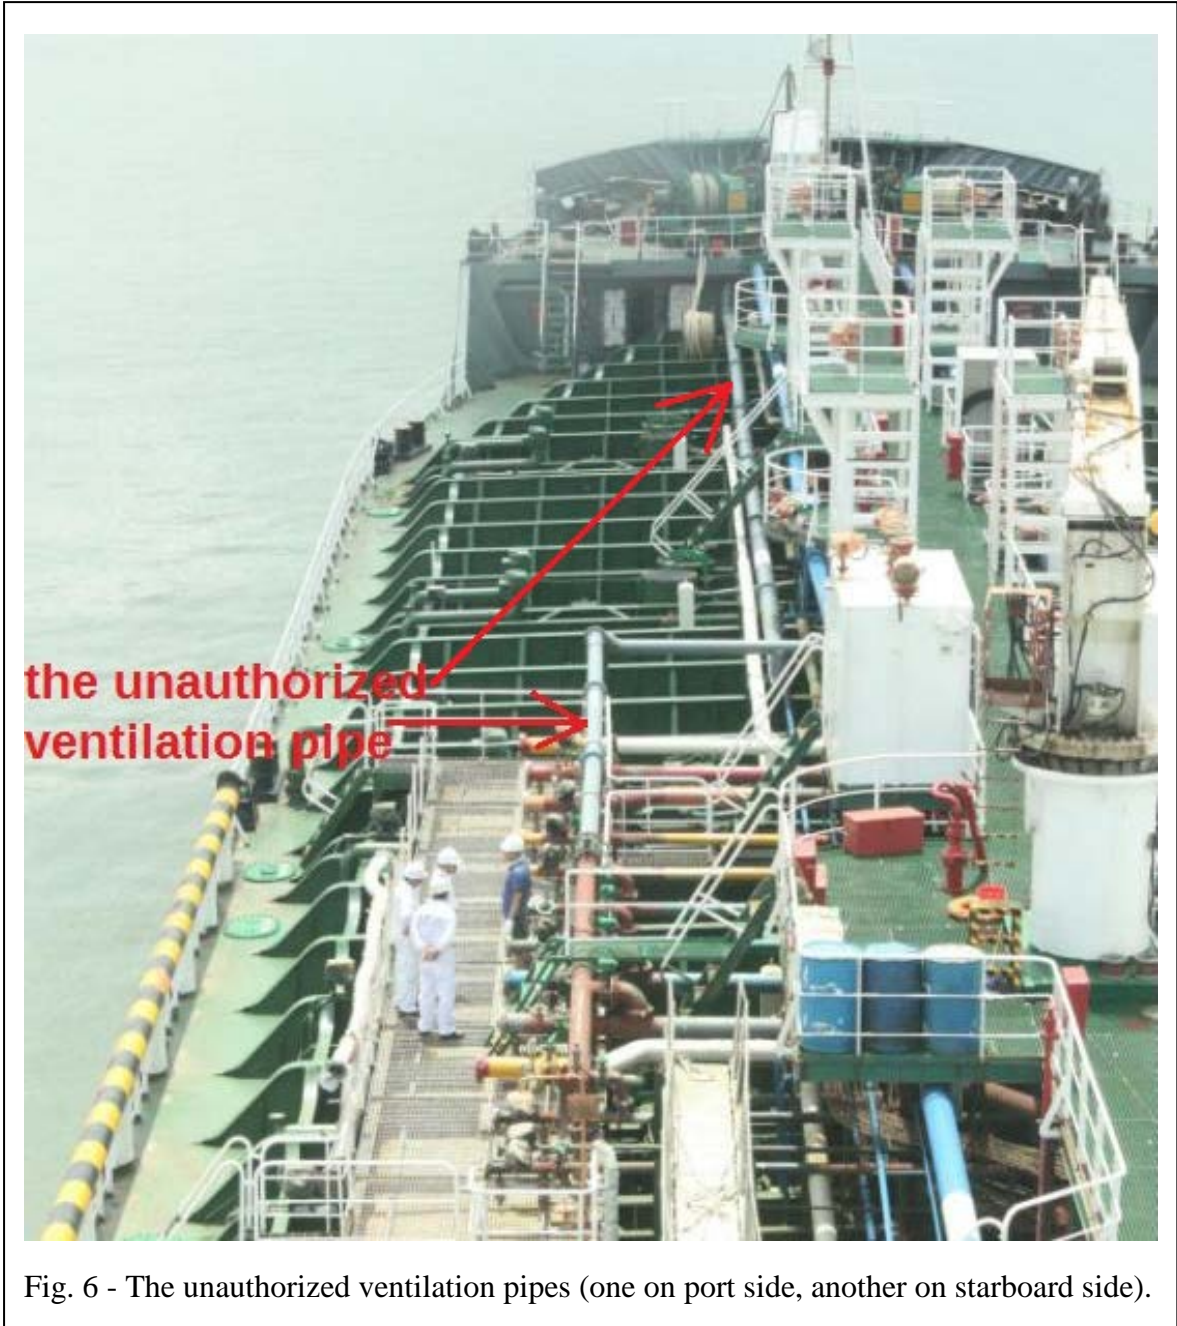
- 5.16 According to the shipowner, *the tanker* was originally owned by an European shipowner who could not take delivery of *the tanker* due to a financial problem. *The tanker* had been laid up for almost 3 years until the current shipowner took over it. The fixed ventilation pipelines (Fig. 5 & 6) and the non-explosion-proof fan for gas-free of cargo tanks had been installed at the time of delivery of the vessel on 30 July 2010. However, neither drawings nor operation procedures of such system was available. There was a cargo tanks gas-free procedure which used a portable type blower for gas-free of cargo tanks. The blower should not generate any spark during the operation, i.e explosion-proof type fan. In fact, such procedure was not applicable to the existing unauthorized ventilation pipelines and fan. Furthermore, no crewmember following such requirement in the cargo tanks gas-free procedure. The Safety Management System was not effectively implemented.

- 5.18 The ventilation pipelines and fan had not been submitted to the classification society for review and approval.
- 5.19 After the incident, the non-explosion-proof fan in the forecandle store room had been removed and an explosion-proof fan was installed in a new fan room and the ventilation pipelines were modified during dry docking. The revised General Arrangement was then approved by Classification Society the Nippon Kaiji Kyokai. A copy of “Instruction For Cargo Tank Gas Free Fan” was provided to *the tanker*.
- 5.20 The investigation also revealed that according to the witness statement, the flammable gas content had not been checked prior to the tank washing operation. It was not consistent with the record in the tank cleansing plan.

Fig. 6 - The unauthorized ventilation pipes (one on port side, another on starboard side).

- (d) to obtain the MSDS of cargo to be loaded for the characteristics of such cargo and take necessary safety measures before cargo operations.
- 7.3 The management company should ensure that any installation or modification to ventilation pipelines or ventilation fans of *the tanker* should be carried out after obtaining the approval from the classification society.

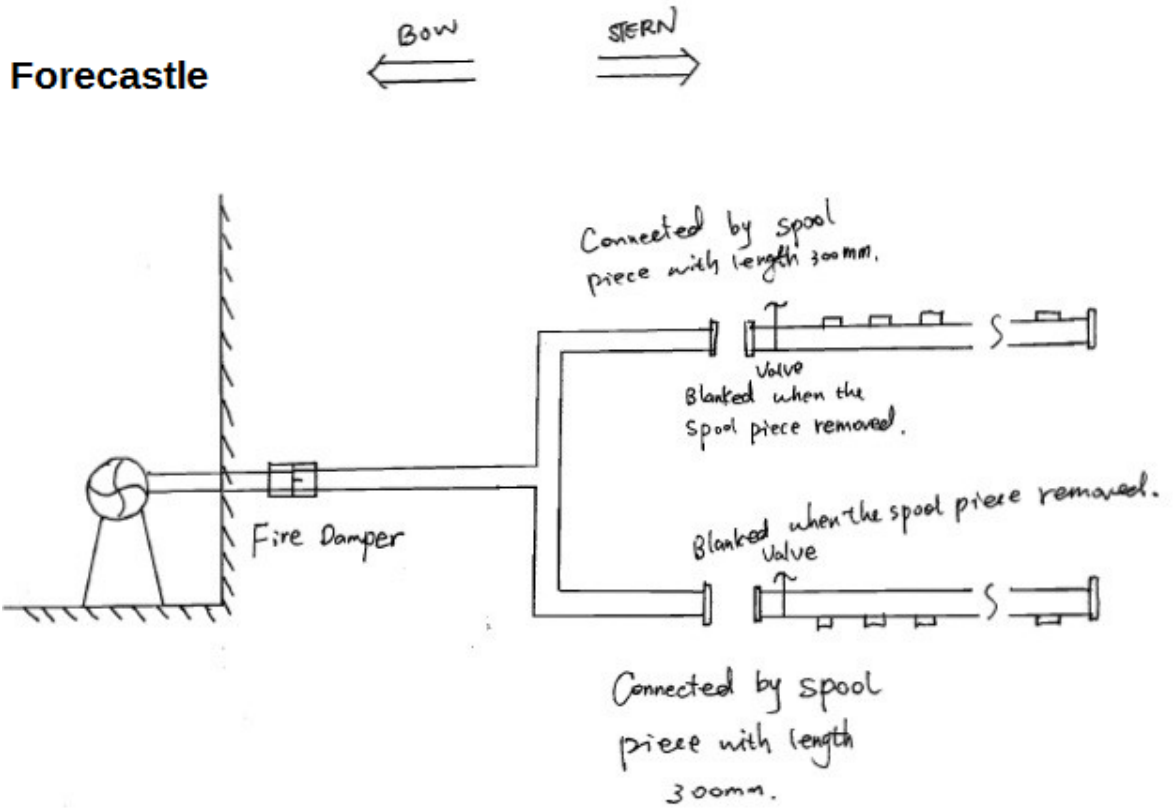
Appendix 1 the ventilation pipeline diagram

- 4.5 At 2100 on 12 July 2014, the cargo tank washing was completed. In order to speed up the gas-free process, an able-bodied seaman (AB) and a deck cadet (DC) removed the blank flanges of the ventilation pipe and the cargo pipe on deck (Appendix 1 the ventilation pipeline diagram). A spool piece was connected in between the ventilation pipe and the cargo pipe. Thus the force draft ventilation fan in the forecastle store room could be used for the cargo tank gas-free operation. This had been the practice adopted by them for gas-free operation.

- a. The fixed ventilation pipelines and a fan for gas-freeing cargo tanks had been installed since the delivery of the vessel on 30 July 2010. However, no pipelines diagram was available to explain the purpose of the ventilation pipelines. The ship owner made a sketch of the ventilation pipelines as shown in Appendix 1. It showed that two ventilation pipelines could be connected to the cargo pipelines on deck at the manifold on port and starboard side by the spool piece with a length of 300mm. In this incident, the two ventilation pipelines had been connected to the cargo lines before the fan was started. Through these ventilation pipelines, the LAB vapour might have spread into the forecastle store room. The Shantou Fire Department reported that there was a trace of continuous burning marks at the end of the ventilation pipe at the ventilator. It indicated that after the explosion, combustible gas continuously emerged from the ventilation pipelines, to support the combustion.

(There was no drawing available, owner provided a sketch as following.)
