**Report of Investigation  
into the fatal accident  
on board Hong Kong  
Registered Ship “*KSL  
Singapore*” at Beilun New  
Mineral Anchorage, Ningbo,  
China on 16 July 2014.**

The Hong Kong Special Administrative Region  
Marine Department  
Marine Accident Investigation Section

26 February 2015

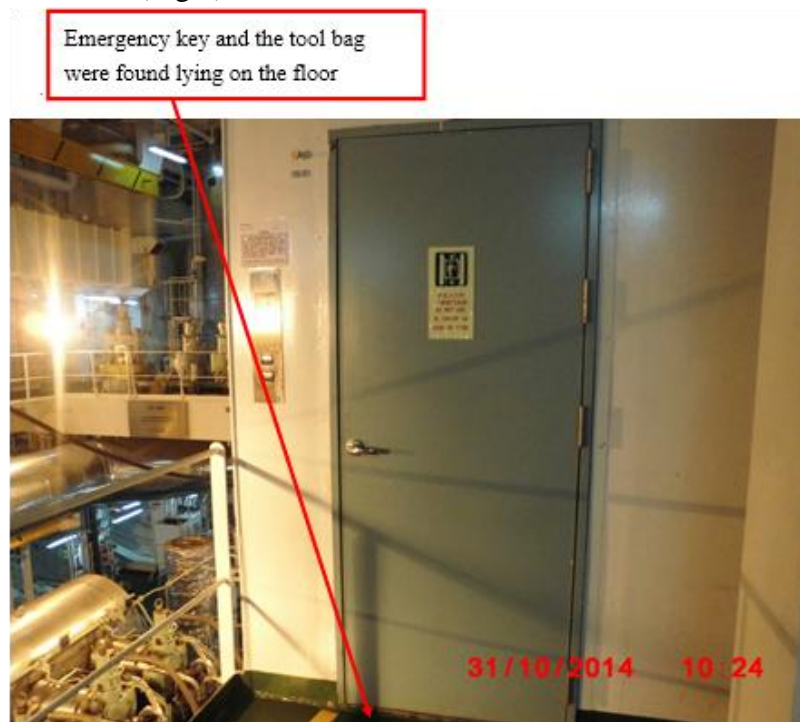
- 4.4 The missing of the E/O was not noticed until he did not present in the mess room for dinner at 1910. The Messman reported his missing to the 2/E. The 2/E then began to look for the E/O in the ER but in vain. The 2/E noticed that an elevator emergency key and a tool bag had been laid on the engine room second deck (ER 2nd deck) beside the elevator entrance door (Fig.2).

Fig. 2: Elevator Entrance Door at Engine Room Second Deck

on the upper deck and saw the posture of the E/O trapped in between the upper deck and the ER 2<sup>nd</sup> deck (Fig.4). The elevator emergency key and the tool bag were laid on the floor beside the elevator door on ER 2<sup>nd</sup> deck (Fig.2).

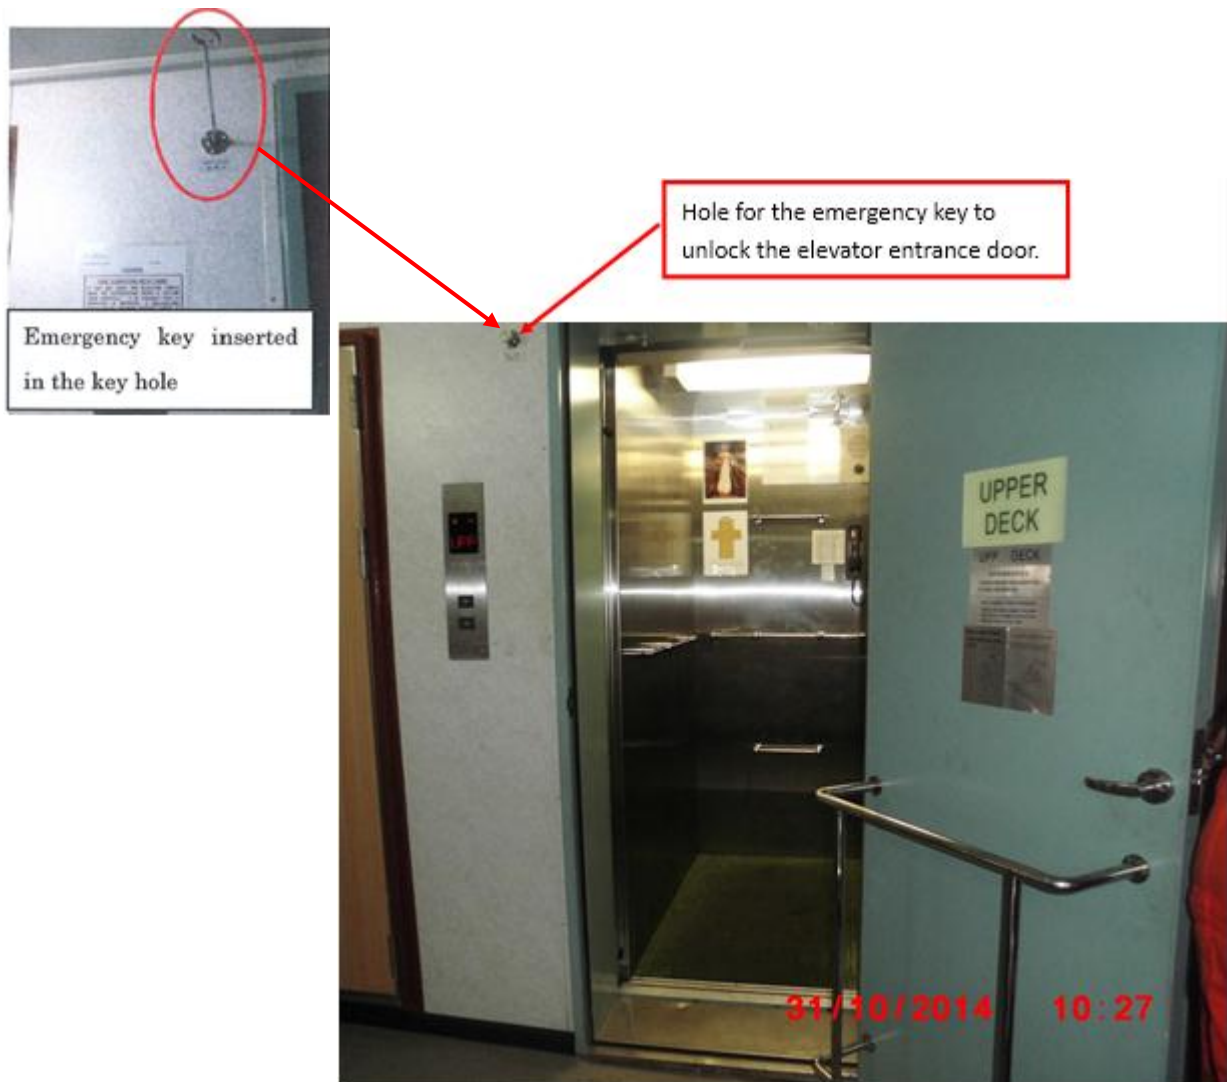
- 4.5 The 2/E opened the elevator door by means of the emergency key and found the elevator cage had gone up and stopped at about half a meter above the ER 2nd deck level. He noticed the blood stain on the door entrance and substantially at the bottom of the elevator trunk. He shouted the name of the E/O but no response.
- 4.6 Afterward the 2/E reported the case at about 1920 to the Chief Officer (C/O) who was the duty officer on the bridge. The C/O then raised the general alarm and mustered all the crew to the upper deck.
- 4.7 The 2/E opened the elevator entrance door on the upper deck by the key (Fig.3). The upper deck was a deck immediately above the ER 2nd deck. By looking downward from the door opening, the E/O was found trapped between the elevator cage and the escape ladder inside the trunk with his head and body in downward vertical position (Fig.4 and Fig.5).

Fig. 3: Elevator Entrance Door at Upper Deck

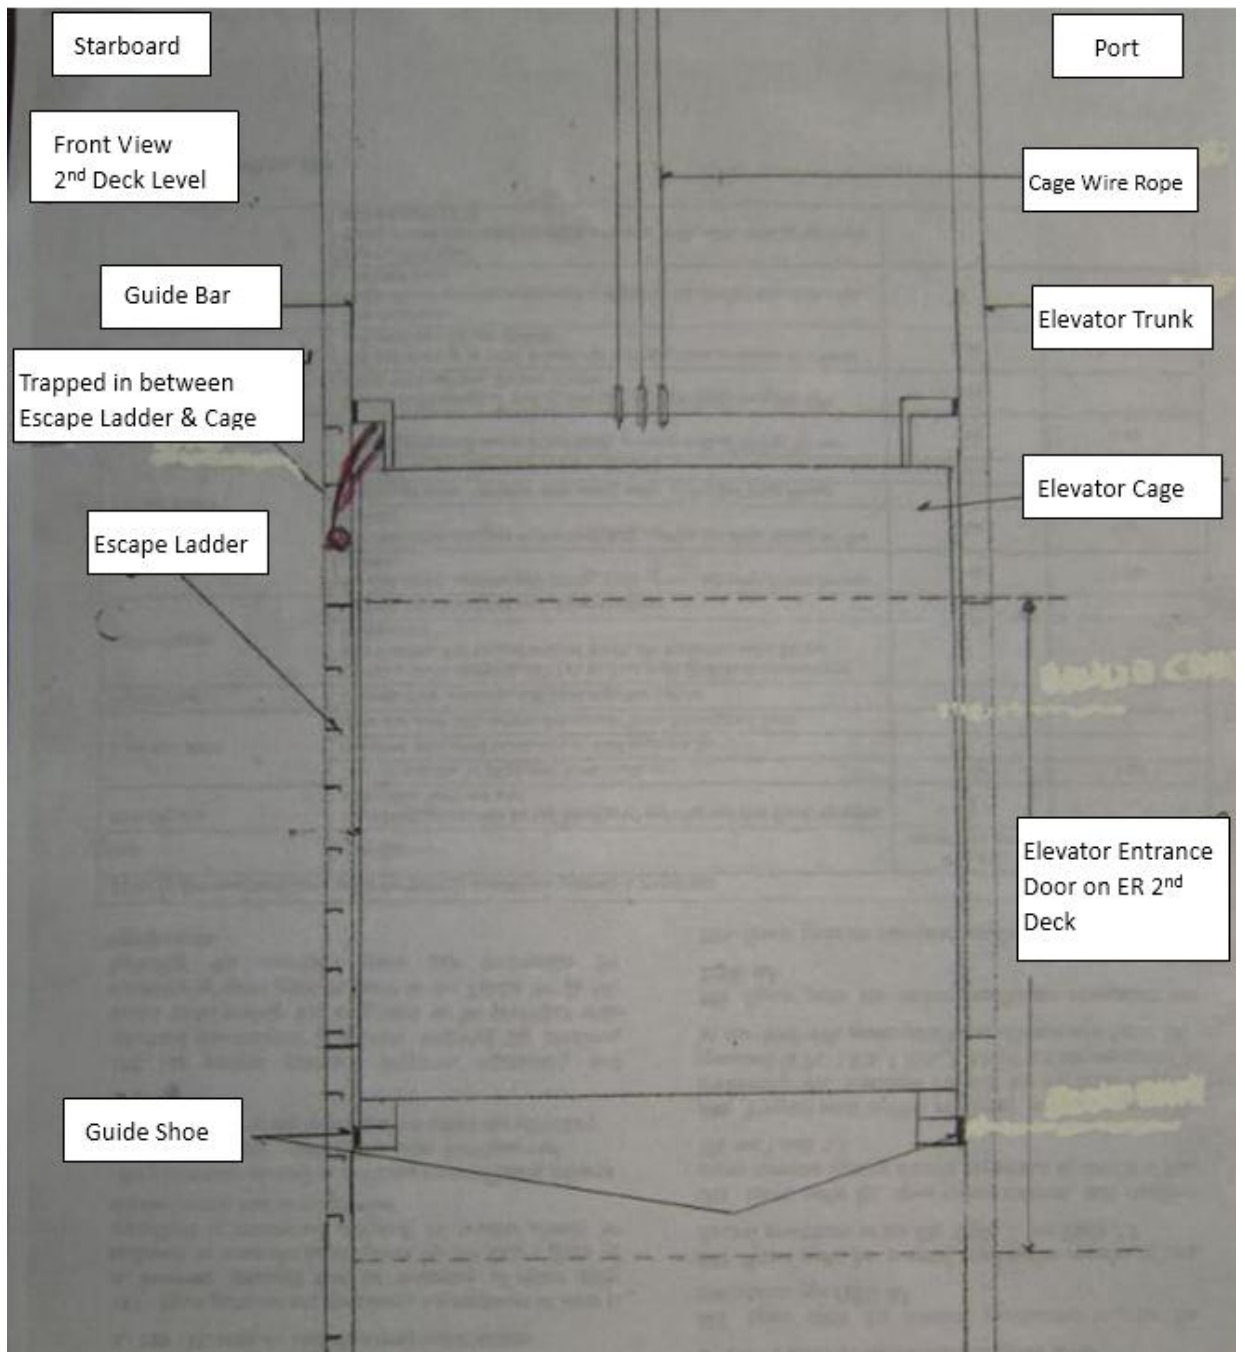
- 4.15 The maker representative also noticed that the body was wedged between the forward starboard side of the cage and escape ladder of the trunk. It was believed that this wedge generated a resistance force on the two guide bars and stopped the elevator cage from travelling up or down.

Fig. 4: Front View of the Cage where the E/O was trapped

- 5.29 As the elevator cage continued to travel upward and passed the 2nd Deck level with the bottom of the cage at about 0.5 meters above the ER 2<sup>nd</sup> deck level, the safety harness dragged him downward, with his head first towards the forward starboard corner of the cage top. The continuing upward force of the elevator crushed the E/O’s head, upper body and buttock against the cage and the escape ladder of the trunk as shown in Fig.4 and Fig.5. This eventually punctured the body and caused a major blood loss that contributed to his death.

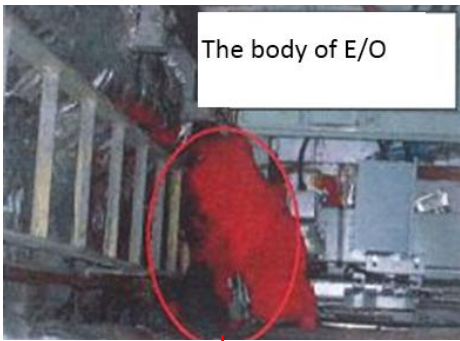
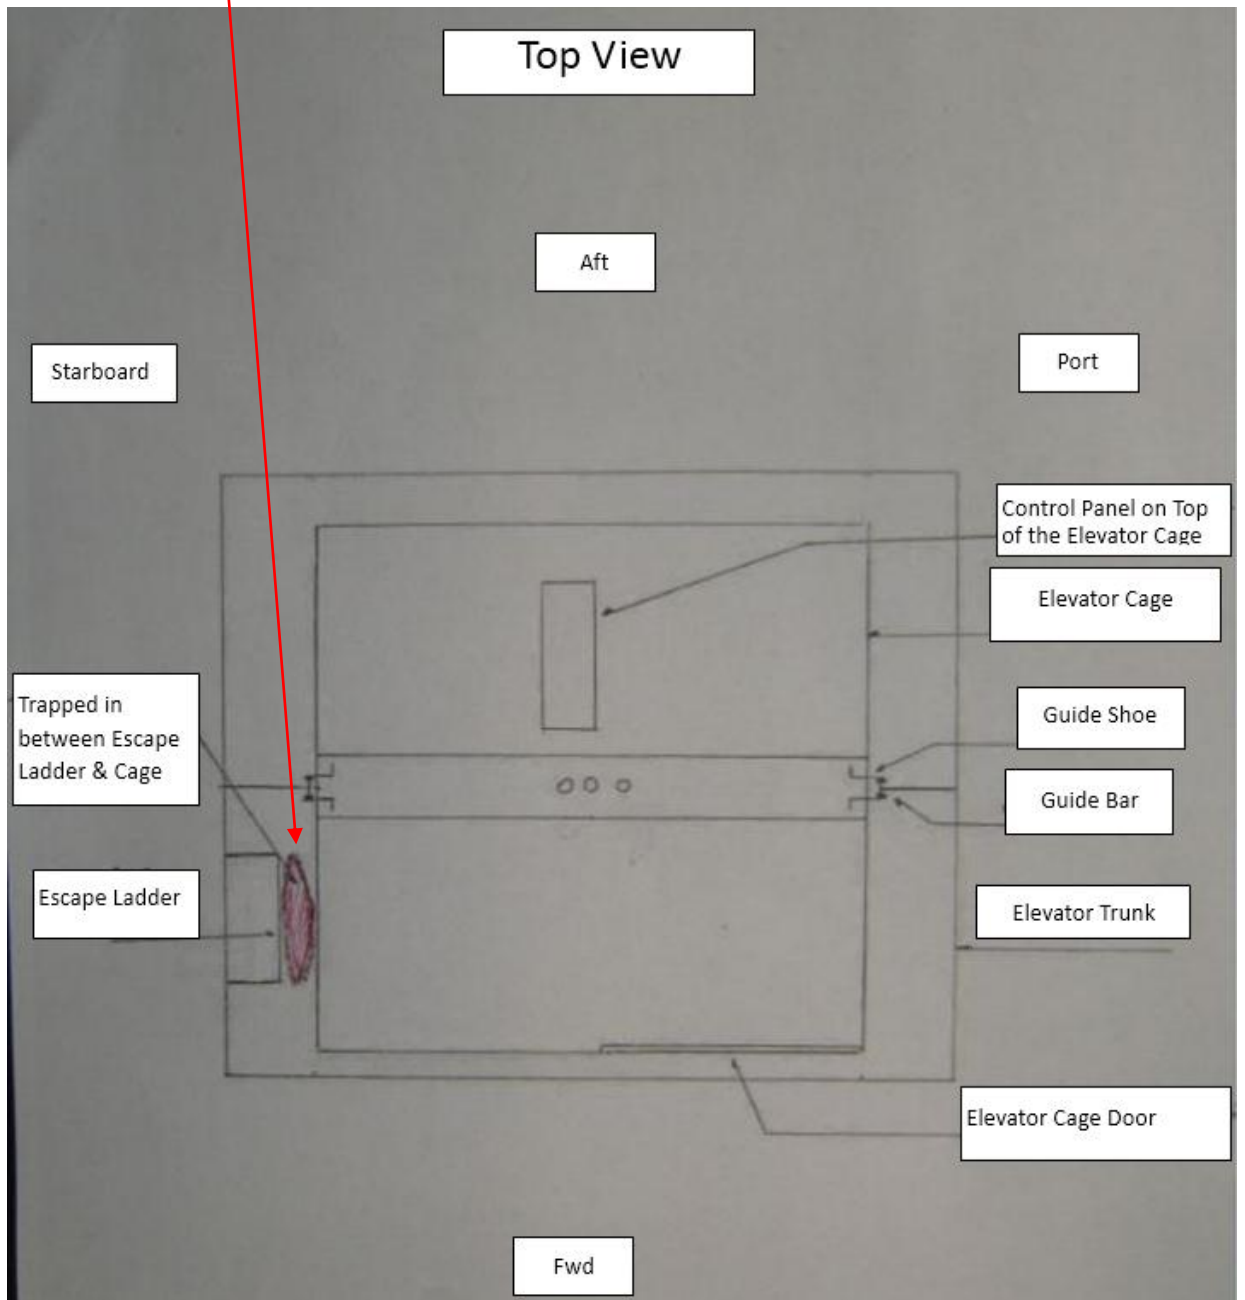
Fig. 5: Top View of the Cage where the E/O was trapped

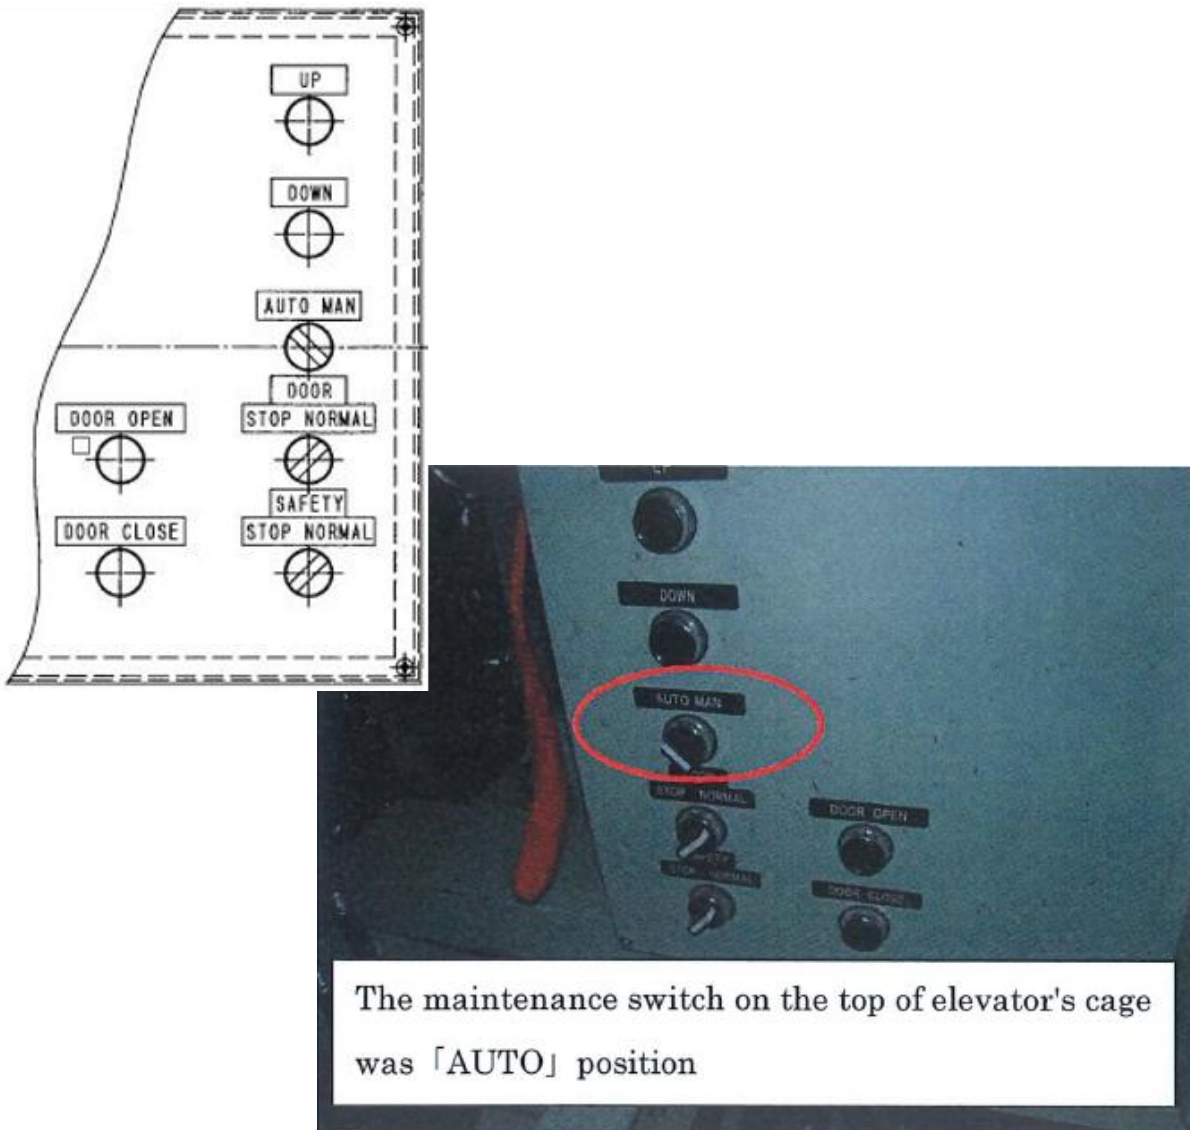
5.21 The operating panel on top of the cage (Fig.6) was used to control the elevator during the maintenance and inspection. There were four push buttons “UP” and “DOWN”; “DOOR OPEN” and “DOOR CLOSE” and three selector switches “AUTO/MANUAL”; “DOOR - STOP/NORMAL”; “SAFETY - STOP/NORMAL” on the control panel. To stop any calling response and to manoeuvre locally on the cage top, the changeover mode switch had to change to “MANUAL”, therefore this switch was also named as the maintenance switch. To stop the travelling of the elevator, the switch “SAFETY” had to be switched to “STOP”. To stop the cage door from operating, the “DOOR” switch had to change to “STOP”.

Fig. 6: The Operating Panel on top of the Cage

- 5.25 The E/O failed to switch the change-over switch from “AUTO” to “MANUAL” on the control panel on the cage top. As a result, the cage was ready to move upon callings.

- The change-over switch (also named as the maintenance switch) at operating panel on the cage top for local control should be switched to “MANAUL”; or
- The exit hatch cover on the ceiling of the cage should be opened, this would achieve the same as the above and should be tested for each month as per maintenance checklist from the maker.
