**Report of Investigation
into the collision between the
Hong Kong registered
container ship *SAFMARINE
NOMAZWE* and the
Indonesian fishing vessel
ANUGRAH 89 in the Lombok
Strait, Indonesia
on 24 August 2014.**

Marine Accident Investigation Section
Marine Department
The Hong Kong Special Administrative Region

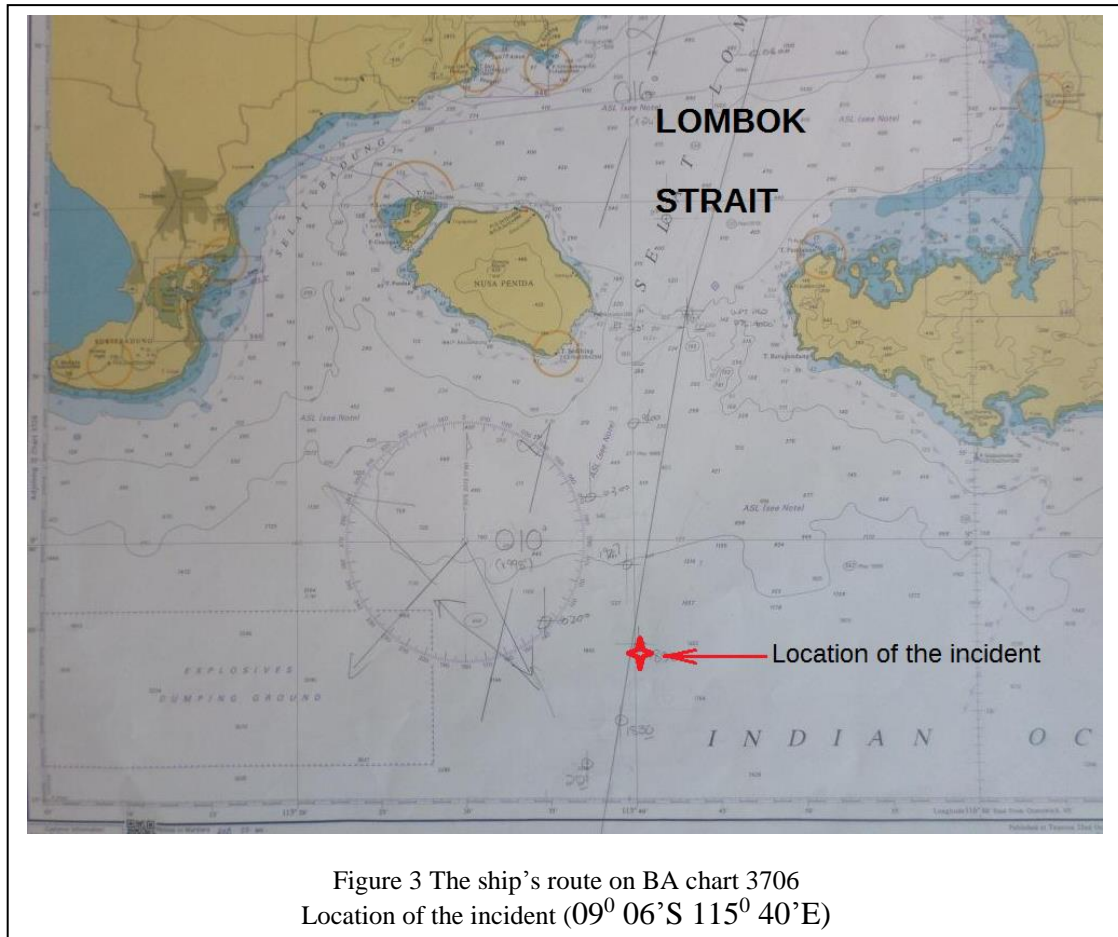
- 4.6 At about 1830, the duty officer changed the working chart to British Admiralty (BA) chart 3706 (Figure 3) which was in large scale covering the Lombok Strait and south of the Bali Island. The ship was located in approximate position $09^{\circ} 10.5' S, 115^{\circ} 39.0' E$. *The container ship* was then on a heading of about 015° to follow her planned

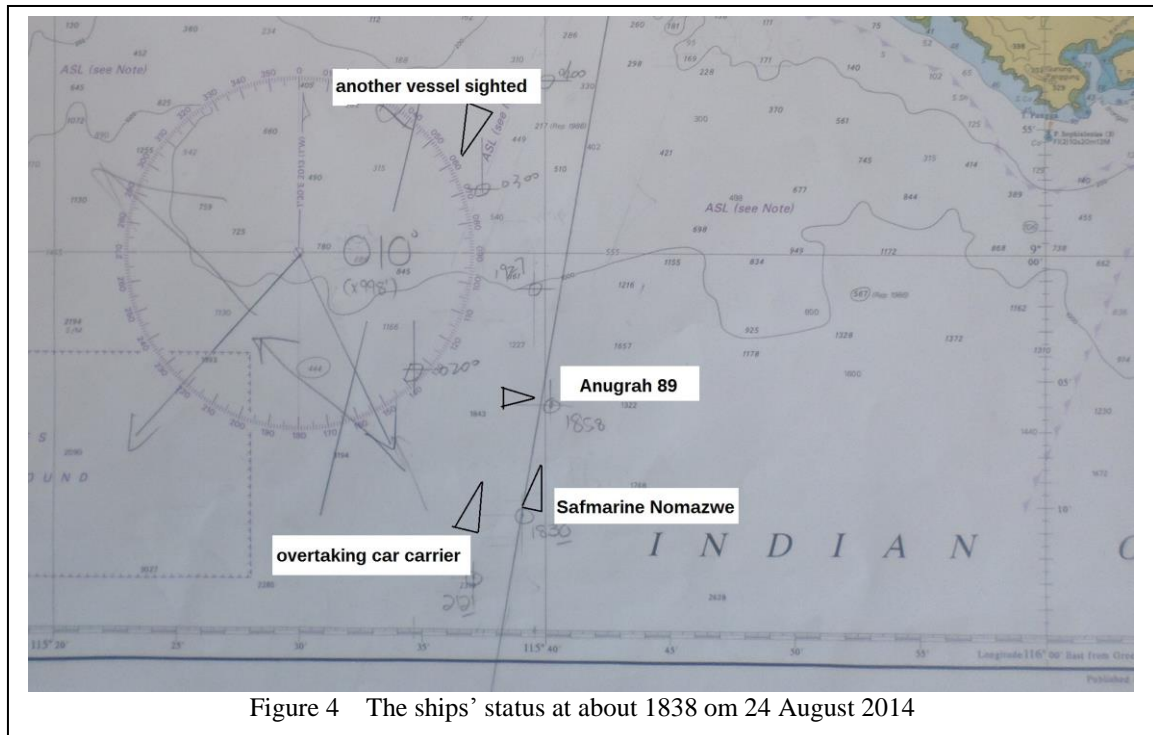
Figure 4 The ships' status at about 1838 on 24 August 2014

- 4.8 At about 1838 the duty officer saw another vessel off the port bow which looked like a small fishing vessel (*the FV*, i.e. *ANUGRAH 89*). So there were 3 vessels surrounding *the container ship*, i.e. *the FV*, the overtaking car carrier and another vessel well clear on the port side (Figure 4). Although it was twilight and partly cloudy, the visibility was good and the shape of *the FV* could be visually observed. The duty officer checked the radar to see if the target of *the FV* would appear on the screen of the radar but there was only clutter. Both radars were maintained on the 12 nm range throughout the incident. The duty officer estimated that *the FV* was at a distance of about 2 to 3 nm, bearing about 35° off the port bow of the vessel. Shortly afterwards, *the FV* turned on a masthead light and some deck lights. However, there were no other identifiable navigation lights. The duty officer stated that *the FV* was about 12 metres in length. It was a blue colored fishing vessel with a white colored accommodation at its stern.

5.2.1 The duty officer of *SAFMARINE NOMAZWE* maintained both the port and starboard radars displaying information provided by the S-band scanner and on a 12 nm range throughout the incident while the X-band scanner was not selected. At about 1838, the duty officer saw a third vessel off the port bow which looked like a small fishing vessel (*the FV*, i.e. *ANUGRAH 89*) at a distance of about 2 to 3 nm but she did not find *the FV* on the radar screen. However, she did not adjust the range scale on any one of the radars and select the X-band scanner as it could have better detection ability for small vessel and help to determine if risk of collision existed. Nor did she check the visual bearing of the target to determine whether there was a risk of collision. Therefore, the duty officer did not use all available means appropriate to the prevailing circumstances and conditions to determine if risk of collision exists in accordance with the Rule 7 (risk of collision) of the COLREGS.

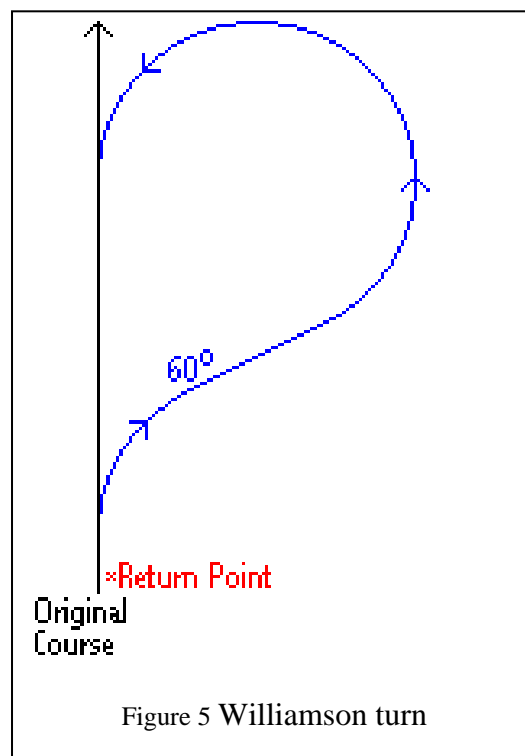
4.16 The master then altered course to starboard and manoeuvred a Williamson turn (Figure 5) to head towards the datum position for the collision. A number of crewmembers were called to assist the search and rescue operation. The chief officer was instructed to prepare safety equipment to assist in the rescue of the survivors
