Report of investigation into the
collision between the Hong Kong
registered bulk carrier *Silver Phoenix*
and Chinese fishing vessel *Zhe Sheng*
Yu 05885 in the approximate position
of 30°48.977'N 123°57.823'E
in the East China Sea
at 2340 on 29 October 2014

The Hong Kong Special Administrative Region
Marine Department
Marine Accident Investigation Section

15 December 2015

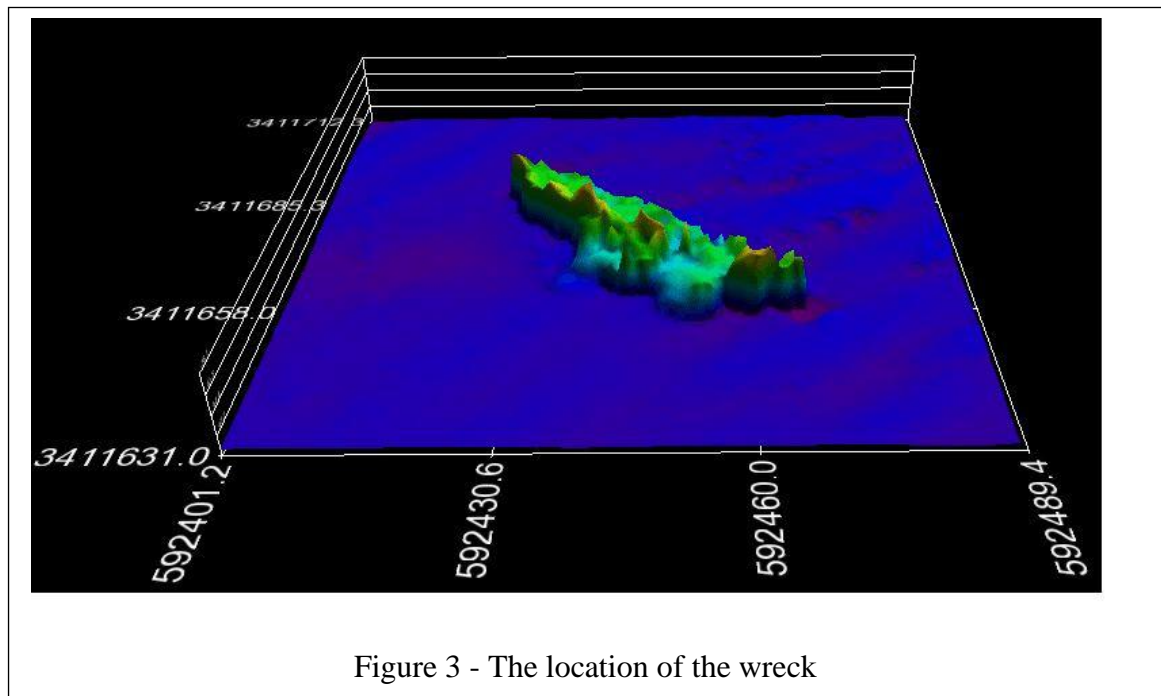
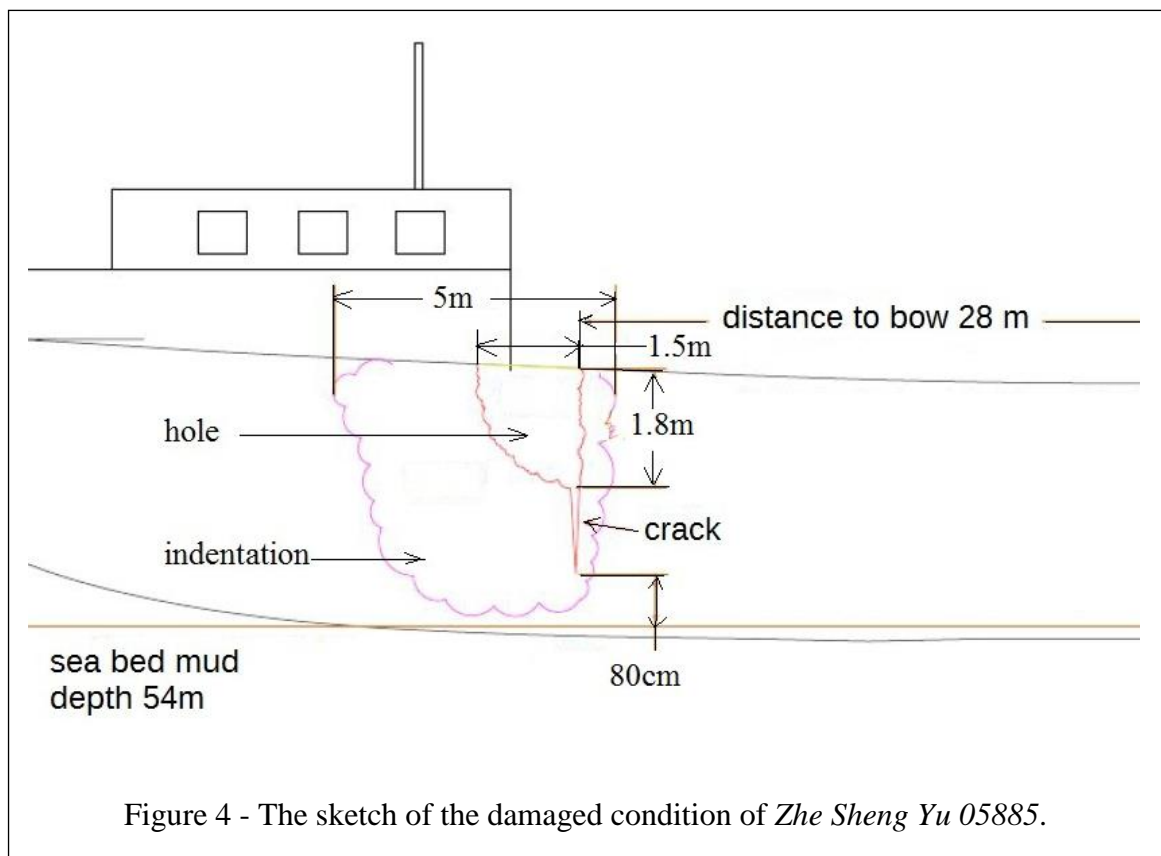
- 4.21 After the SAR operation, *Hai Xun 166* from MSA detected a wreck in the approximate position of 30°49.338'N 123°57.972'E which lied on the seabed in a depth of water of about 53 metres. Its dimension was about 46 metres in length, 10 metres in breadth and 9 metres in height (figure 3).
- 4.22 On 5 November 2014, *Ju Li Hao* from Shanghai Salvage Bureau was assigned to conduct underwater survey and took video recording of the wreck. The divers confirmed that the wreck was *the FV*. She sustained damage with a hole, cracks and indentations on the starboard side hull as shown in figure 4.

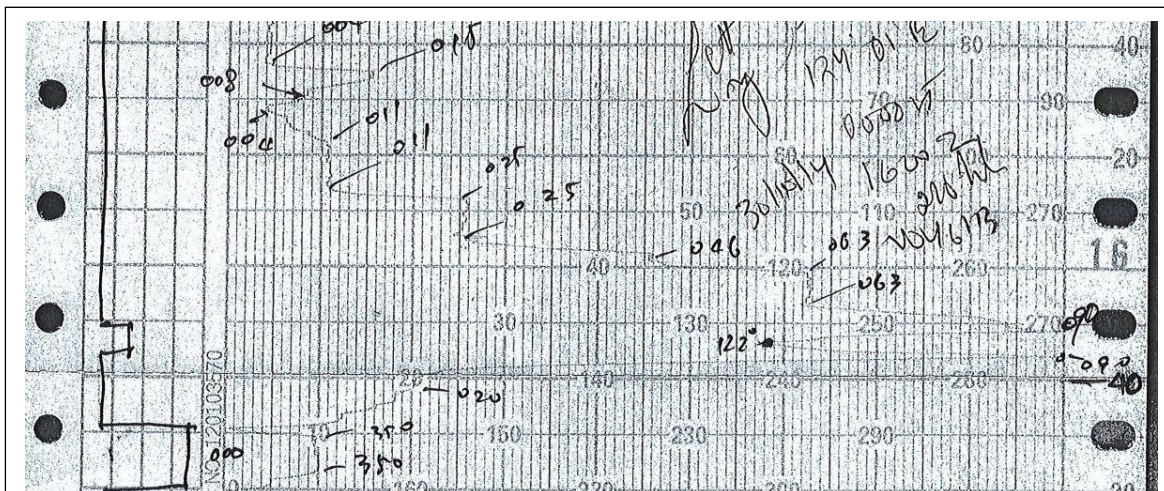
Figure 5 - The course recorder of *Silver Phoenix*

- 5.8 It could be verified from the course recorder of *the bulk carrier* that her heading was largely altering to starboard from 020° at 2339 to 122° at 2347 on 29 October 2014 (figure 5).

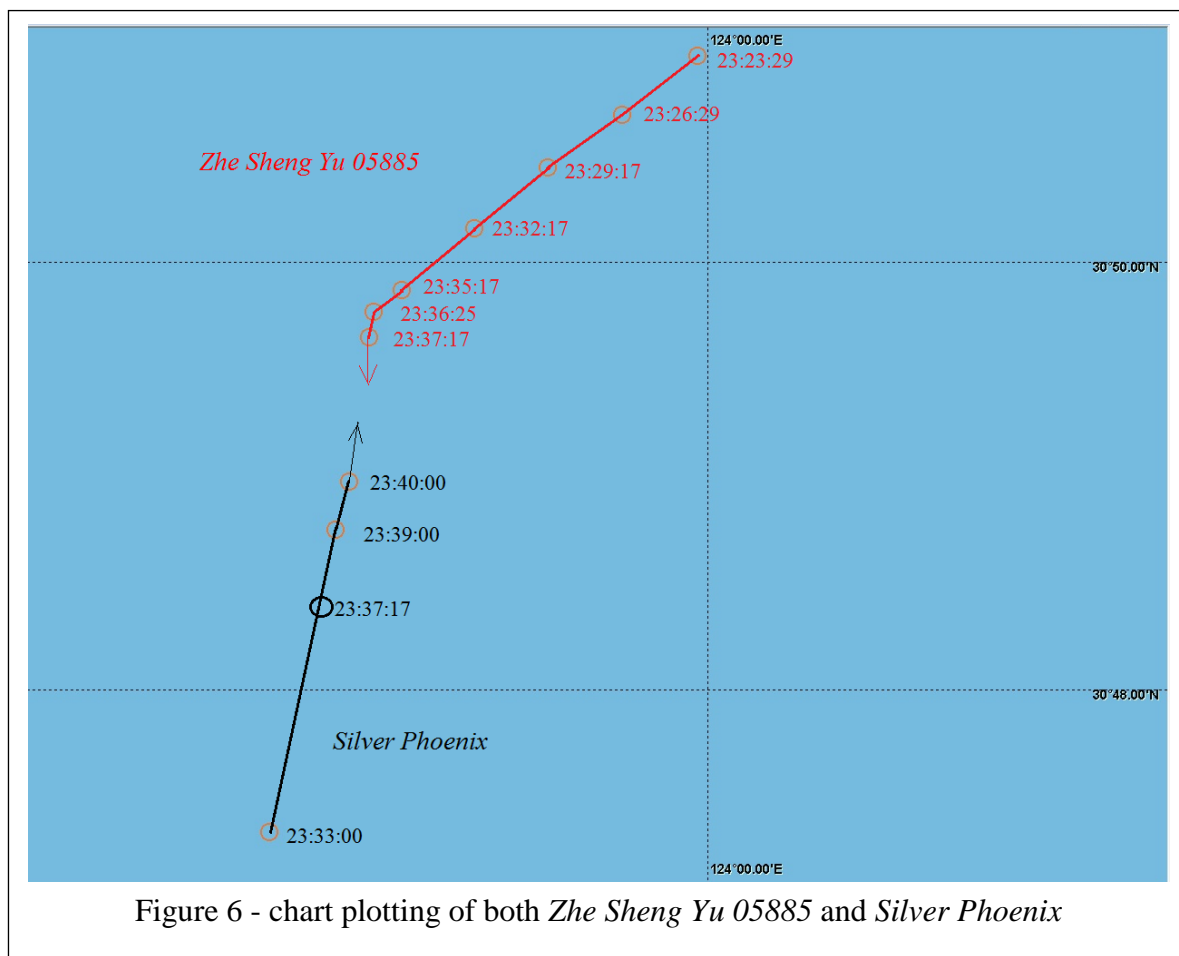
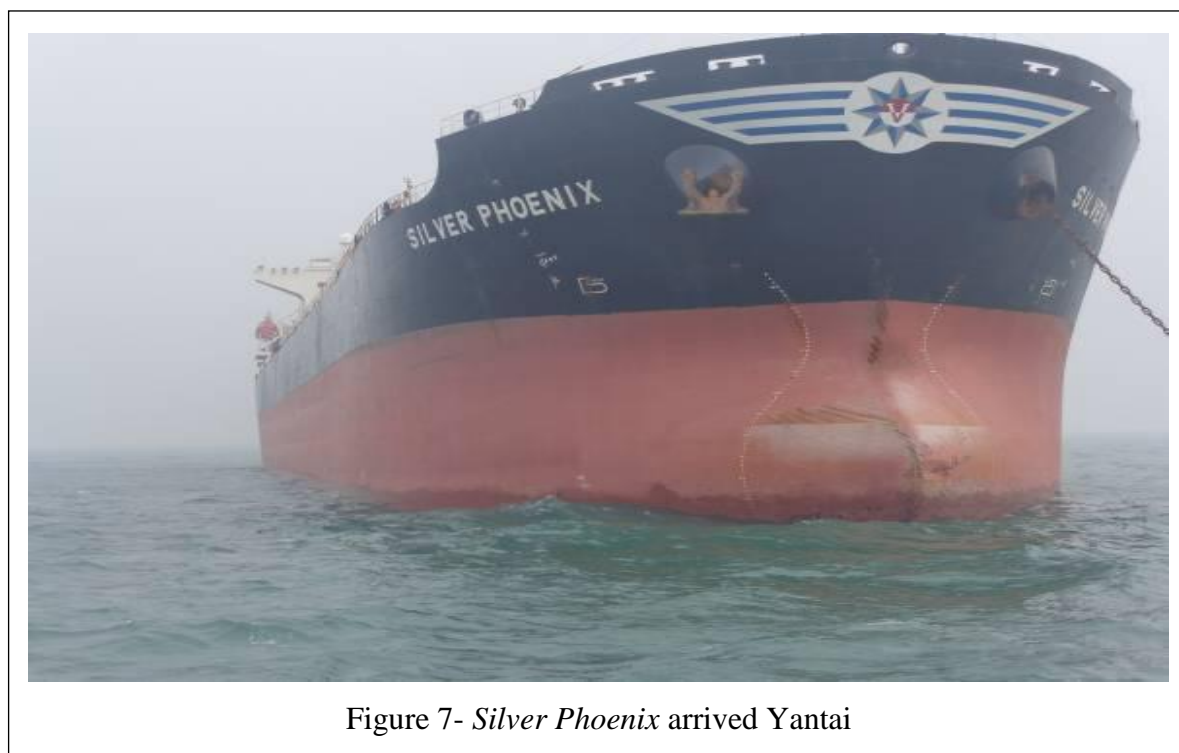
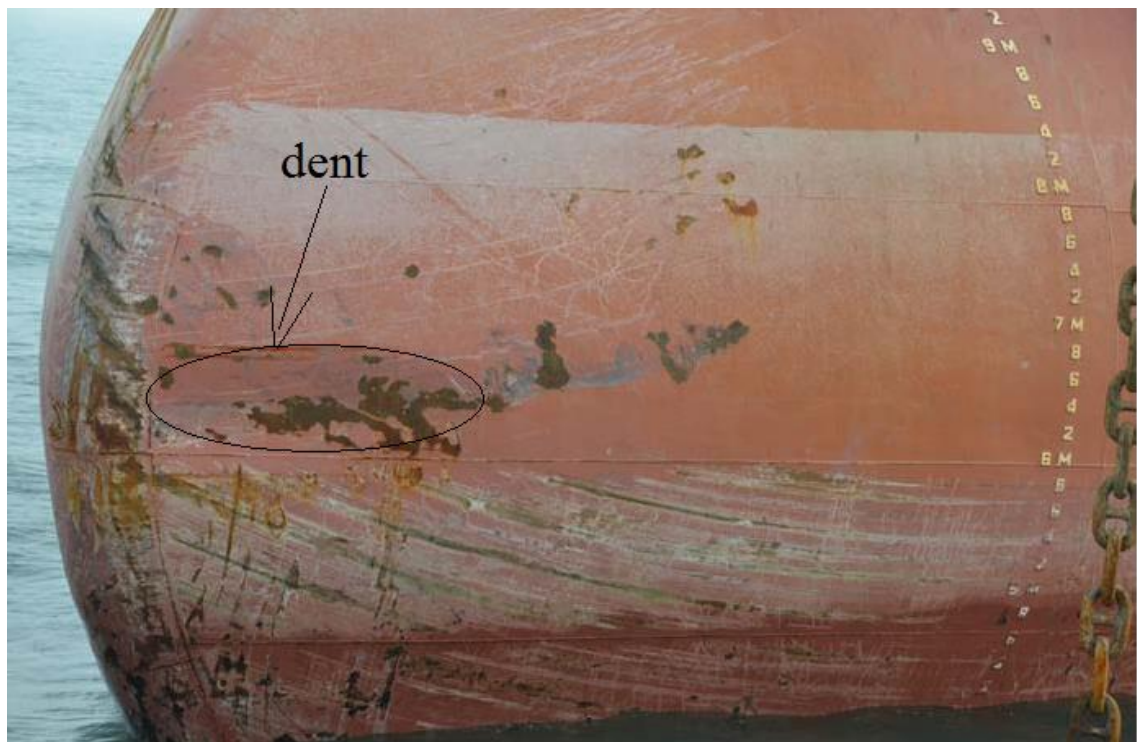
- 5.11 After *the bulk carrier* arrived Yantai on 1 November 2014, an inspection of the ship's hull was carried out. It was found that, on the bulbous bow port side, there were some fresh scratch marks and a dent estimated of 1500 mm in length, 500 mm in width and 40mm in depth in way of the draft marks between 6.2 to 6.8 metres. Some blue-gray color paint coating not originated from *the bulk carrier* was found on the shell plate while the original red color paint coating on the

bulbous bow was peeled off at that position (Figure 7, 8 & 9).

Figure 8- Bulbous bow of *Silver Phoenix* - a dent length 1500mm, width 500mm and depth 40mm

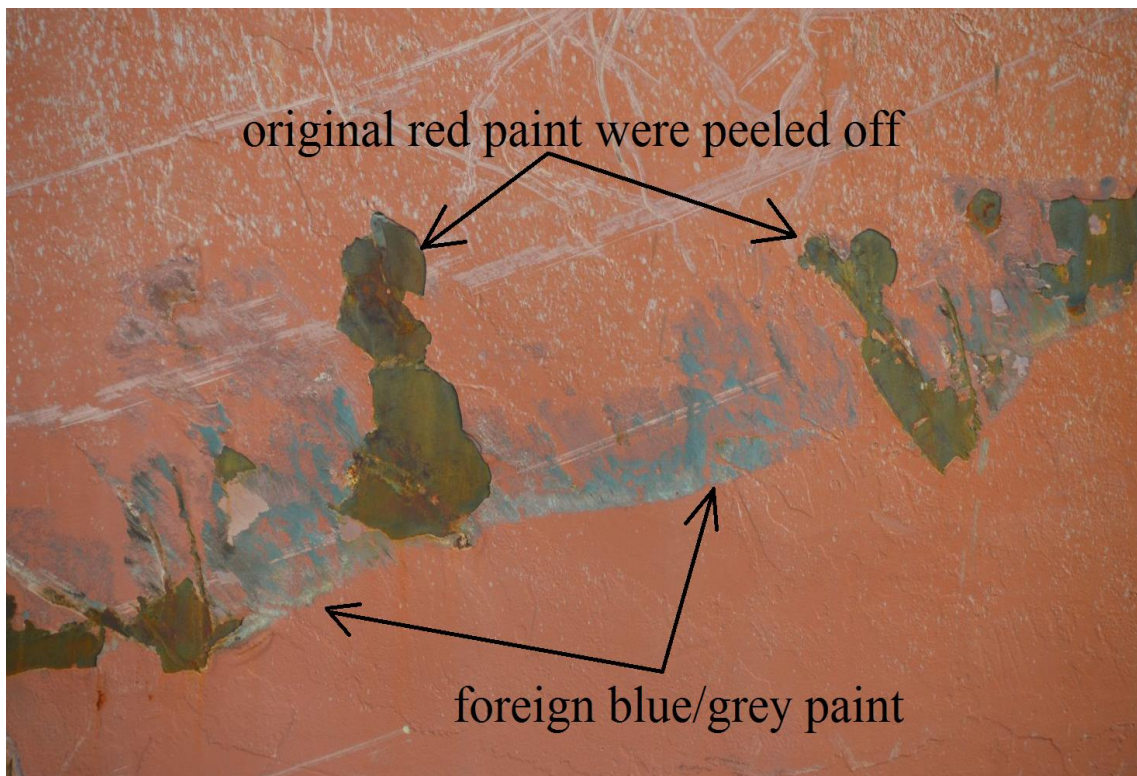
Figure 9- Bulbous bow of *Silver Phoenix* foreign blue-gray paint and its red paint

- 5.15 It was found that the blue-gray color paint coating on the bulbous bow on the port side of *the bulk carrier* matched with the blue-gray color paint coating applied on the hull of *the FV* in terms of their color, texture and infrared spectra. They shared the major elements of Calcium, Titanium, Chlorine, Silicon, Sulphur, and Iron.

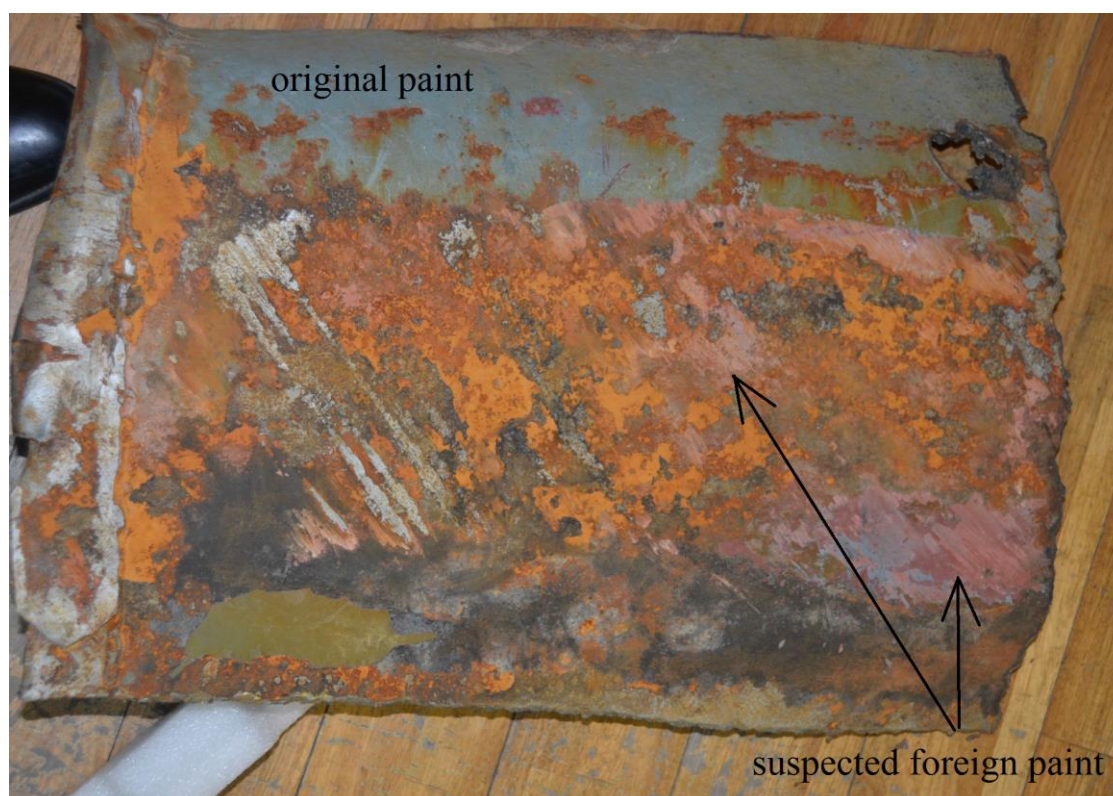
- 5.12 A sample of steel plate near to the edge of the hole on the damaged hull of the sunken *FV* was collected (Figure 10). There was some red color paint coating not originated from the fishing vessel could be seen on it.

Figure 10 - Sample of steel plate cut from hole of the sunk *Zhe Sheng Yu 05885*

- 5.16 Besides, the red color paint coating taken from *the FV* matched with the red color paint coating applied on of the bulbous bow of *the bulk carrier* in terms of their color, texture and infrared spectra. They shared the major elements of Copper, Chlorine, Iron, Silicon, Titanium, Calcium, Magnesium and Sodium.
- 5.17 Taken all the above analysis into account, it was deduced that at about 2340 on 29 October 2014, while *the bulk carrier* altering to starboard, the port bow collided with the starboard side of *the FV* which was altering to port at the same time (Figure 11). The approximate position of the collision was 30°48.977'N 123°57.823'E.
