**Report of Investigation  
into the fatal accident  
on board Hong Kong  
Registered Ship “CF  
CRYSTAL” at Port Authur,  
Texas, the USA on 13  
December 2014.**

The Hong Kong Special Administrative Region  
Marine Department  
Marine Accident Investigation Section

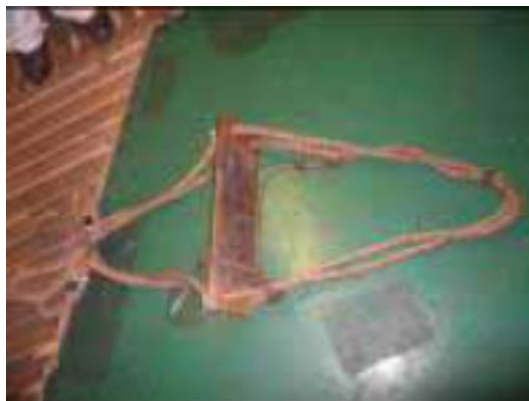
Fig 2: the bosun chair for working over the side

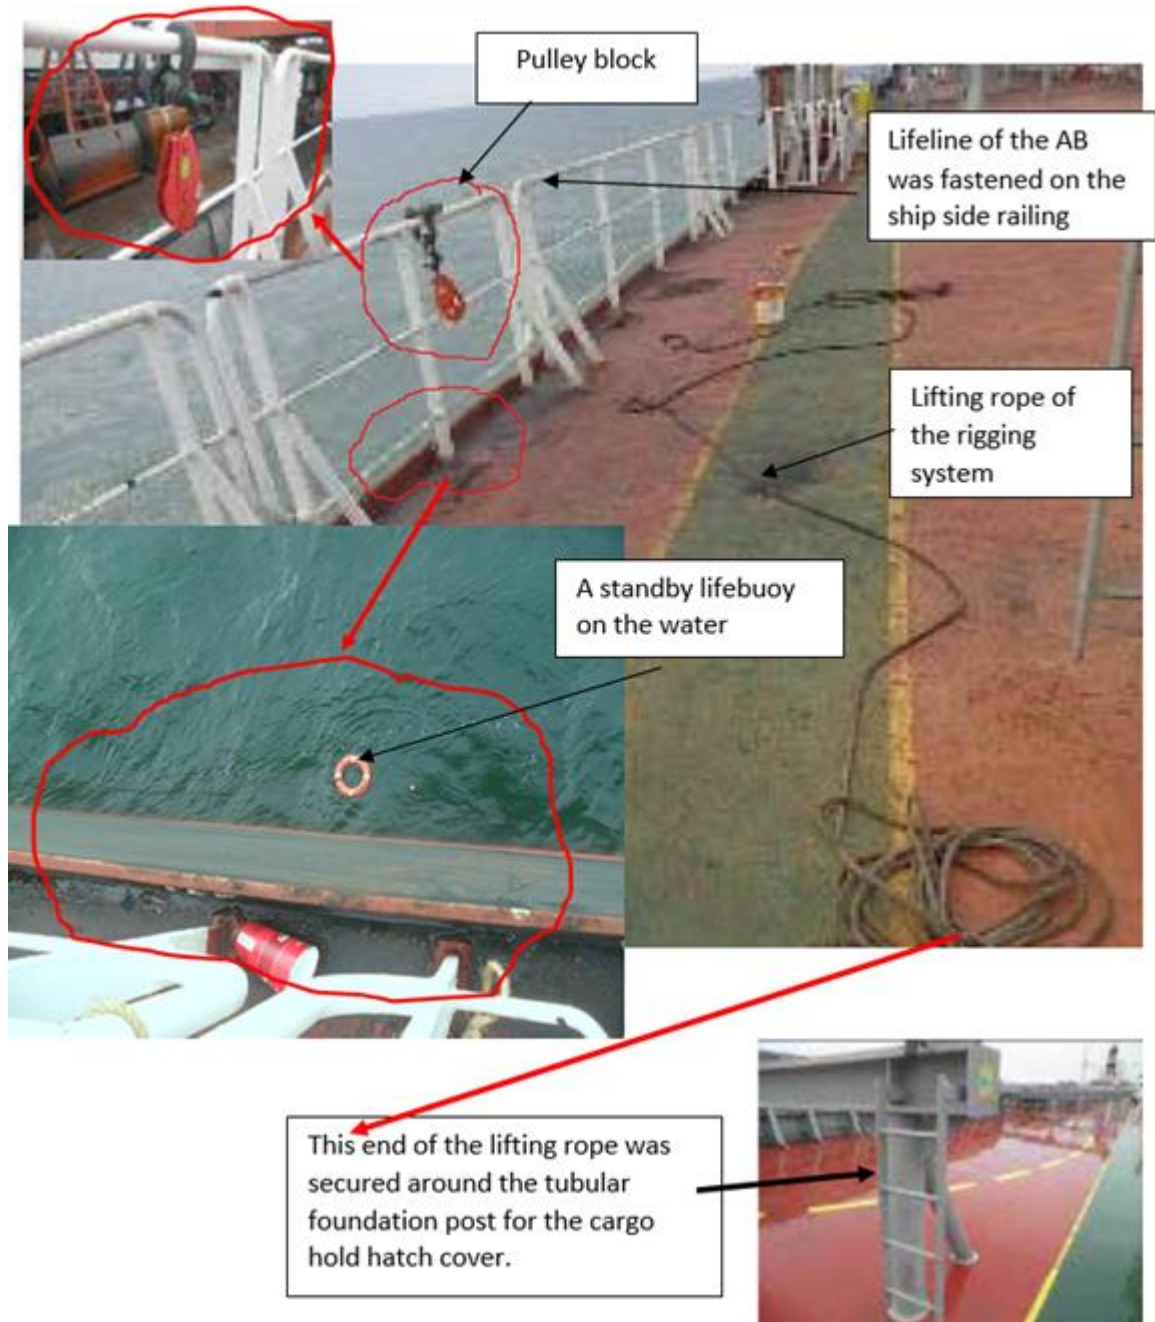
Fig 3: Rigging arrangement at midship starboard side

- 5.14 A lifeline was used to safeguard the AB from falling into the water when working at height in this incident. However, the lifeline did not work as it was not properly secured the ship side railing.

- 7.2 The owners / management company and master of the vessel must instruct that : -
- (a) all crew members on board ship must strictly follow all shipboard safety procedures and code of safety working practice relevant to the work to be performed (for example: donning of lifejacket when working over the ship side and securing of lifeline properly);

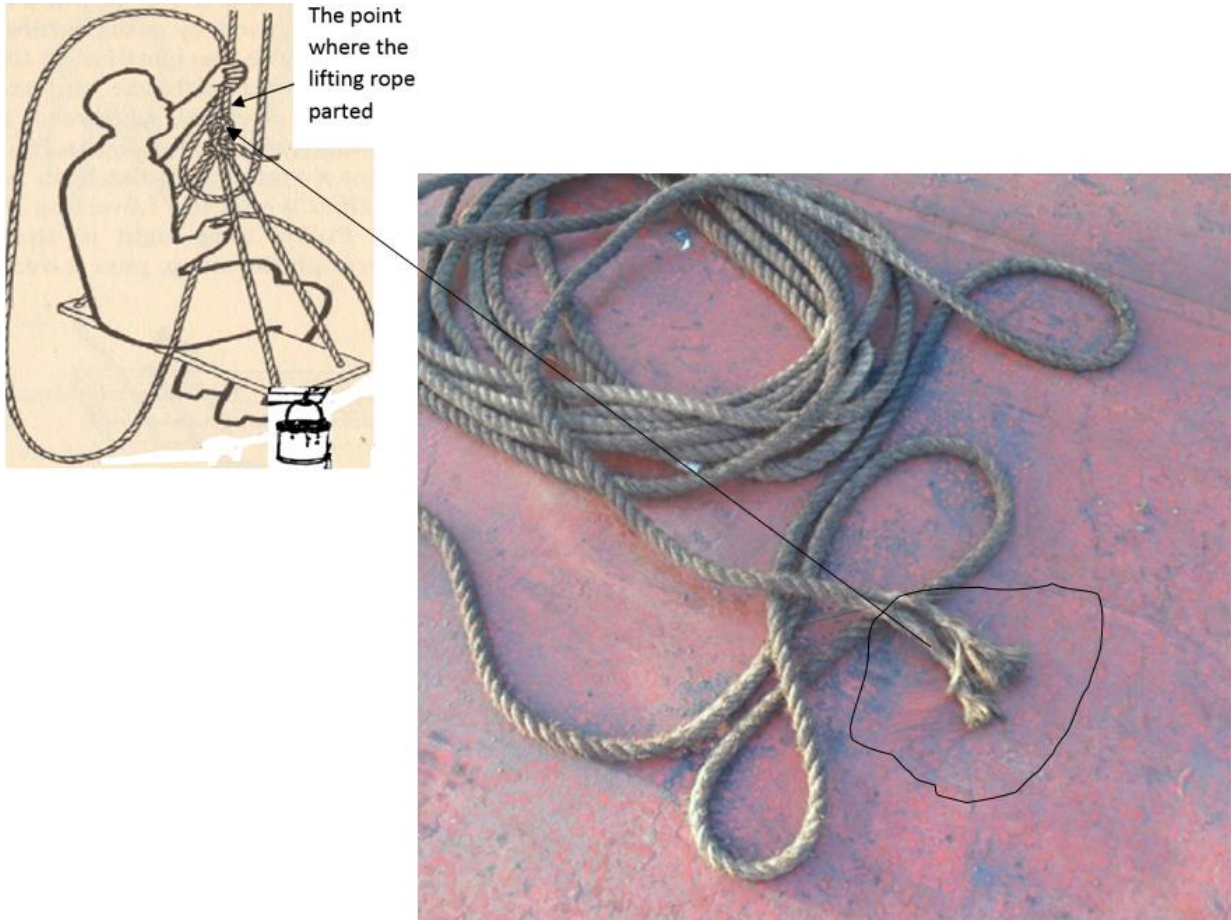
- 5.9 During heaving up the bosun chair wherein the AB was seated, the lifting rope parted at a position slightly above the knot tying to the bosun chair (Fig.4).

Fig 4: The lifting rope parted.

- 5.10 The lifting rope was a 3-strand manila rope of diameter 24 mm. As per the product certificate, the average tensile strength of the rope was 35.9 kilo-newton (about 3660 kilogram force) measured in accordance with the Federal Specification and Cordage Institute Standard.

- 5.11 In this accident, the total weight of the AB and the work items carried by him was about 82 kilogram, which was well below the breaking load of the lifting rope.

- 5.12 There was no maintenance records of the lifting rope on board. As shown in Fig.4, the point where the rope parted appeared to be a transverse cut. The general condition of the rope was deemed having deteriorated with signs of wears and molten yarns at the broken section of the lifting rope. Under such circumstances, the strength of the lifting rope could have been reduced substantially. In the case of sharp pulling forces applied on the lifting rope during pulling up of the AB, shock loading could have caused the deteriorated rope to part.

- (b) all equipment used for the work (for example : lifting rope) must be in good working conditions;
  - (c) officer who is in charge of work must closely monitor the safe operation of work carried out by crew members; and
