**Report of Investigation
into the fatal accident
on board Hong Kong registered
oil tanker “*North Glory*”
on 17 December 2014.**

9 December 2015

The Hong Kong Special Administrative Region
Marine Department
Marine Accident Investigation Section

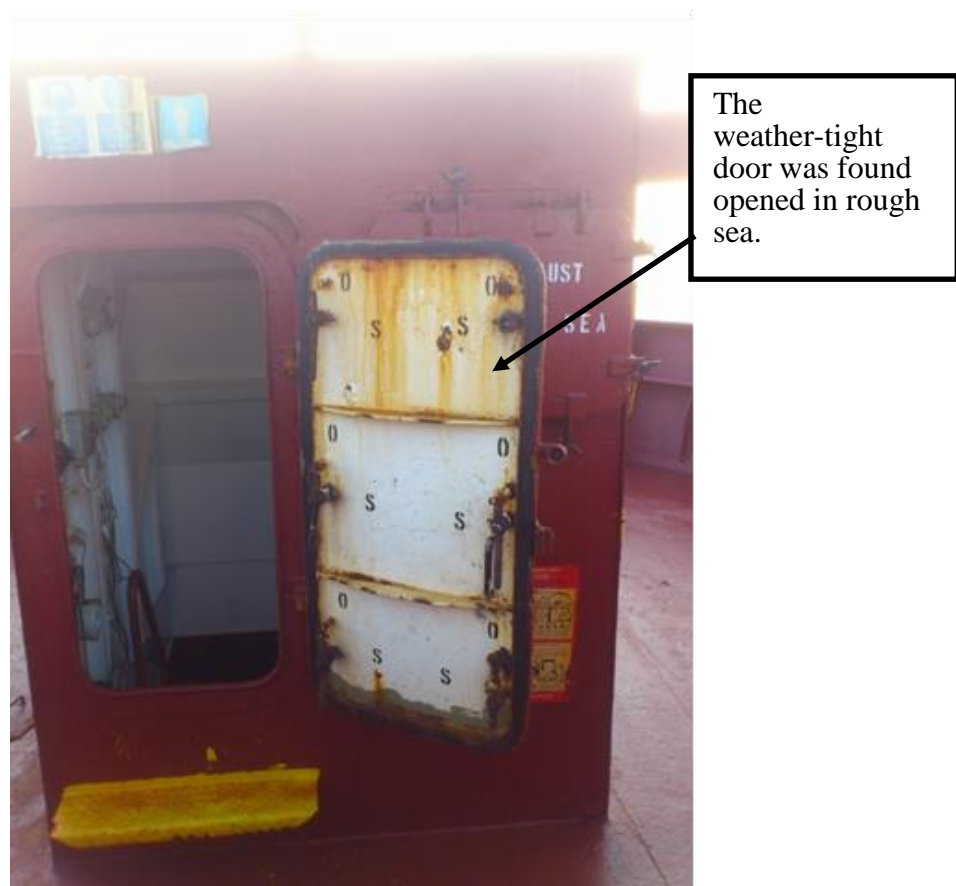
- 4.3 At about 1445, the 2/O noticed from the bridge that the weather-tight door on the forecastle deck was opened (Fig.2). Seawater could have entered into the bosun store underneath the forecastle deck. So he instructed the bosun to close the door. Neither the master nor the chief officer (C/O) was informed of his instruction to the bosun.

Fig.2 The weather-tight door on the forecastle deck

- 5.10 The 2/O found out that the weather-tight door on the forecastle deck was opened. There was a danger of seawater entering into the forward compartment that might affect the ship’s stability. However, he did not immediately explain the situation to the master of the *vessel*. Instead, he instructed the bosun to go to the forecastle deck to close the weather-tight door. The 2/O did not strictly follow the relevant requirements stipulated in the Seafarers’ Training, Certification and Watchkeeping (STCW) Convention and Code¹.

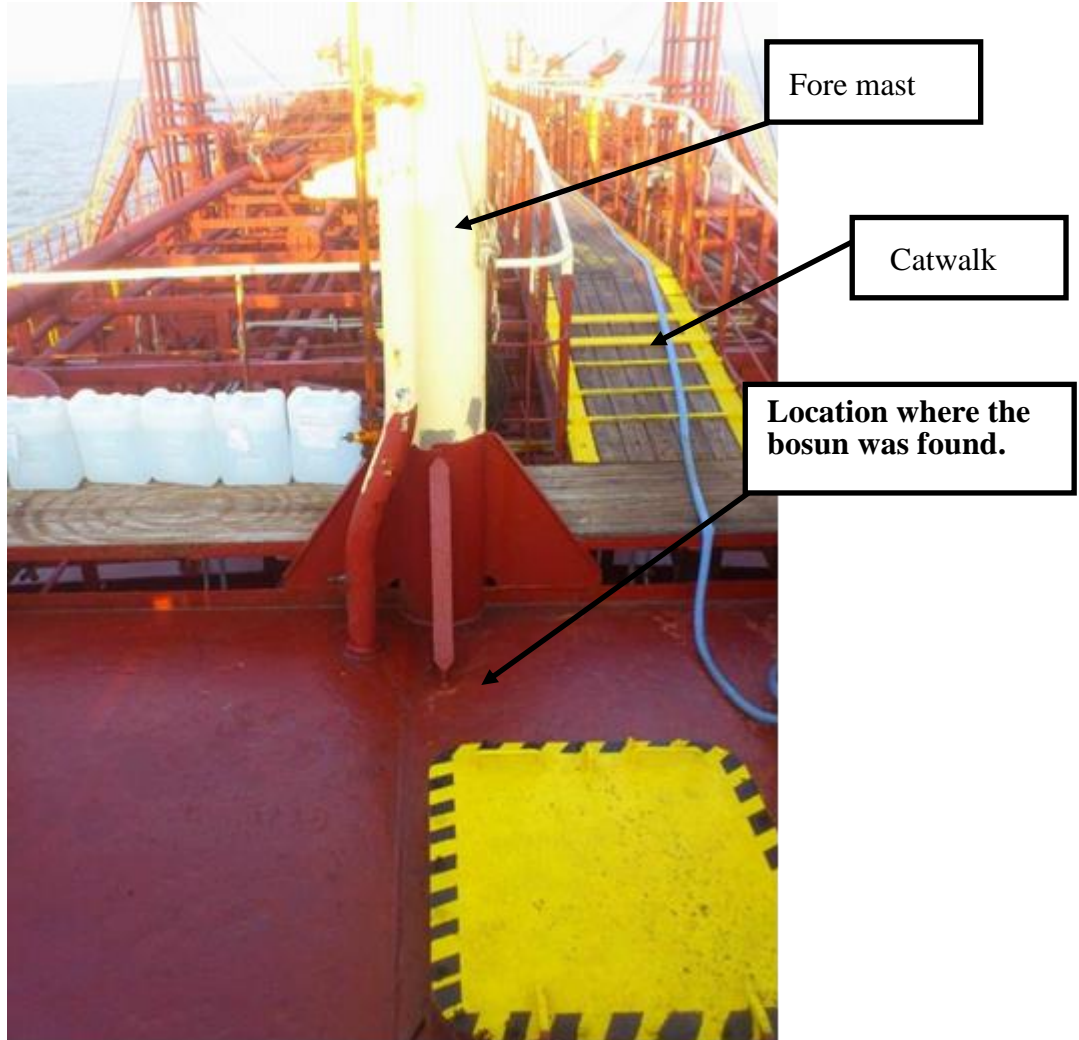
- 4.7 Shortly afterwards, the master arrived at the bridge. He immediately turned the *vessel* around to sail in downwind direction. In response to the announcement of the 2/O, a mechanic and a cadet successfully reached the forecastle deck at about 1455. They found the bosun kneeling beside the forward mast. He seemed to be suffering from a severe pain (Fig.3 & Fig.4).

Fig.3 Location where the bosun was found

- 5.15 The autopsy report revealed that the death of the bosun was due to injury of abdominal organs and contusion of chest wall. Multiple bruises were found on the skull, the face and the neck.
- 5.16 Considering the findings of the autopsy report, it was likely that the bosun had been pushed by waves to knock heavily against fixtures on the forecastle deck.

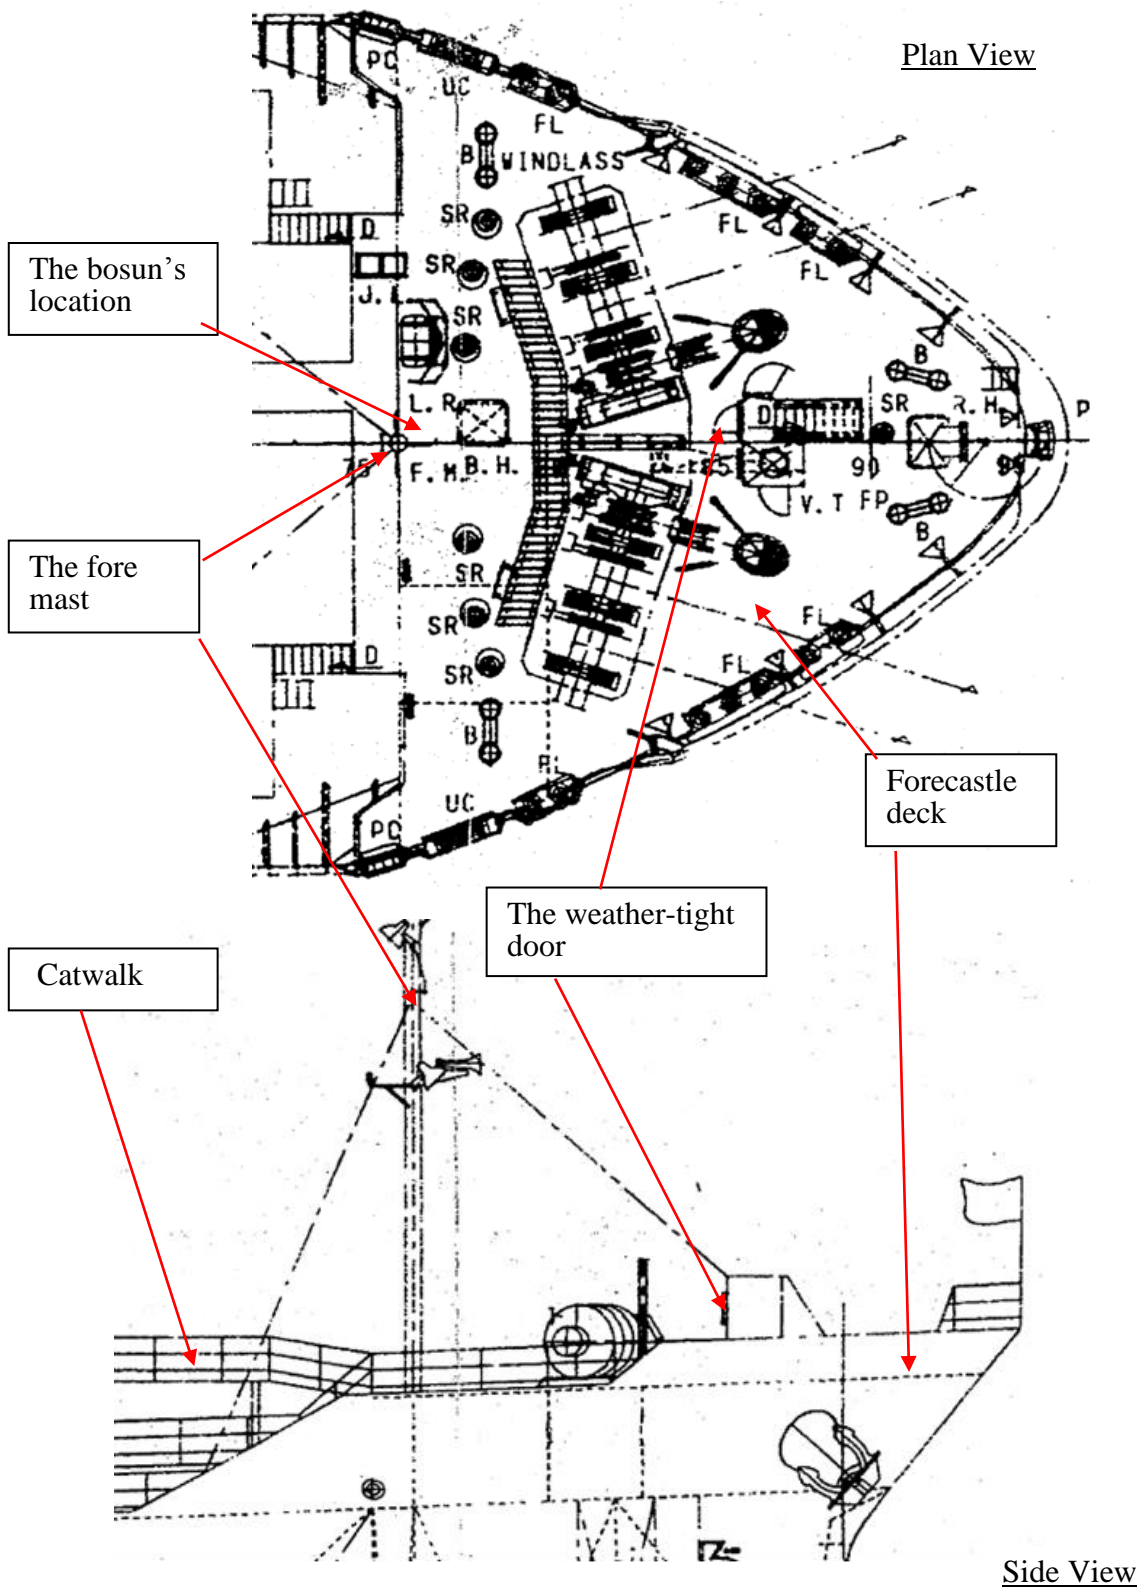
- 4.5 When the bosun was on his way to the forecastle deck along the safe access (i.e. the catwalk as shown in Fig.3 and Fig.4), he had to stop several times to dodge the waves washing over the deck. The ship's course was kept unchanged while the bosun was going to the forecastle deck. At about 1450 when the *vessel* was in the approximate position 24° 53.5N 122° 25.0E, the bosun was seen trapped by waves washing over the forecastle deck and disappeared from the sight of the 2/O.

Fig.4 The Forecastle Deck, Plan View & Side View
