Report of investigation into the
collision between the Cyprus registered
container vessel “*RBD Jutlandia*” and
the Hong Kong licensed fishing vessel
“CM63963A” in position 21°26.7’N
113°06.8’E on 25 December 2014

The Hong Kong Special Administrative Region
Marine Department
Marine Accident Investigation Section

06 November 2015

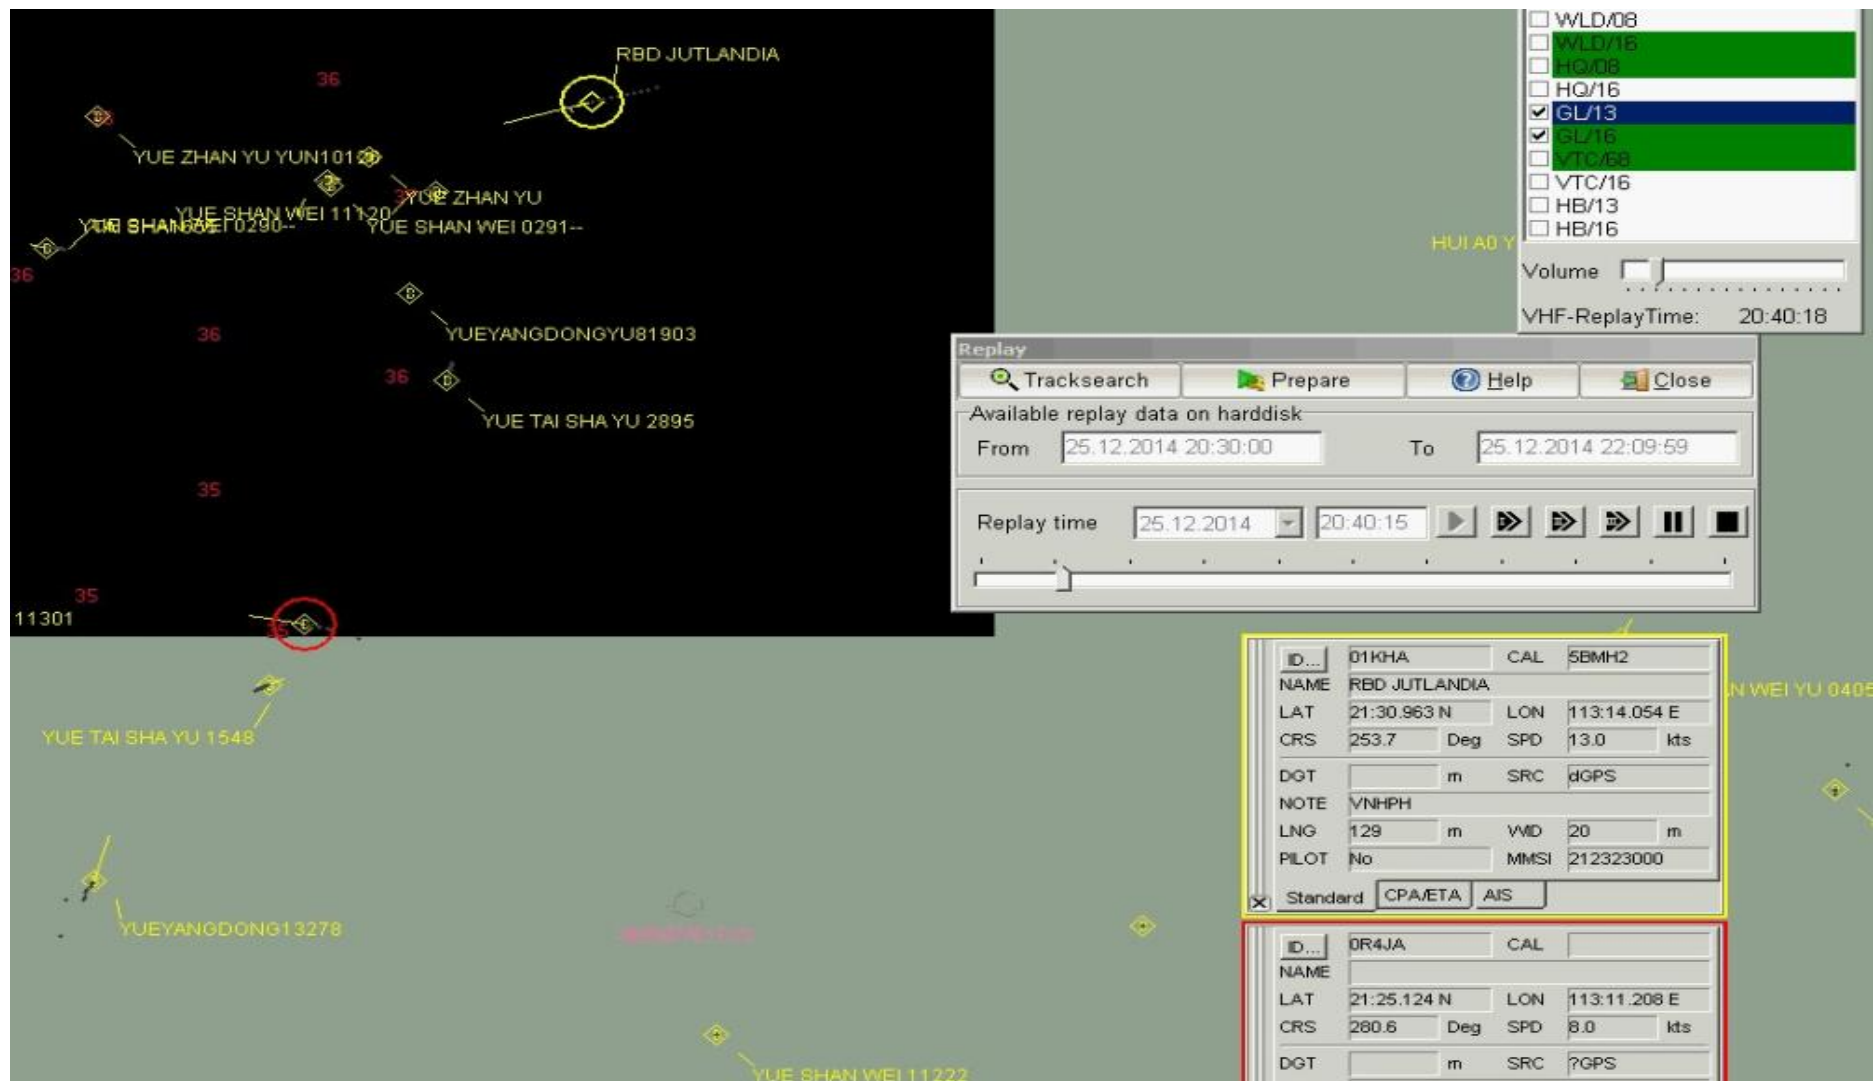
- 4.3 At about 2040, *the fishing vessel* was in position 21°25.1’N 113°11.2’E, maintaining a course of about 280° and steaming at a speed of 6 knots. A cargo vessel (“RBD Jutlandia”) was on the northeast of the fishing vessel in position 21°30.9’N 113°14.1’E and sailing on a course of about 254° and at a speed of 13 knots. The distance between the two vessels was about 3.8 Nm (Refer to P.10 Fig.4- the Zhuhai VTS radar screen at 2040 hours).

Fig.4- the Zhuhai VTS radar screen at 2040 hours.

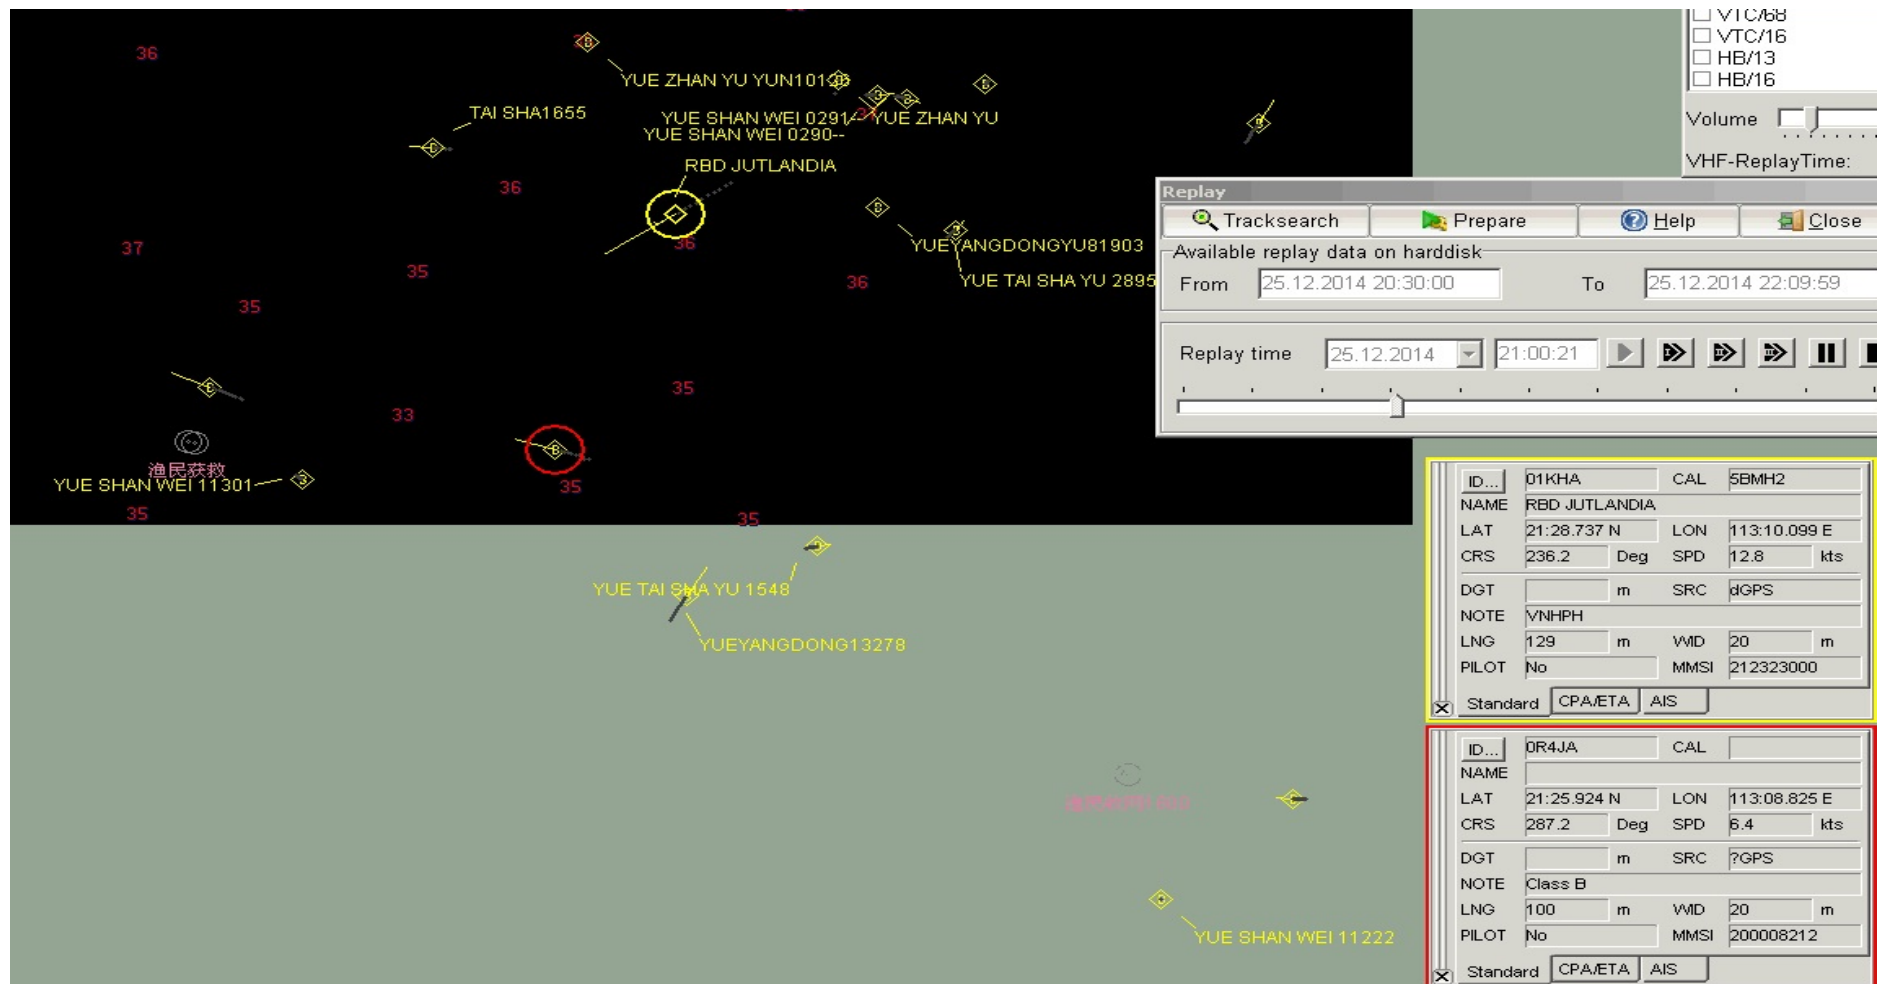
- 4.11 At about 2100, *the cargo vessel* was in the position 21°28.7'N 113°10.1'E, on a course of 238° and a speed of 12.8 knots. The chief engineer came to the bridge and chatting with master who was on navigation watch. The OS was allowed to leave the bridge to join the Christmas party celebration in the saloon. At this moment, a fishing vessel was at the position 21°25.9'N 113°08.8'E, on a course of 287° and a speed of 6.4 knots. The distance and bearing to *the fishing vessel* were 3 nm and 202° respectively. No one on the bridge noticed any significant target of vessels forming a risk of collision by visual and radar look-out. (Refer to P.11 Fig.5- the Zhuhai VTS radar screen at 2100 hours, the two vessels were approaching to each other on convergent courses with a risk of collision.)

Fig.5 - the Zhuhai VTS radar screen at 2100 hours, the two vessels were approaching to each other on convergent courses with a risk of collision.

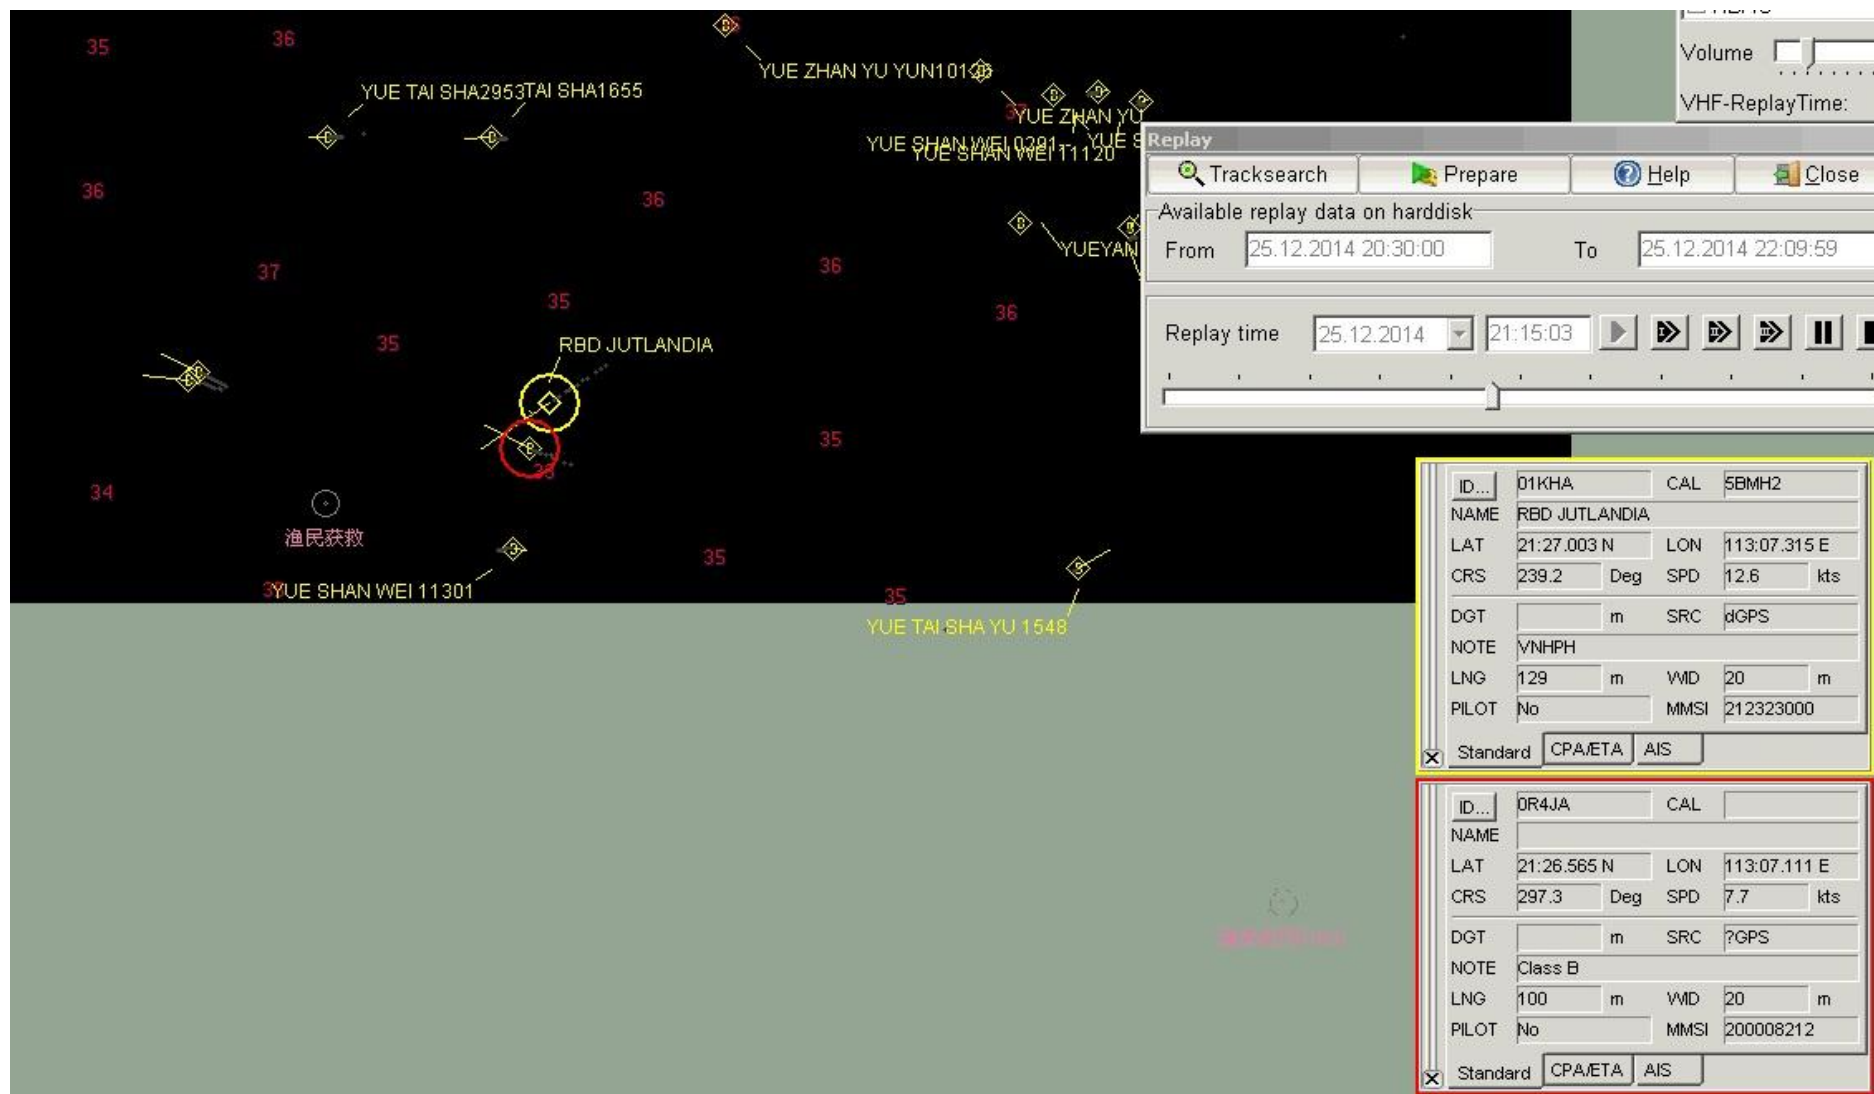
course of 297°. The bearing from the cargo vessel to the fishing vessel was 204°, and the distance was reduced to about 0.44 nm (817 m). But the master of *the cargo vessel* did not see *the fishing vessel*. Up to this moment, both vessels still had not taken any action to avoid collision. (Refer to P.12 Fig. 6 – the Zhuhai VTS radar screen at 2115, both vessels were closing under high risk of collision.)

Fig.6 – the Zhuhai VTS radar screen at 2115, both vessels were closing under high risk of collision.

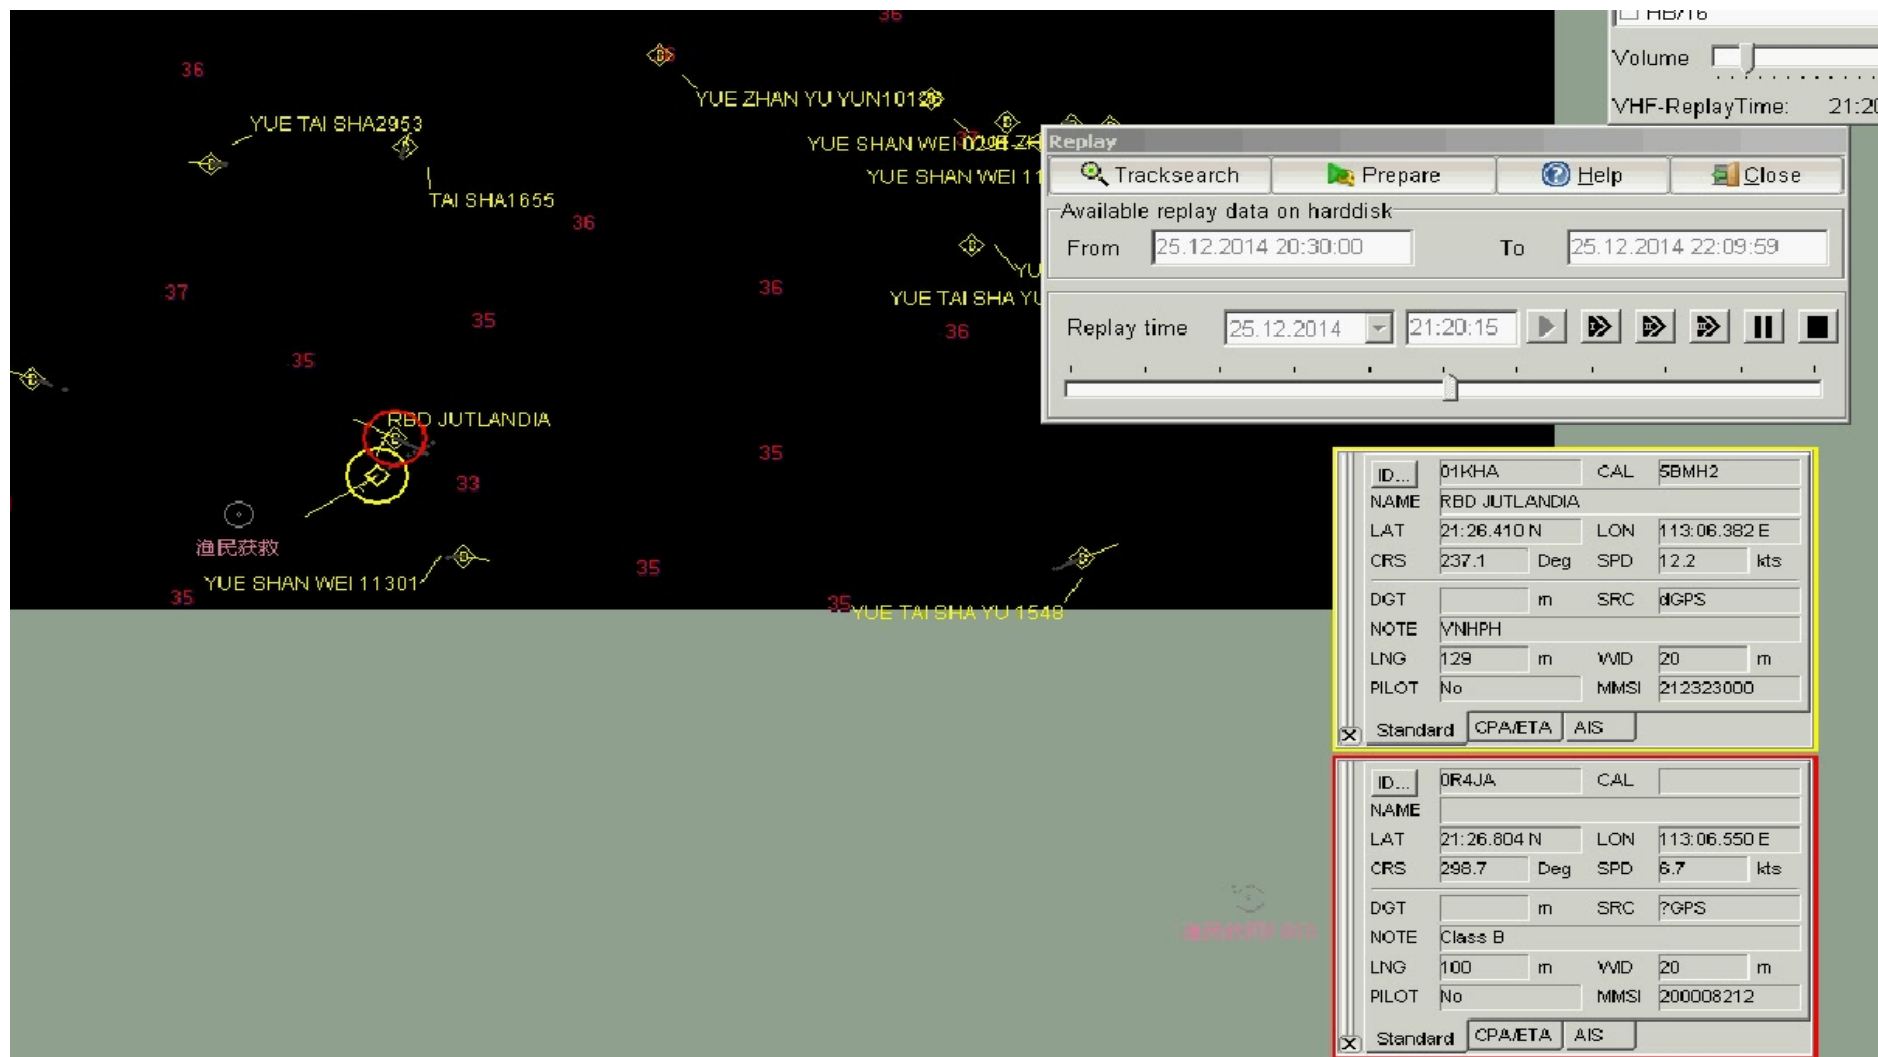
- 4.14 The collision of the vessels occurred at about 2117, but both the master and chief engineer on the bridge of *the cargo vessel* did not notice the collision. They did not hear any sound or feel any vibration of *the cargo vessel*. *The cargo vessel* continued her voyage to the next port without stoppage. (Refer to P.14 Fig.8- the Zhuhai VTS radar screen at about 2120, *the cargo vessel* “*RBD Jutlandia*” maintained her course and speed no change after collision.)

Fig.8- the Zhuhai VTS radar screen at about 2120, the cargo vessel “RBD Jutlandia” maintained her course and speed no change after collision.

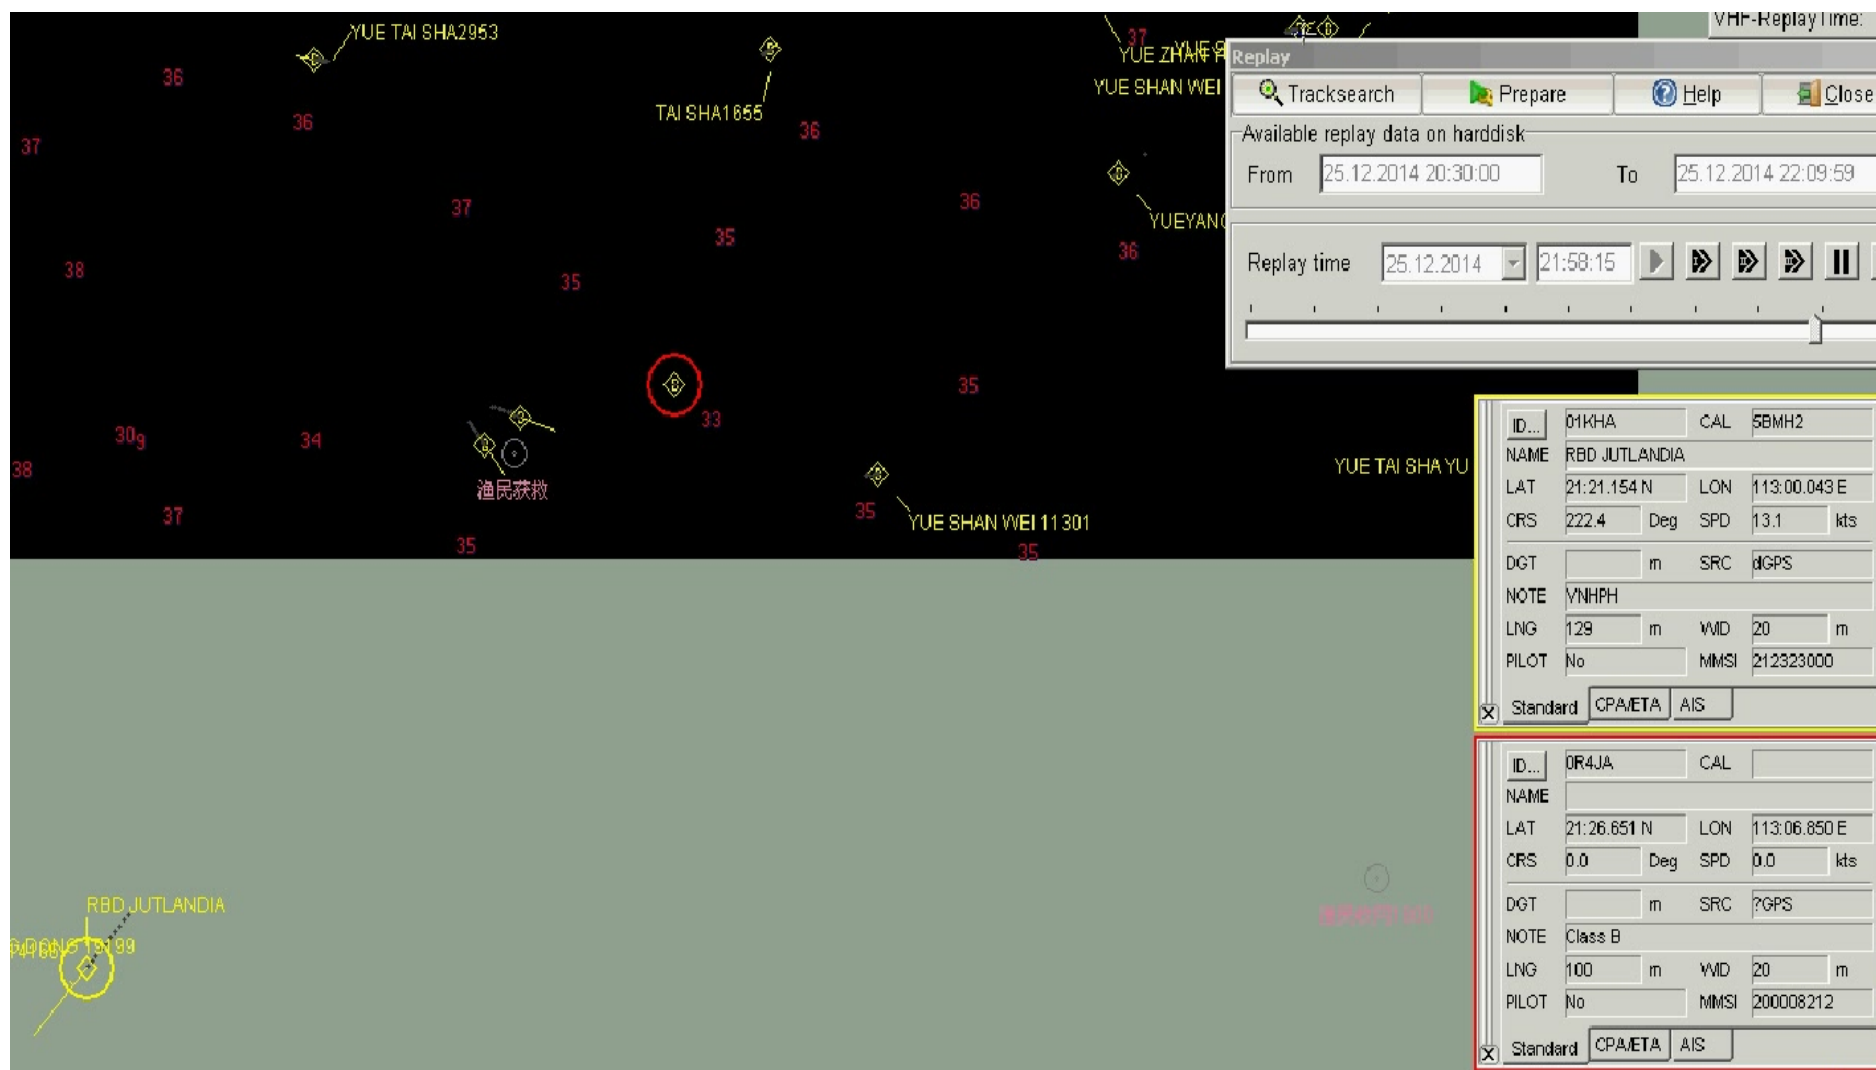
- 4.18 The Zhuhai VTS radar recorded that two unnamed fishing vessels had arrived at the survivors pick up position at about 2158. One of them was “Zhuxiang 1664”. (Refer to P.15 Fig.9– the VTS radar screen at about 2158, two unnamed vessels arrived on the site of survivors.) Three minutes later, *the fishing vessel* sank at a distance of about 1.8 nm away from that position and her signal then disappeared from the radar screen at 2201. (Refer to P.16 Fig.10- the VTS radar screen at about 2202, no AIS signal of the fishing vessel was received and displayed on radar screen anymore.)

Fig.9 – The VTS radar screen at about 2158, two unnamed vessels arrived on the site of survivors.

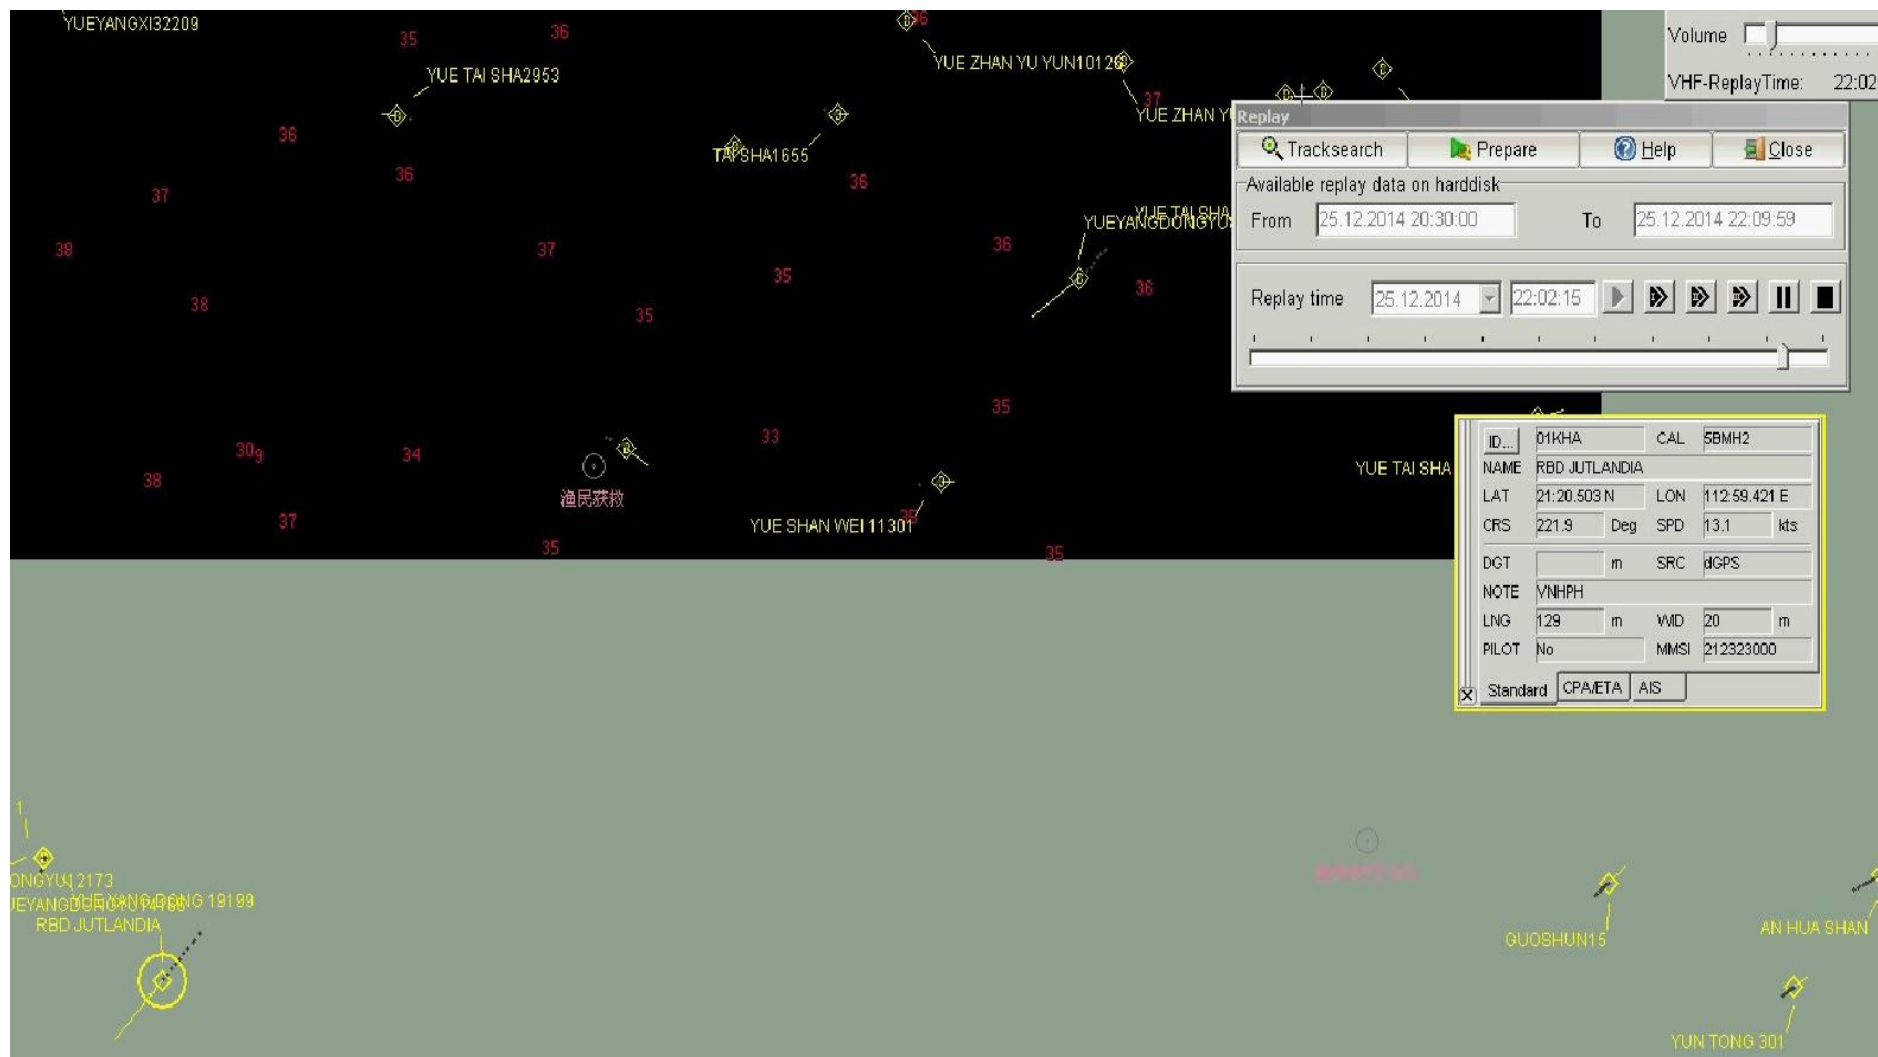
Fig.10- the VTS radar screen at about 2202, no AIS signal of the fishing vessel was received and displayed on radar screen anymore.

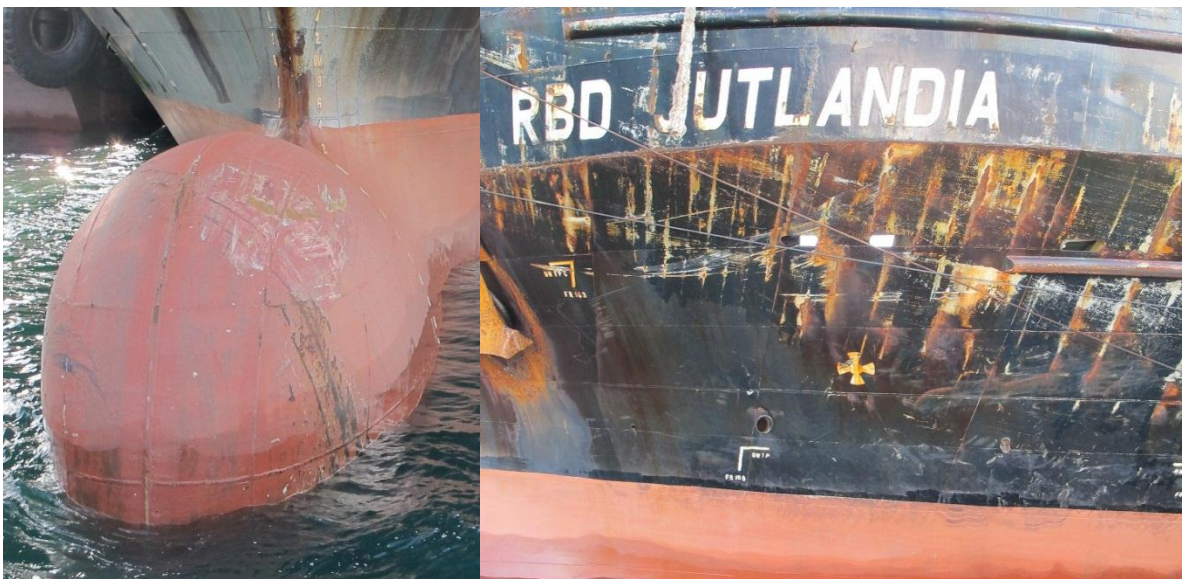
- 5.7 At about 2117, the VTS radar screen displayed that the echo of this *cargo vessel* overlapped with an echo of an unnamed vessel in position about 21°26.7'N 113°06.8'E. This position was about 1.8 nm northeast off the survivors rescue position. The echo of unnamed vessel then disappeared about 40 minutes later at about 50 metres east of the above overlapping point.
- 5.8 On 30 December 2014, an inspection on *the cargo vessel* was conducted after her arrival at Hong Kong. Fresh scratching was found on the port side of bulbous bow and port side hull (Fig.11).

Fig.11 - Fresh scratches were found on the bulbous bow and port side hull of “RBD Jutlandia”

- 5.9 As per the statements of the survivors, *the fishing vessel* was in collision of her starboard forward of mid-ship with a big ship at about 2100 hours. There was no other big vessel in the vicinity at that time except *the cargo vessel* “RBD Jutlandia”. Taken all the above evidence into account, it was deduced that *the cargo vessel* collided on the starboard side of *the wooden fishing vessel* by her port bow.
