Report of investigation into the fatal accident when working aloft during the cargo hold cleansing on board Hong Kong registered woodchip carrier “*Surabaya Express*” on 16 February 2015

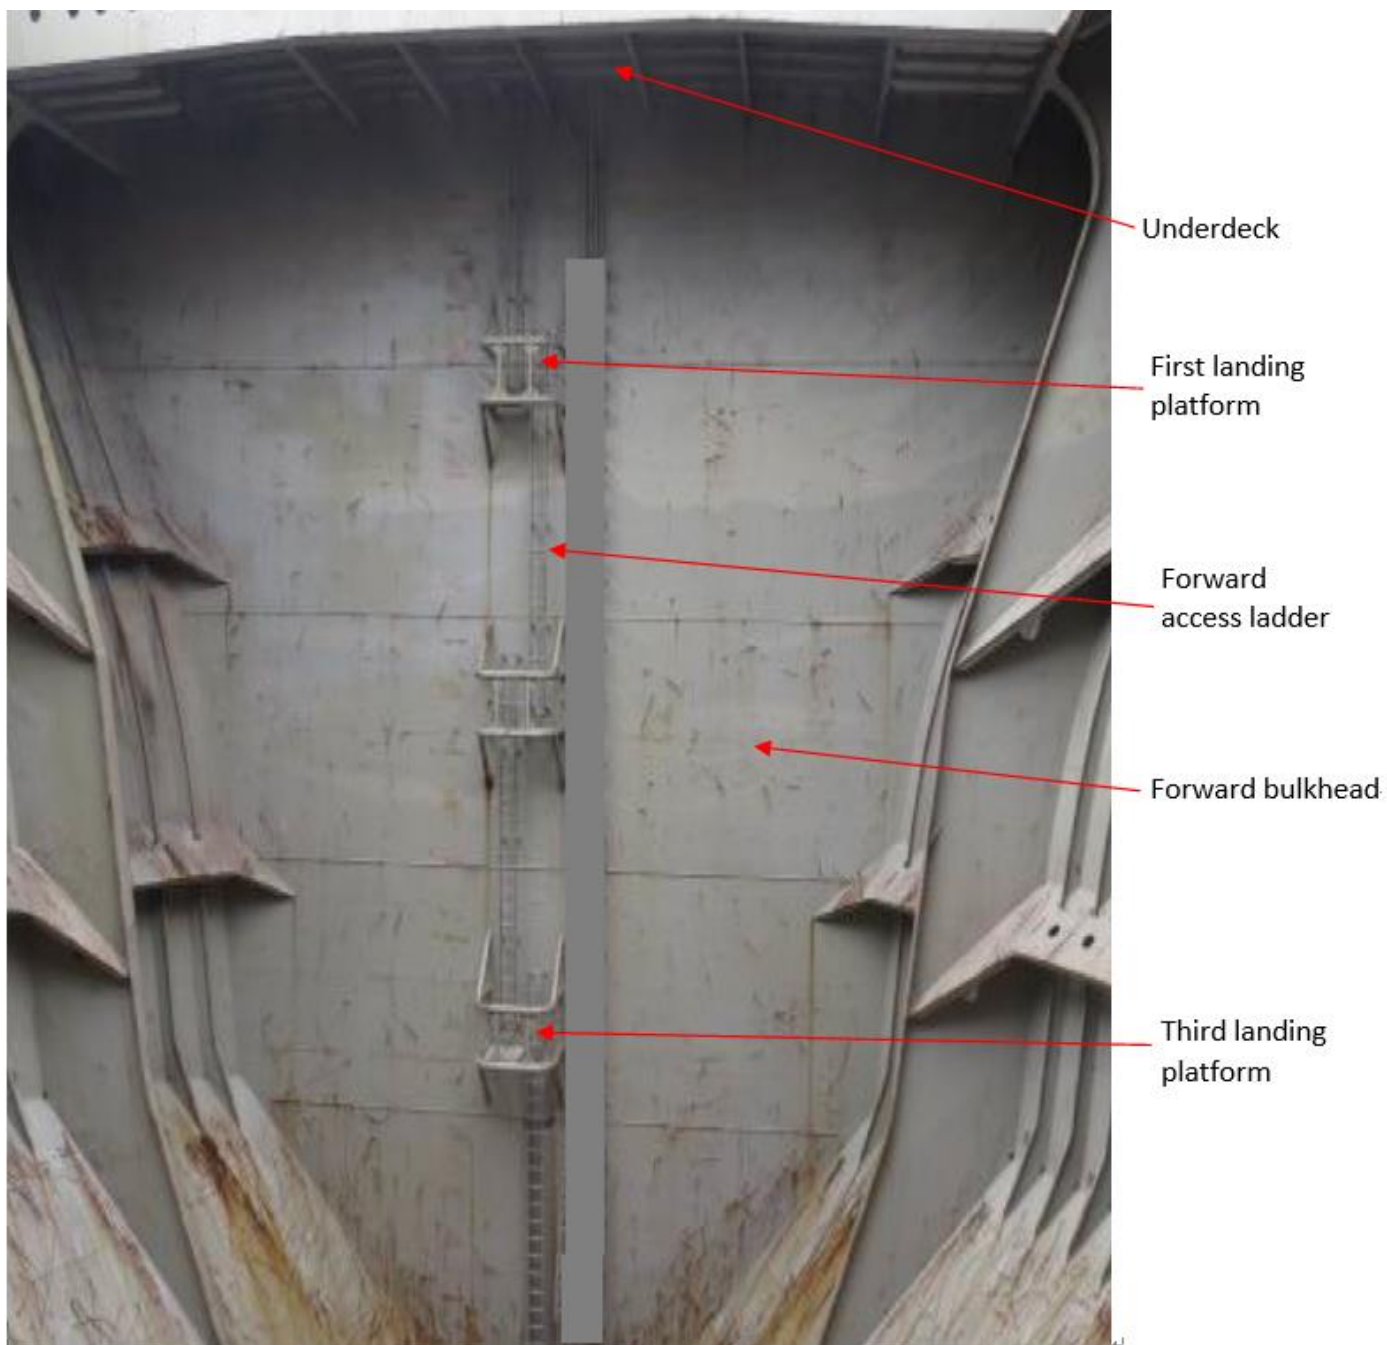
**Fig.2 No.1 Cargo Hold, forward bulkhead**

- 5.11 There was no witness to the cause of the accident.
- 5.12 The vertical ladder got wet and slippery when cleansing work was carried out inside the cargo hold. Although the ordinary seaman had his non-slippery safety shoes on during the cleansing work, it was probably that he lost his balance and fell down due to a slip on the wet and slippery ladder.

- 5.14 His intention of entering into the cargo hold was not known despite his teammate, the able-bodied seaman, had told him not to enter into the cargo hold before leaving the work place for taking a rest. And it was unlikely that the ordinary seaman accidentally fell into the cargo hold through the access hatch opening. Based on the available evidence, it was apparent that the ordinary seaman climbed down the wet and slippery vertical ladder alone into the cargo hold with unknown reason. He underestimated the risk of doing so. While he was on his way climbing down the ladder, he could not maintain a three-point contact probably due to a slip and lost his grasp on the vertical ladder. He fell down to the third landing platform of about 7 metres in height.

- (a) the safety awareness of crew members on board ship in respect of climbing a vertical ladder at height must be enhanced through on board education and training; and

- (b) stipulate clear procedures that the work of inexperienced crew members on board must be closely supervised and should not leave them alone on deck.

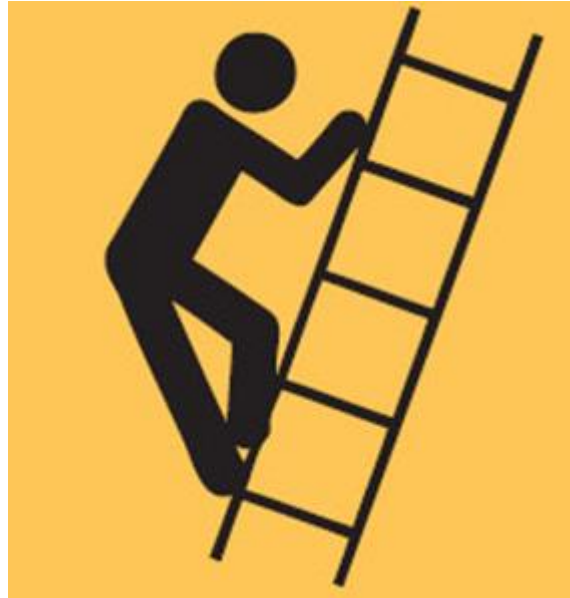
**Fig.3 Maintain three-point contact to climb a vertical ladder**

- 5.9 Safe working practice is crucial when climbing a vertical ladder on board ship. A seafarer should maintain a three-point contact (i.e. either two hands and one foot or two

feet and one hand) with the ladder at all times during climbing (Fig.3). Breaking of the three-point contact only before landing.
