Report of investigation into the
incident of the Hong Kong registered
cargo vessel “Eastern Amber” hit a
wreck in the position west coast of
Korea on 4 March 2015

The Hong Kong Special Administrative Region
Marine Department
Marine Accident Investigation Section

09 November 2015

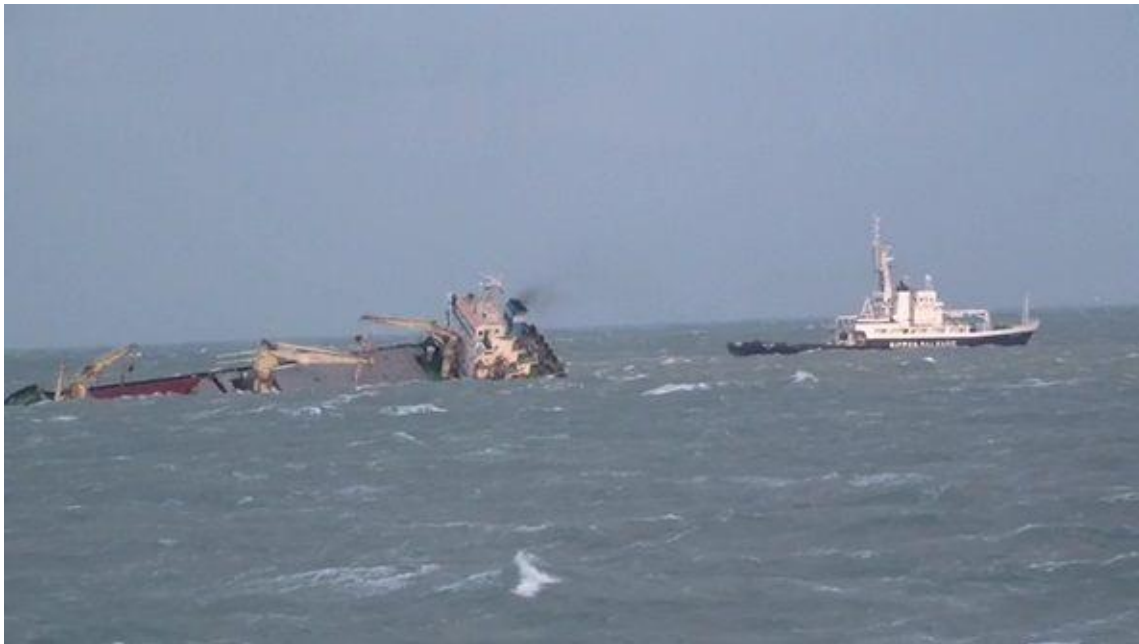
Fig.2 – *“Eastern Amber” went to capsize during salvage*

- 4.16 On 10 March 2015, the chief engineer found that the problem of water ingress into No.1 cargo hold was worsening. *The vessel* further listed to the port side by about 15°. The salvage team used a tug boat to evacuate all personnel from *the vessel*.

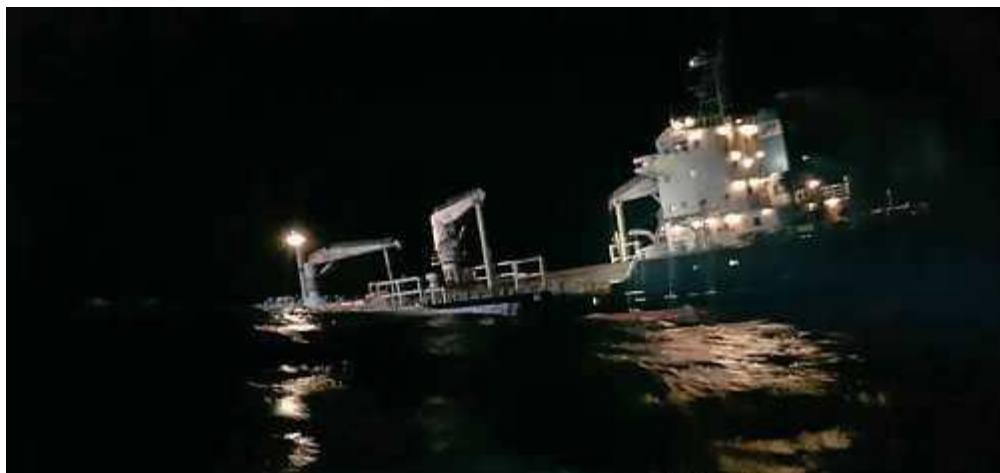
- 4.9 At about 2300, the emergency alarm was rung by the duty officer. The master ordered to abandon ship about 5 minutes later. The 2nd officer activated the distress transmission of EPIRB, IMARSAT C and SART. The chief officer immediately proceeded to check the hull condition at the forward. However, he retreated after he found that the forward part of *the vessel* was submerging into the water.

Fig.3- Condition of “*Eastern Amber*” after hitting a wreck.

- 4.10 Gradually, the bow of *the vessel* was fully submerged into the water. She listed to port side as sea water ingressed from the damaged hull at the port bow.
- 4.11 The starboard side lifeboat was launched and automatically released from the falls. While the boat was waterborne, it had drifted away before crewmembers embarked the boat. They switched to and successfully launched the port side lifeboat with a total of nine crewmembers embarking the boat.
- 4.12 The two inflatable liferafts were also launched, but the crewmembers could not embark anyone of them due to failure of the embarkation ladder. The port side lifeboat sailed away from *the vessel*. All the nine crewmembers were later on rescued by a ship in the vicinity.

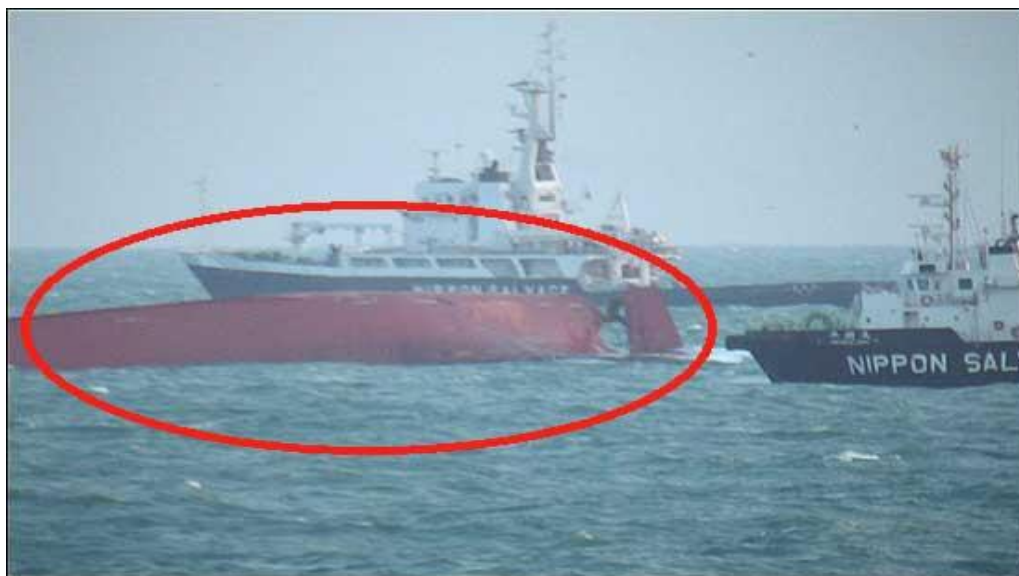
- 4.17 At about 2040 hours on 10 March 2015, *the vessel* capsized at position 33°34.36'N 126°46.13'E, about 9 n.m from Jeju Island.

Fig.4-“*Eastern Amber*” capsized during salvage
