**Report of Investigation  
into the fatal accident  
on board Hong Kong  
Registered Ship “*GENCO  
SUGAR*” at Puerto Montt,  
Chile on 05 March 2015.**

The Hong Kong Special Administrative Region  
Marine Department  
Marine Accident Investigation Section

11 March 2016

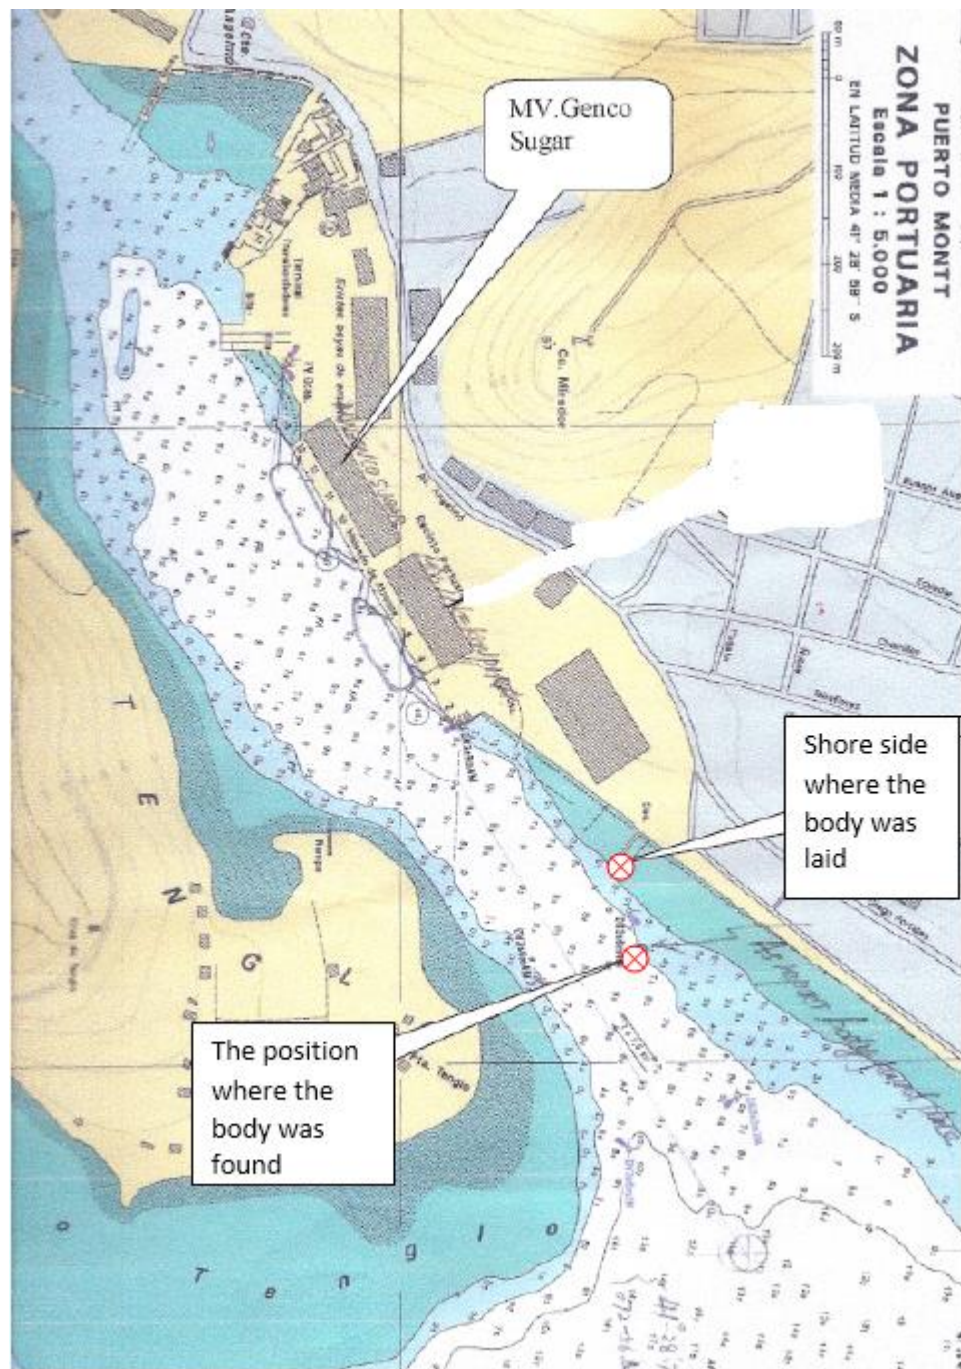
Fig. 2: the relative positions of the vessel and the body of the second officer

- 4.7 At about 1915, the master informed the ship agent and asked for assistance to call the police. At about 2010, the ship agent informed the master that a dead body was found floating in water at about 600 meters away from the forward of the *vessel* (Fig.2).

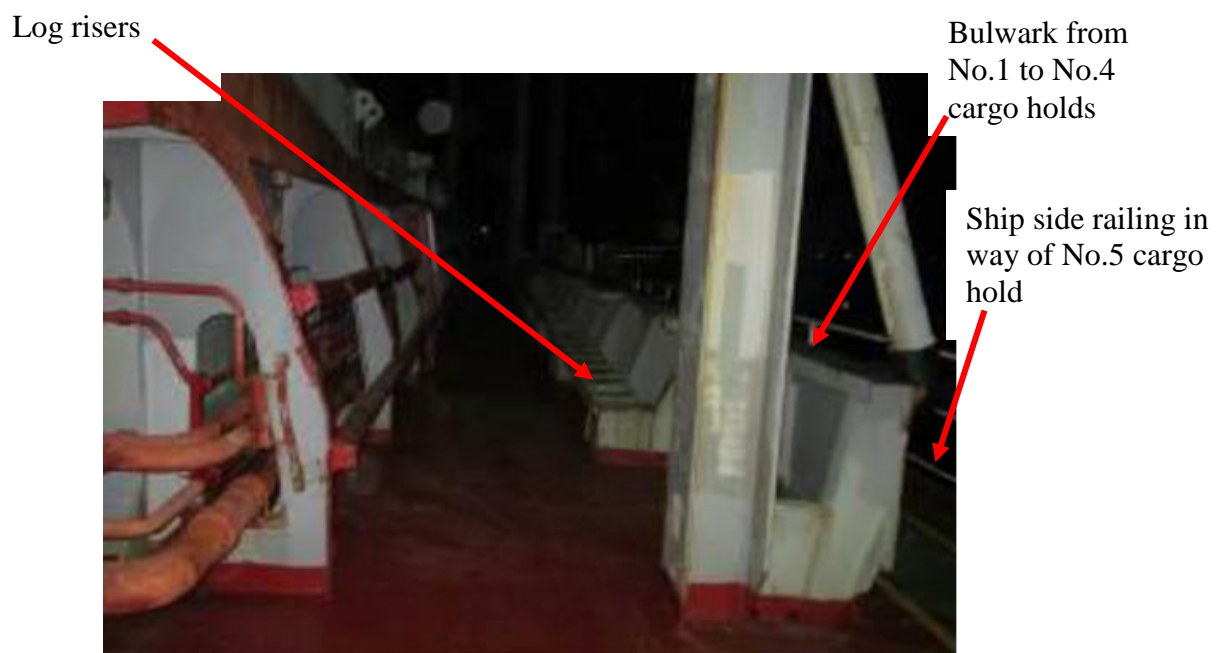
Fig. 3: overboard falling protection

#### **Bulwark and log risers on main deck**

- 5.14 On the port and starboard side main decks, bulwark was fitted throughout the cargo area of the *vessel* except in way of No.5 cargo hold where ship side railings were fitted for the convenience of rigging the embarkation ladders.
- 5.15 Log risers were fitted on deck beside the bulwark. At the material time, log risers were lowered down, stacked and clung to the bulwark. Under such circumstances, the height of the stacked log risers was slightly lower than the height of the bulwark (Fig.3).

- 5.18 At the time of the accident, the 2/O did not wear safety harness. The main deck was wet due to rain in the past few days. The cargo residues of "UREA" had been scattered everywhere on the main deck and fittings. "UREA" was soluble in water and hygroscopic, thus facilitated the formation of lumps that could cause a person to slip, trip and fall.

- 5.19 Without using a rope ladder and the assistance of other crew members, the 2/O could only roughly check the ship's draught marks on the starboard side by leaning his body over the ship side. It was probable that he stepped on the stacking of log risers beside the bulwark for his convenience of checking the draught marks. In the case of the 2/O had stepped on the log risers and leaned his body forward over the ship side, the slippery surfaces could have caused him losing his balance and fell overboard.

- 7.1 The owners / management company of the *vessel* should issue a safety circular to inform all masters, officers and crew on board ships the findings of the accident investigation and lessons learnt, and instruct them to strictly follow the safe working procedures stipulated in the Company Safety Management System Manual.
- 7.2 A Hong Kong Merchant Shipping Information Notice is to be issued to promulgate the lessons learnt from the accident.
