**Report of investigation
into the fatal accident on
board the Hong Kong
registered ship “*Saga
Frontier*” at Antwerp,
Belgium on 11 April 2015**

The Hong Kong Special Administrative Region
Marine Department
Marine Accident Investigation Section

2 April 2016

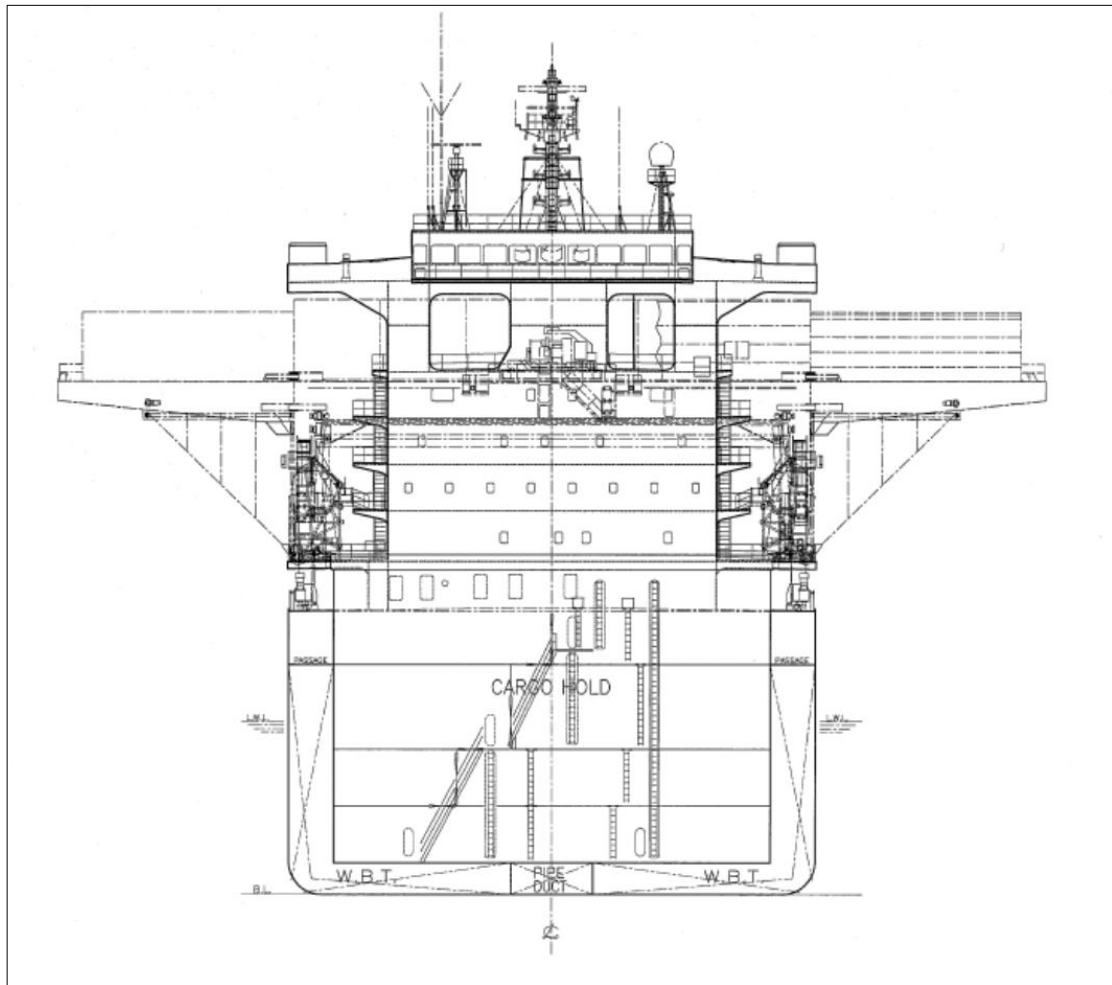
Fig 2: Cross section view of “*Saga Frontier*” (View from forward)

- 2.2 The vessel (see Fig. 1) is a double hull, ten-hold general cargo carrier. The cargo holds are separated by bulkheads with access stair trunks fitted with 2 straight stairways, 3 access doors and 3 landing points at different levels for accessing the cargo holds (see Fig. 2).
- 2.3 The vessel is fitted with two gantry cranes that run on fixed rails for cargo work.

- 5.2.1 The stair trunk in question was a void space between No. 3 and No.4 cargo hold (Fig.4). There were three landing points respectively at above the first deck, second deck and bottom deck (tanktop), each of them provided with a steel door in the bulkhead opening into the No.4 cargo hold (Fig.2). These steel doors were not gas-tight, therefore the atmosphere inside the stair trunk could be affected by the atmosphere inside the cargo hold even though the steel doors were closed.

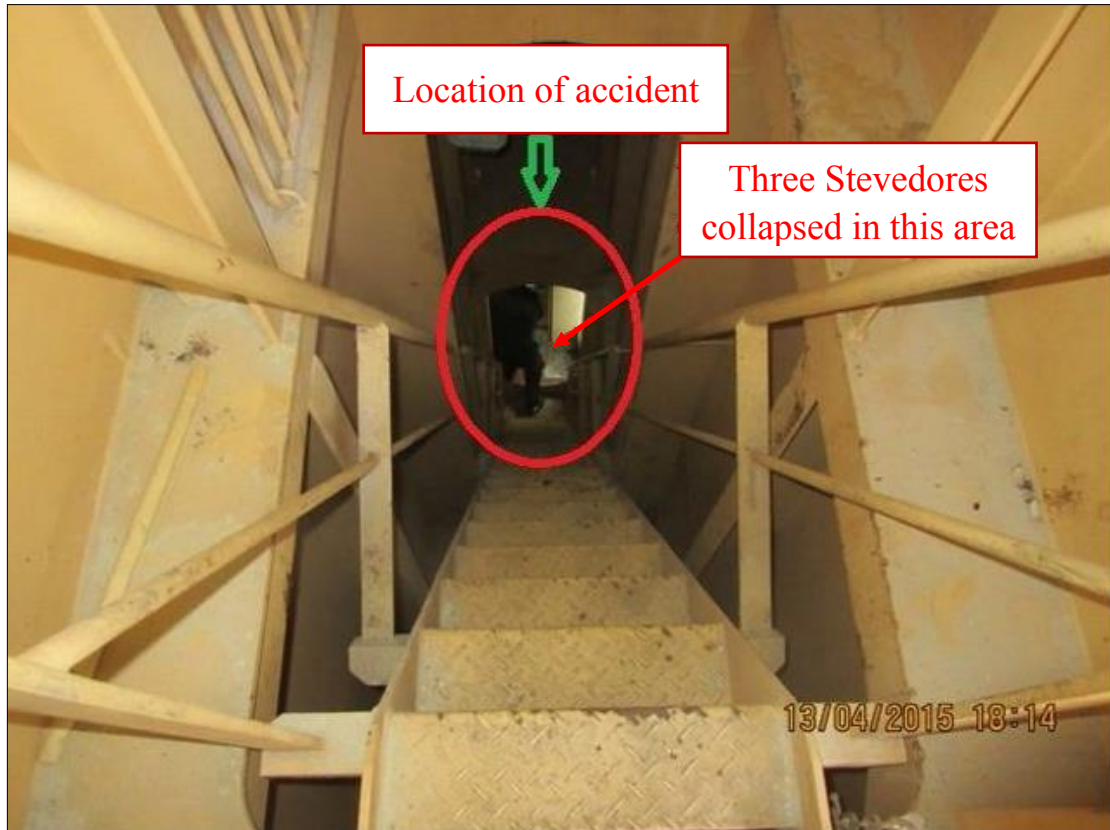
Fig. 4 - Three stevedores collapsed at the bottom of the trunk

- 5.2.5 The oxygen content in the normal atmosphere is 20.9%. When the oxygen content in the enclosed stair trunk dropped down to 15%, a person would feel of dyspnea, emotional instable and extreme tiredness. If the oxygen content was further reduced to 10%, fatal would occur in minutes. It was highly probable that the stevedores suffered from asphyxiation when they were entering into the stair trunk while the oxygen content was in a danger level, i.e. less than 10%.

- To assign an entrance attendant or a barrier secured across the entry with an attached warning sign when the enclosed space is not sealed off or it has no enclosed space entry permit issued;

- To ventilate the enclosed spaces by positive forced draft ventilation in order to secure sufficient air change;
 - To issue enclosed space entry permit after the risk assessment and gas free having been complied with; and
