**Report of Investigation into the
grounding of the open cruiser
NAA-3797, at Cham Tau Chau,
Hong Kong on 26 April 2015**

The Hong Kong Special Administrative Region
Marine Department
Marine Accident Investigation Section

14 April 2016

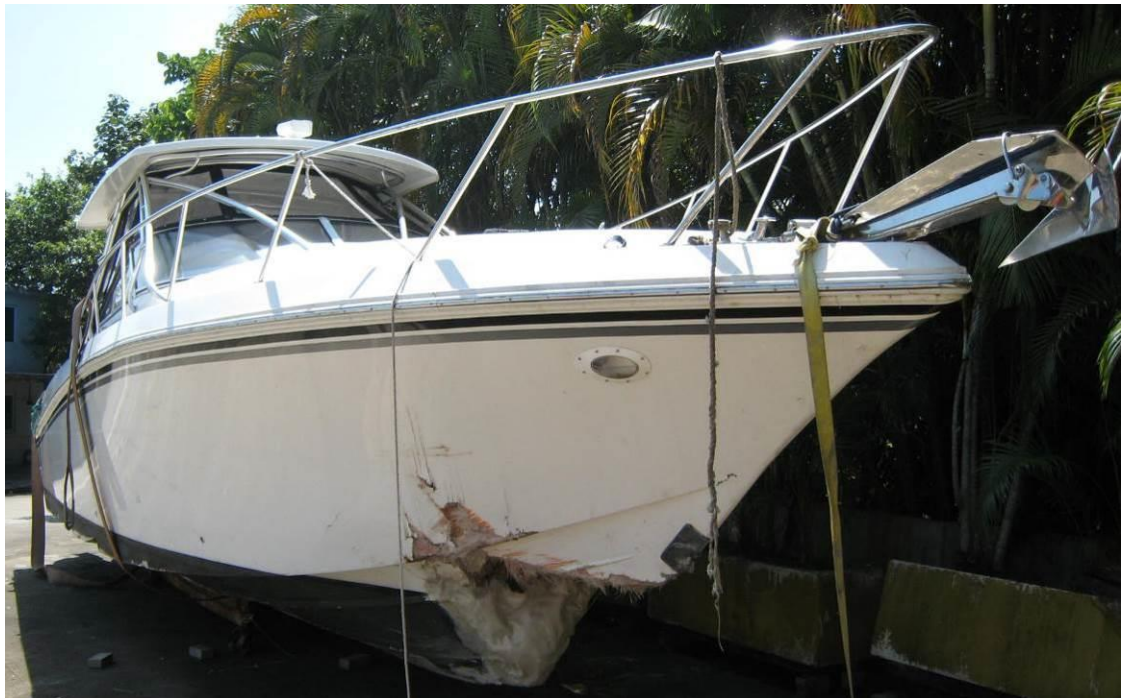
Fig. 1 –NAA-3797 view after the incident

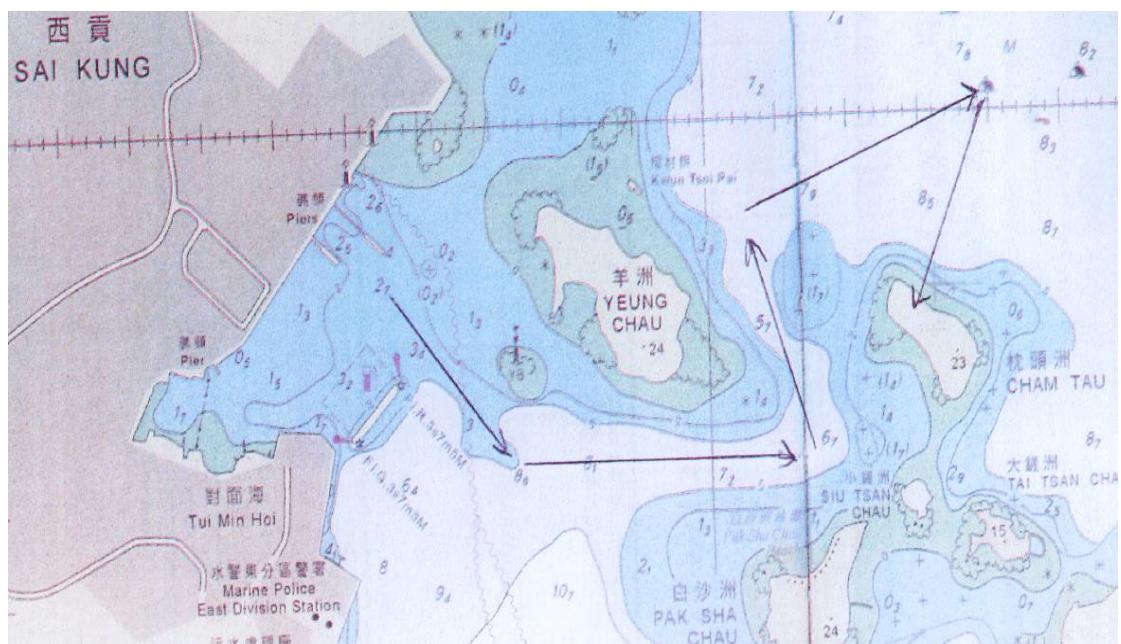
- 4.4 Shortly after passing the water in between Yeung Chau and Cham Tau Chau, *the cruiser* altered course to starboard (Fig. 2). Suddenly, *the cruiser* crushed into an object (it was later found to be a mooring buoy). The coxswain was ejected from the driver position and hit on the front wind shield, then fell on the deck unconsciously. *The cruiser* became not under control and veered towards the north of Cham Tau Chau. Finally, she went up and stranded on the beach at the north of Cham Tau Chau, in the approximately position of 22° 22.81'N, 114° 17.32'E at about 0210 (Fig. 3).

Fig. 2 –route of NAA-3797

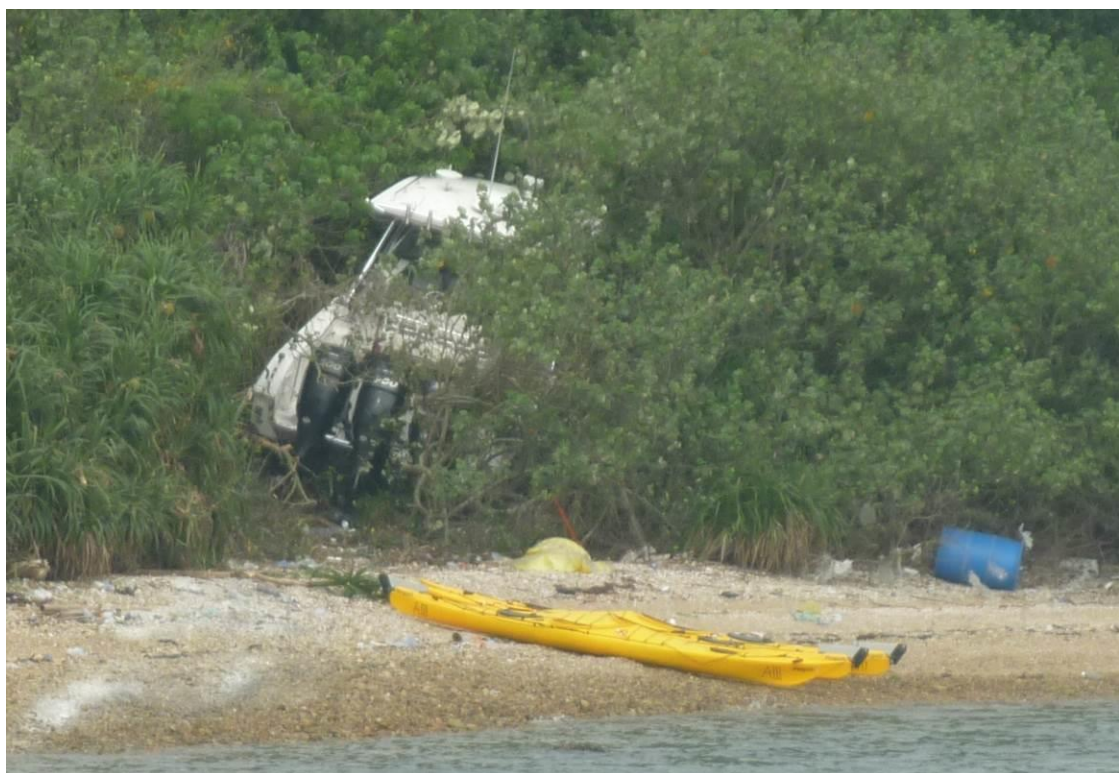
Fig. 3 - NAA-3797 went up and stranded on the beach of Cham Tau Chau

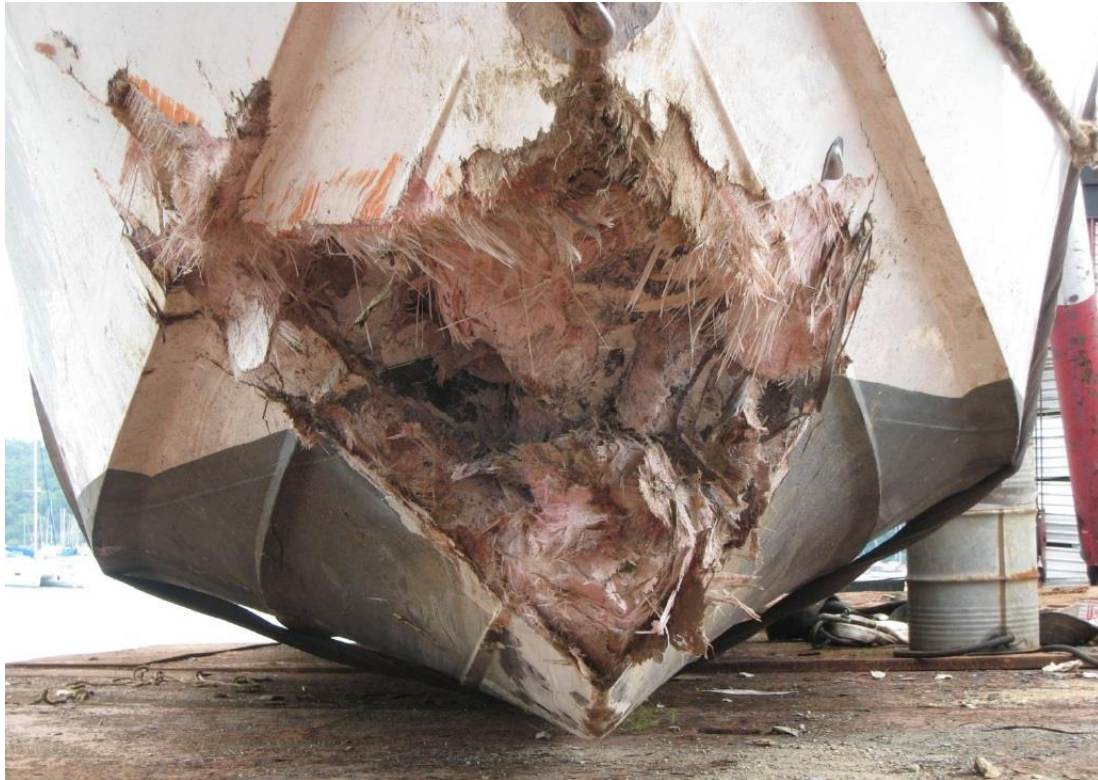
- 4.7 *The cruiser* sustained serious damage to its bow (Fig. 4) and the propeller and skeg of port outboard engine (Fig. 5).

Fig. 4 - The damage of NAA-3797 at the bow

to the extent of damage to the bow of *the cruiser* and her position of stranding on the island which was about 400 metres distance from the buoy, it was probable that she was sailing at a high speed prior to hit the mooring buoy. After hitting the mooring buoy, *the cruiser* lost control and veered towards the island at a high speed. It was deduced that *the cruiser* did not proceed at a safe speed. As a result, the coxswain of the cruiser could not take proper and effective action to avoid hitting the mooring buoy.

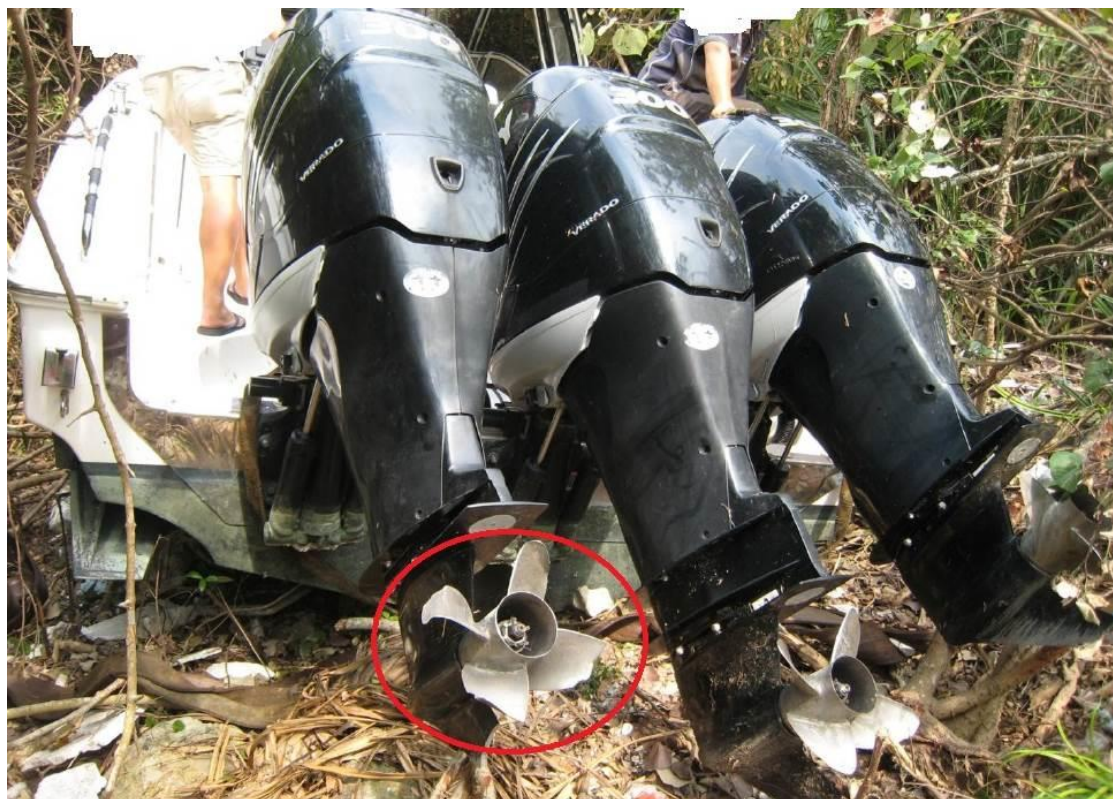
Fig. 5 – The propeller and skeg of the port outboard engine was damaged

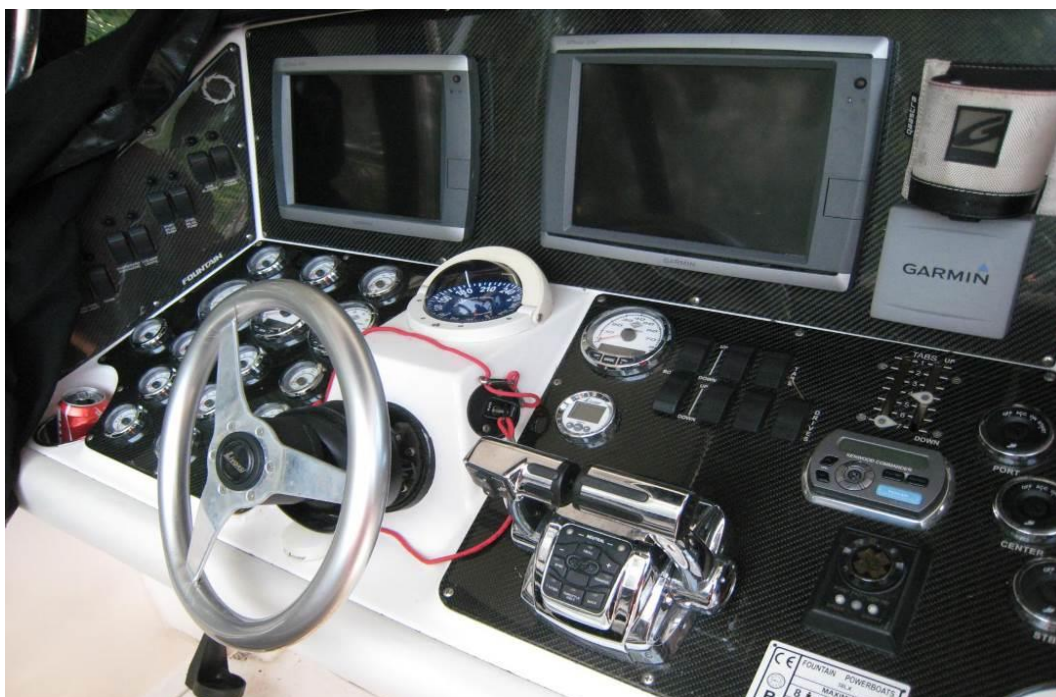
Fig. 6 – The safety lanyard and the toggle safety switch were intact after the accident

- 5.13 After hitting the mooring buoy, the coxswain lost his consciousness and laid down on the deck away from the steering position. The boat continued to run about 400 metres with no-one at the helm at high speed and the boat finally went aground on the beach. Inspection of the boat found the toggle safety switch and safety lanyard were intact and tidy on the console. The evidence indicated that the safety lanyard was not worn/attached by the coxswain while the boat was under way before hitting the buoy. Therefore, the engines of the cruiser could not be shut down as no pulling of the safety lanyard was initiated by the coxswain. The cruiser continued running at a high speed until went aground on the beach.

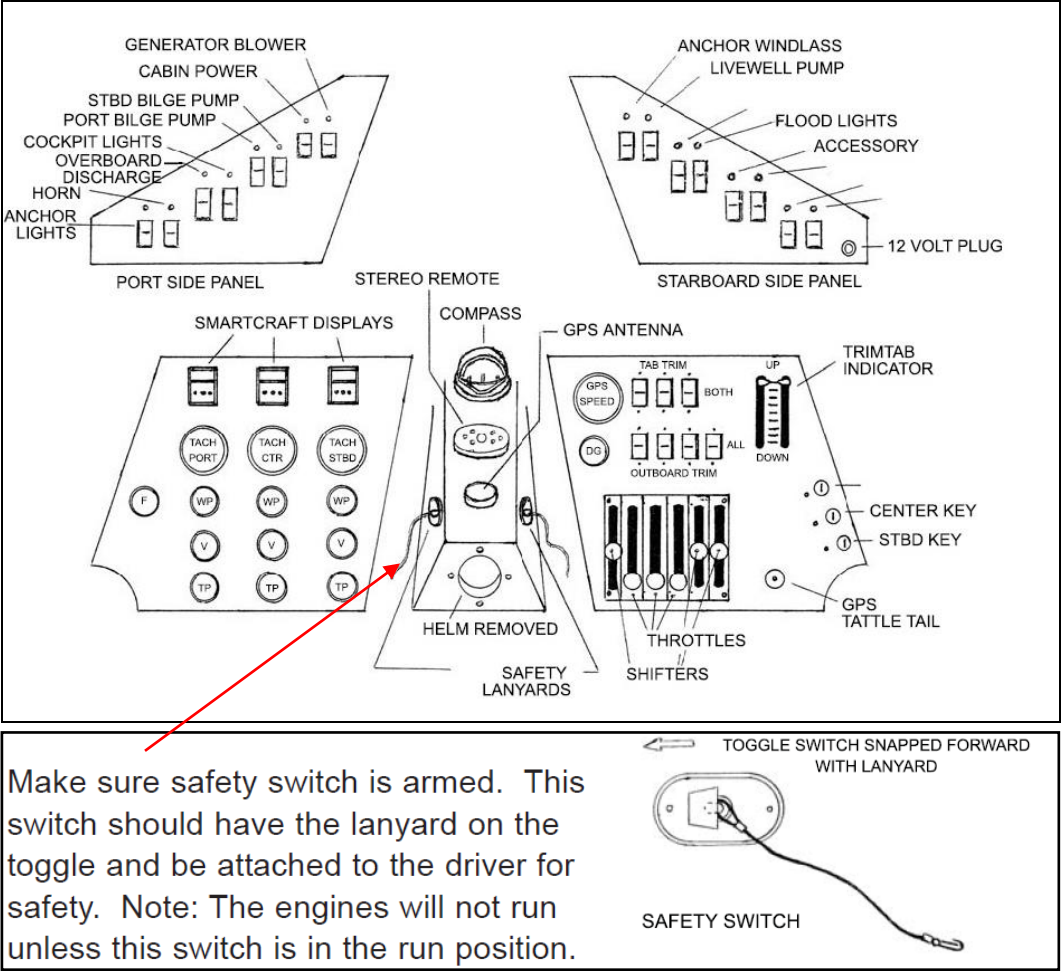
- 5.11 A safety switch with a red safety lanyard (also known as a kill cord) was fitted on the control panel of the cruiser (Fig.6, Fig.7). It was a safety mechanism used to shut off the engines in an emergency situation to stop the cruiser. The toggle safety switch could be activated by pulling the red safety lanyard to stop the propulsion engines.

Fig.7 – The control console and the safety switch (from the manual).

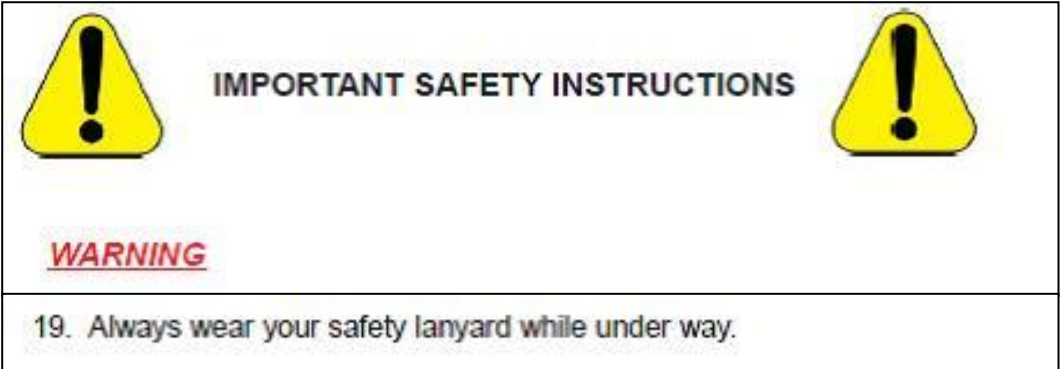
- 5.12 A warning list was highlighted in the important safety instruction of the “Operation, Maintenance and Warranty Manual” of the boat. Warning item 19

described that “Always wear your safety lanyard while under way.” (Fig.7) If the safety lanyard was worn by the driver, the leaving of the driver from the driver position would pull the safety lanyard to activate the toggle safety switch to stop the engines.

Fig.8 - The warning of wearing safety lanyard in the manual (from the manual)

- 7.1 A copy of the investigation report should be sent to the owner and coxswain of *the cruiser* informing them the findings of the accident investigation.
- 7.2 The owner of *the cruiser* should instruct the coxswains of the vessel that during sailing, they should :
- i) maintain a proper lookout by all available means;
 - ii) proceed at a safe speed; and
 - iii) follow strictly the “Important Safety Instruction” of operation manual to wear the safety lanyard (the kill cord) while under way.
- 7.3 Marine Department should strengthen the education on water sport safety, highlighting the usage of safety lanyard (kill cord) if fitted and the compliance of other important safety instructions of pleasure vessels. Promotional pamphlets should be considered to be distributed to publics to escalate publicity.

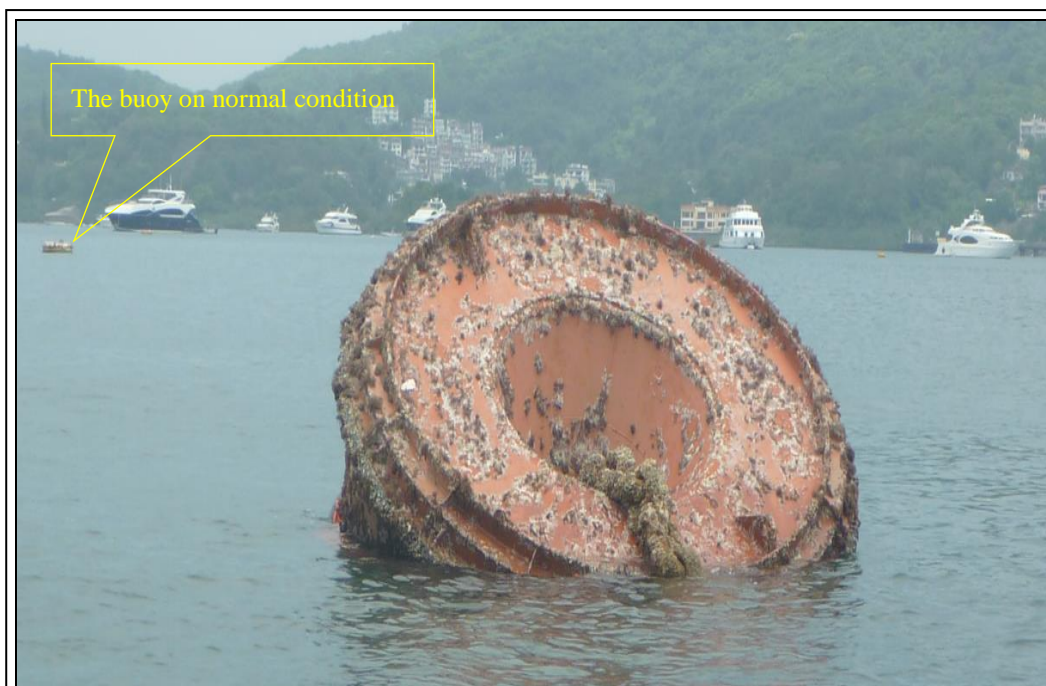
- 5.8 Investigation revealed that one of the mooring buoys with marking “PETWH-C” was turned upside down and there was a fresh paint scratch mark and dent on the buoy (Fig. 8 and Fig. 9). It was highly probable that *the cruiser* hit that mooring buoy before stranding on the beach in the incident.

Fig. 9 – Mooring buoys exist off the north of Cham Tau Chau, one capsized.

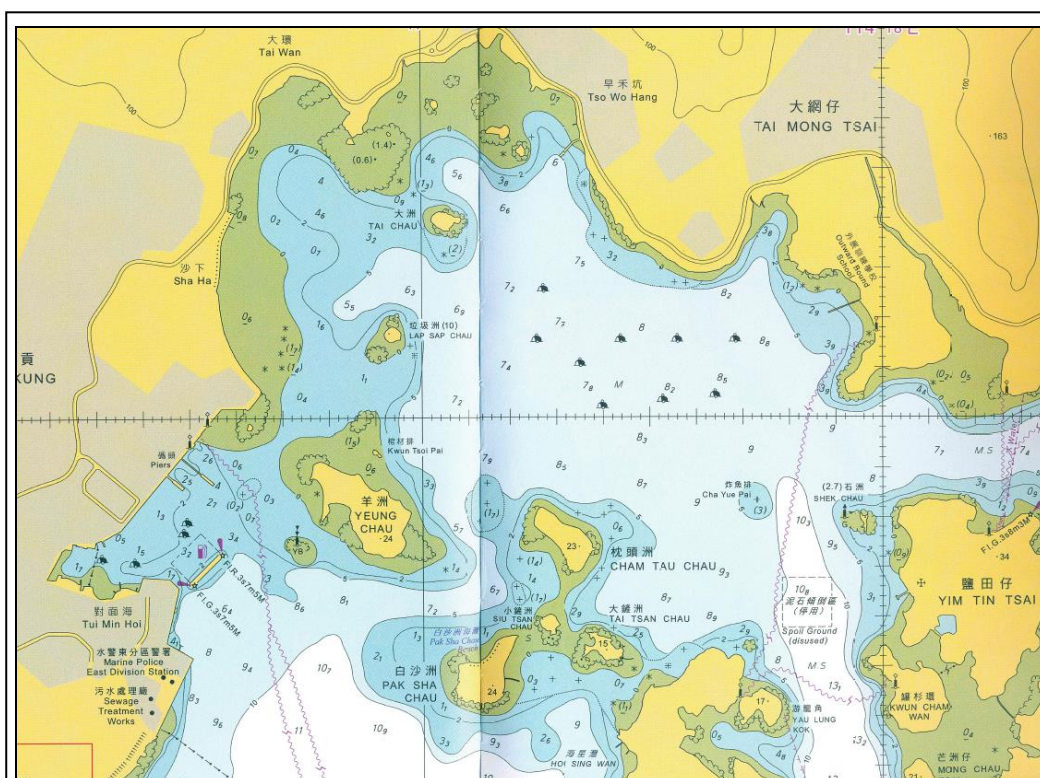
- 5.6 According to the statement of the crew and one of the passengers, there was no other vessel in the vicinity while *the cruiser* was under way.
- 5.7 In the waters off the north of Cham Tau Chau, there is a group of steel mooring buoys (diameter 3.66 meters x height 1.845 meters, 9 buoys) which have been placed in the water for many years. The Charts for Local Vessels in Hong Kong Waters published by the Hydrographic Office of Hong Kong Marine Department have clearly indicated the locations of the mooring buoys (Fig.7). An experienced coxswain or navigator should be well familiarized with these mooring buoys.

Fig. 10 – Nine mooring buoys exist off the north of Cham Tau Chau

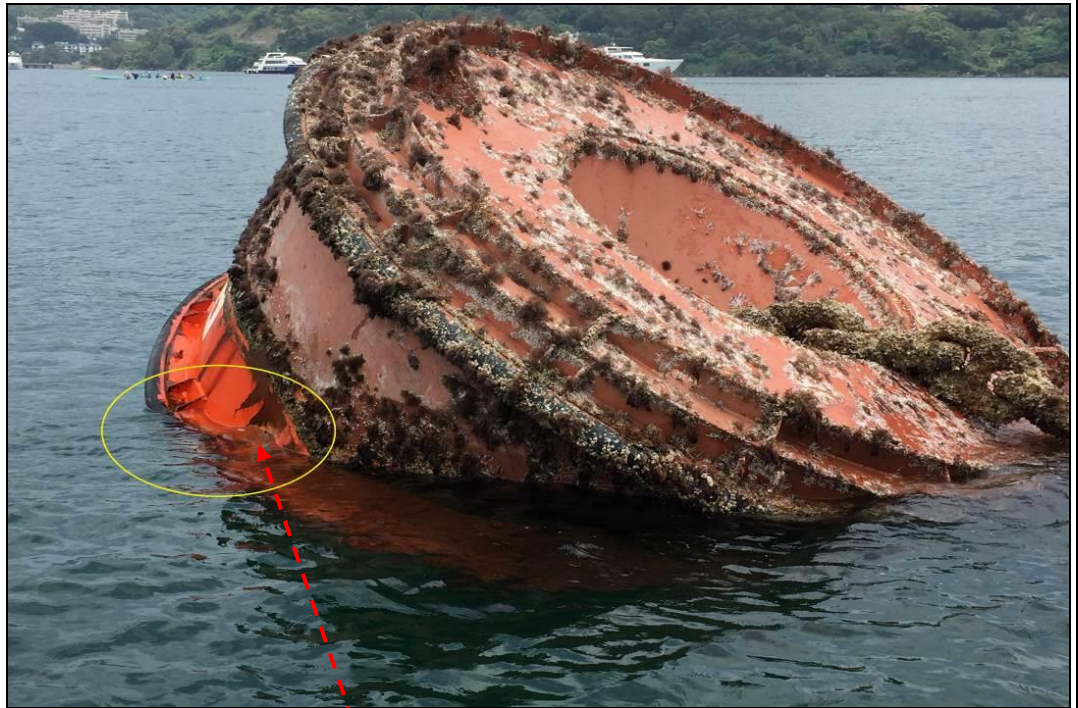
Fig. 11 – Fresh paint scratch and dent on the upside down mooring buoy (with marking of “PETWH-C”)

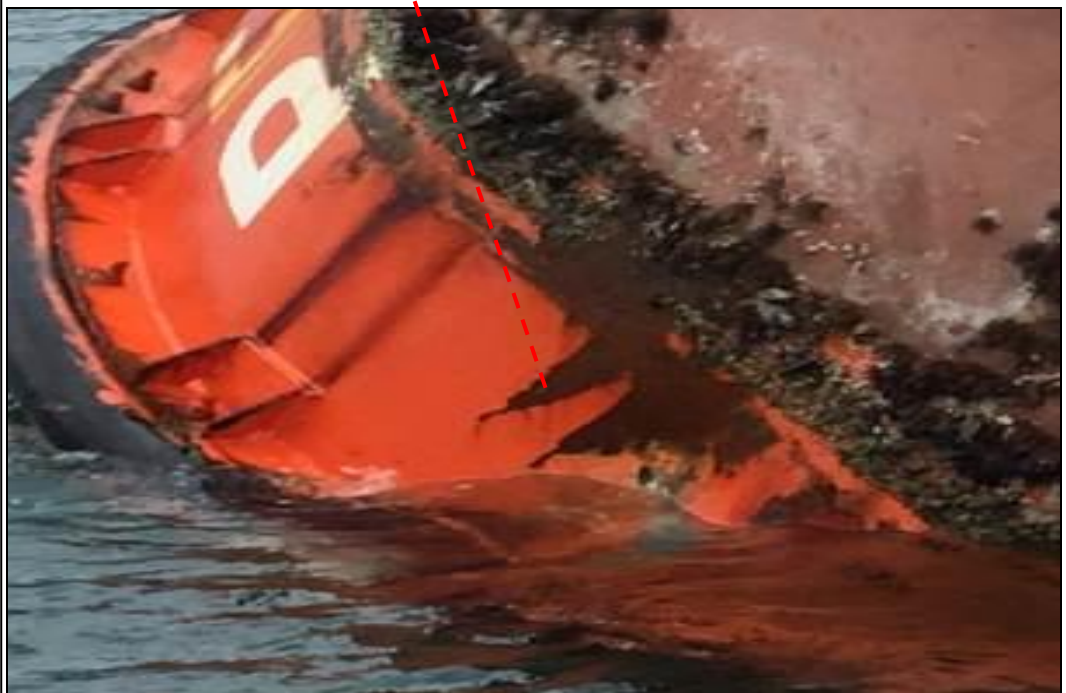
Fig. 12 – Fresh paint scratch and dent on the mooring buoy
