**Report of Investigation into the
electrocution of a fitter on
board Hong Kong registered
container ship “Maple Leaf 25”
on 14 May 2015**

The Hong Kong Special Administrative Region
Marine Department
Marine Accident Investigation Section

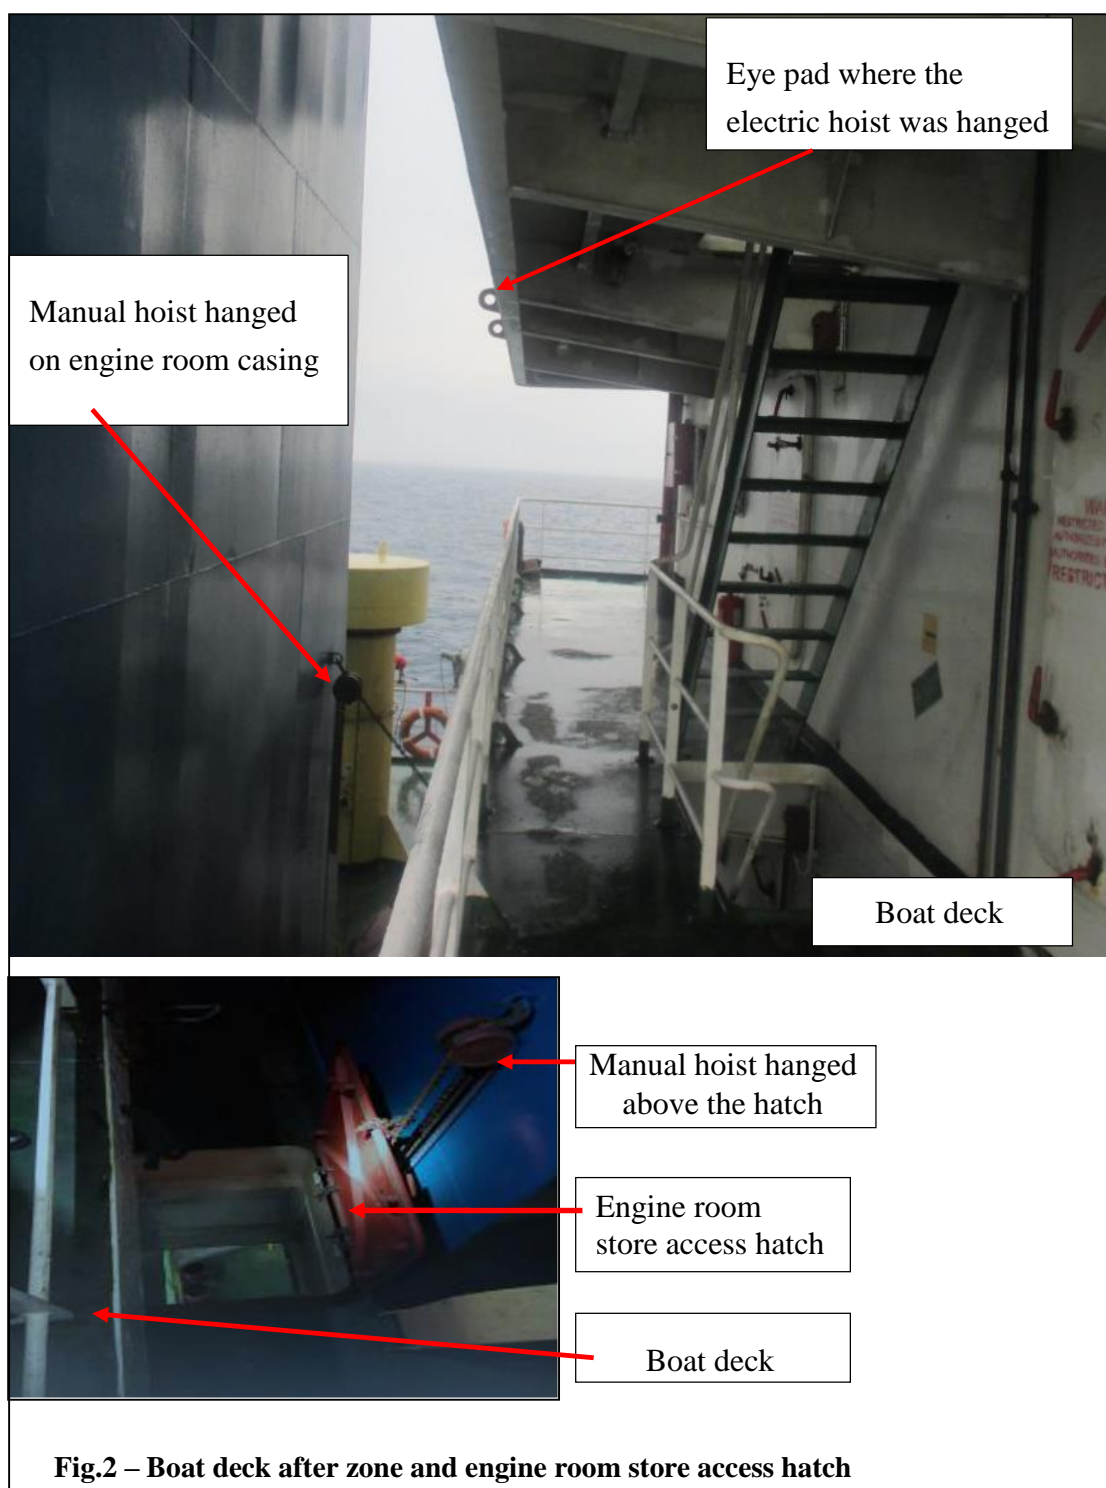
- 4.5 Shortly afterwards, the electric hoist was secured to a pad eye located on the deck above the boat deck and it was about 5.2 metres above the hatch opening (Fig. 2). The casing was lifted from the boat deck and subsequently lowered downward. But it was stuck in the hatch opening.

- 5.15 According to the maker's recommendation, the electric hoist should not be used to lift a load at an angle of more than 3.5° from the vertical. Thus, the electric hoist should not be used for shifting the casing horizontally. When the casing was lowering down to the hatch opening for the engine room, the angle of the force applied to the electric hoist was about 7° from vertical.

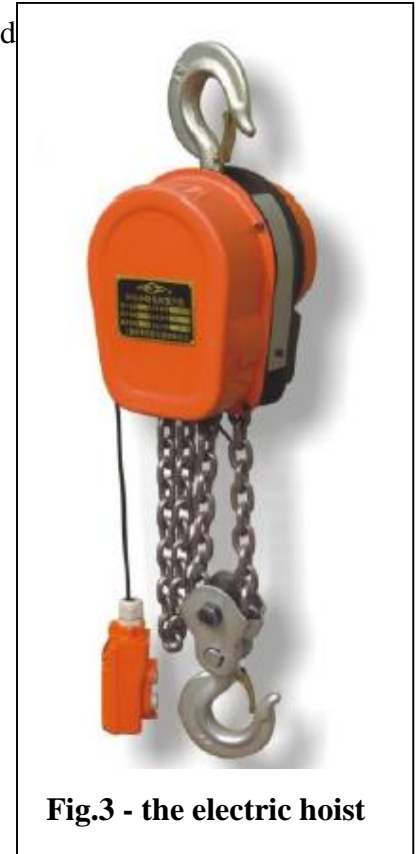
Fig.3 - the electric hoist

- 5.9 The particulars of the electric hoist (Fig.3) used in the incident were as follow : -

Maker	: Shanghai Tie Ying Co., Limited
Type	: DHS Electric Chain Hoist
Model	: YHPE
SWL	: 2 tonnes
Power Source	: 380 V/ 50Hz
Year of Manufacture	: 2013
Application	: Onshore industries

- 5.10 The electric hoist was not designed for marine use. It was not suitable for use on ship as the equipment would expose to wet and humid environment and saline atmosphere.

- 5.12 The electric hoist in question was designed to operate under a power supply of 380V 50Hz. Noting that the power source on board *the vessel* was 450V 60Hz, the motor of the electric hoist would turn at a higher speed that easily led to overheating of the equipment, short circuit and earth fault.

- 5.20 It was deduced that the most probable cause of the accident was due to electrical faults occurred in the electric motor of the electric hoist during operation. As there was no earth fault protection of the equipment, the cover and lifting chain of the hoist became live. When the fitter came into contact with the chain by his hands wearing wetted cotton groves, electrical current passed through his body down to ship's hull. The level of electrical current was high enough to kill him by electric shock.

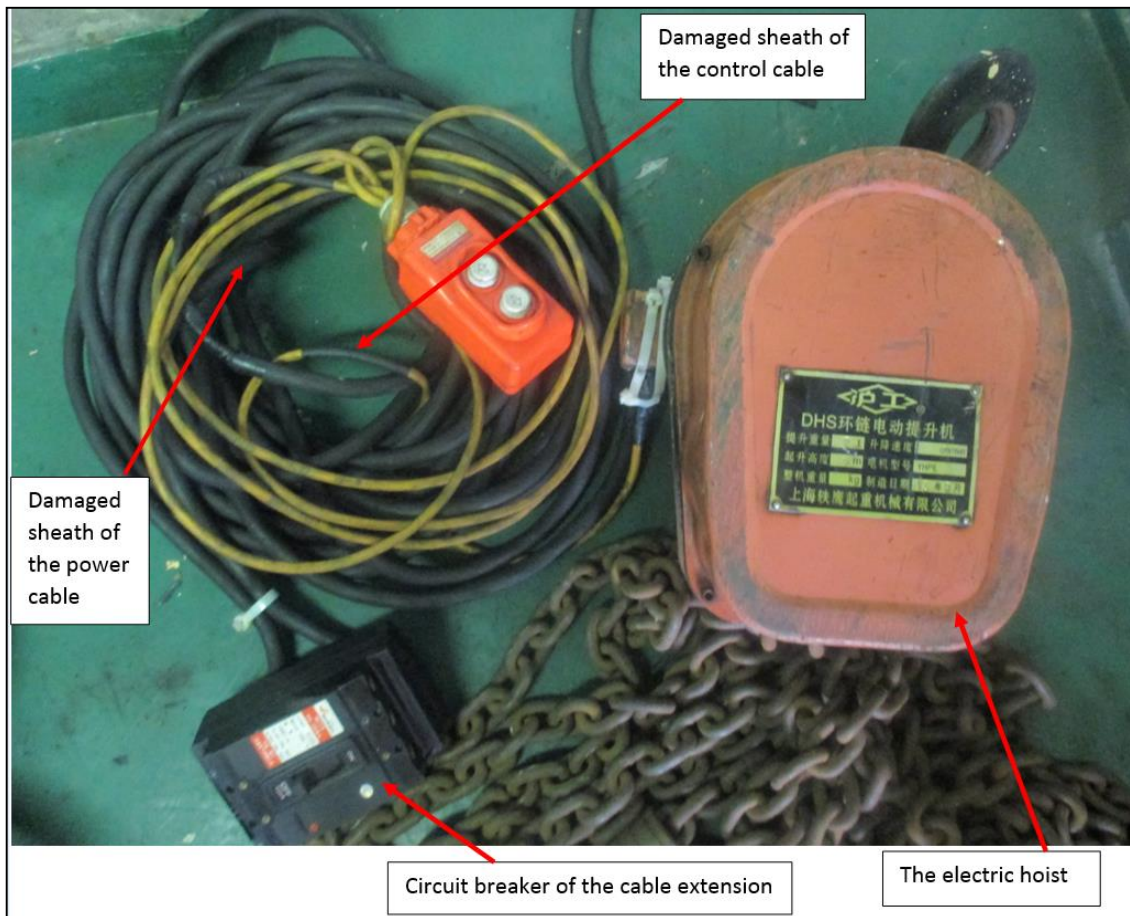
- 5.13 The insulating sheathing of the electrical power cable (black colour) and the control cable (yellow colour) of the electric hoist were in damaged or deteriorated condition but were just repaired by electrical tape. The extension electrical power cable

supplying power from ship's main was connected to the electric hoist by means of a non-water-proof type circuit breaker (Fig.4), which was not suitable for use on open deck. Besides, there was no earth fault protection for the equipment.

Fig.4 - Poor maintenance of the electric hoist
