**Report of investigation into the fatal
accident of a stevedore on board the
Hong Kong registered bulk carrier
“*Vienna Wood N*” at R union Port, an
insular region of France in Indian
Ocean, on 7 July 2015**

The Hong Kong Special Administrative Region
Marine Department
Marine Accident Investigation Section

28 April 2016

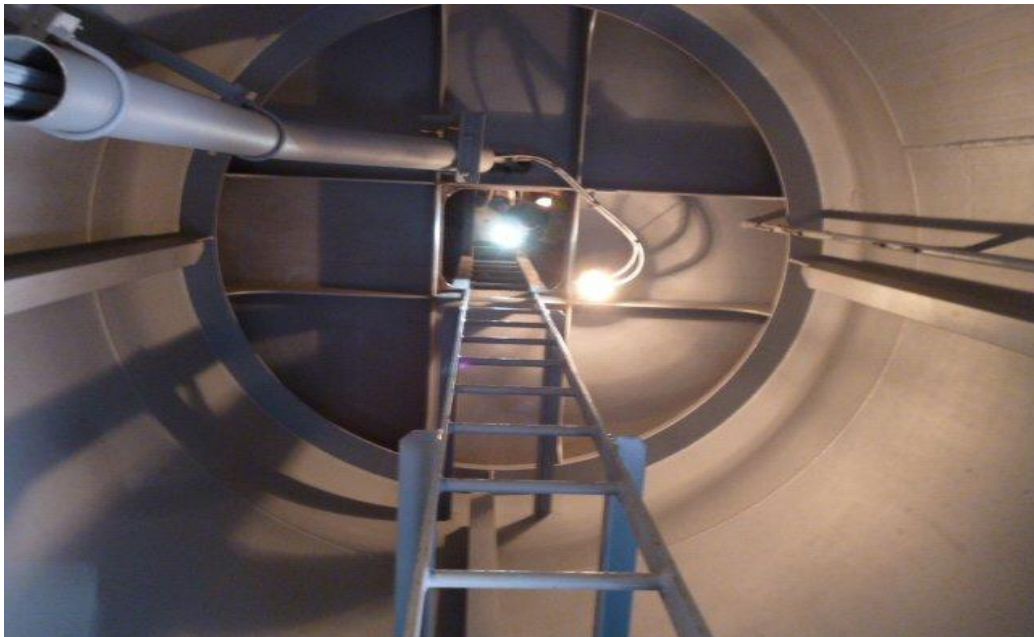
Fig.2 - The vertical ladder inside the trunk of No.2 ship crane

- 4.4 About 30 minutes later, two stevedores found the crane operator lying on the bottom of the trunk (Fig. 2). The third officer and an able-bodied seaman of *the vessel* arrived on the scene at about 2215. They informed the master and the chief officer of the accident. The crane operator was later certified dead. Police officers came on board *the vessel* at 2230 for an investigation and left *the vessel* at 2325.

5.8 Similar access ladders were fitted to other ship cranes and without guard rings. Thus, a person climbing up or down the vertical ladder would have a risk of falling sideways.

5.9 At the time of the accident, the internal of the trunk of the No.2 ship crane was clear from any obstruction and adequately illuminated. The internal ladder for the No.2 ship crane was also in satisfactory condition without damage.

- 7.1 A copy of the investigation report of the accident should be provided to the management company and the master of “*Vienna Wood N*” informing them of the findings of the investigation.
- 7.2 The management company should issue safety instructions to all vessels instructing all masters and crew, as well as reminding all other personnel working on board ships, that precaution should be taken to avoid falling from height while climbing a vertical ladder. The management company may consider fitting guard rings on the vertical ladders of the similar ship crane on all vessels under their management in order to prevent re-occurrence of similar accident.
- 7.3 A Hong Kong Merchant Shipping Information Notice is to be issued to promulgate the lessons learnt from the accident.

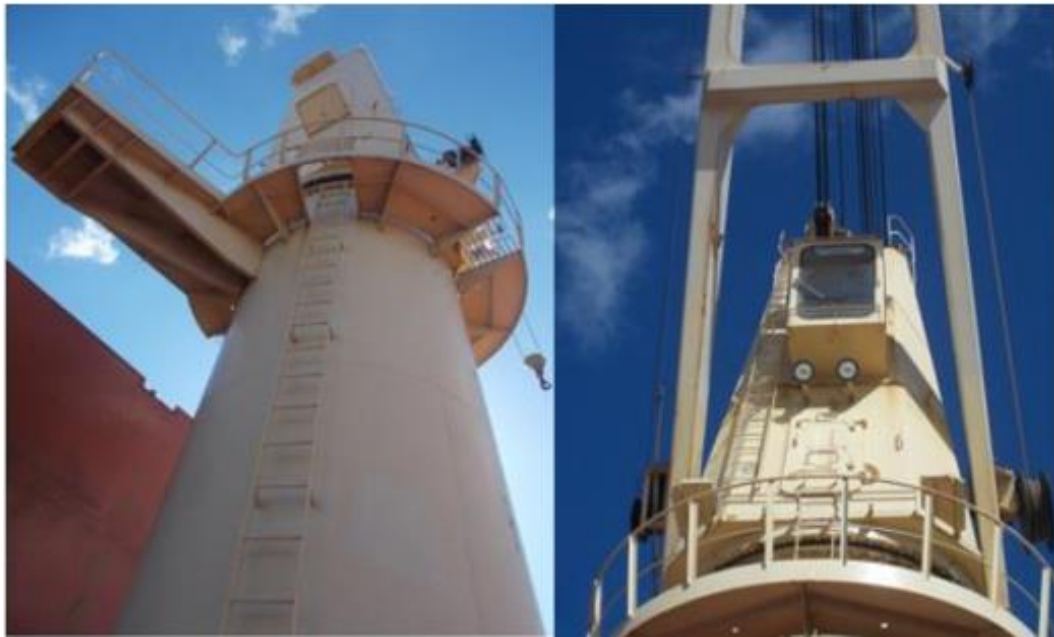
- 5.7 There were two vertical ladders for access to the control cabin of the No.2 ship crane. One was fitted on the external wall of the trunk of the crane (Fig.4). The other was fitted inside the trunk of the crane (Fig. 2). According to the drawing of the internal

Fig.4- The vertical ladder outside and the driving cabin of the No.2 ship crane

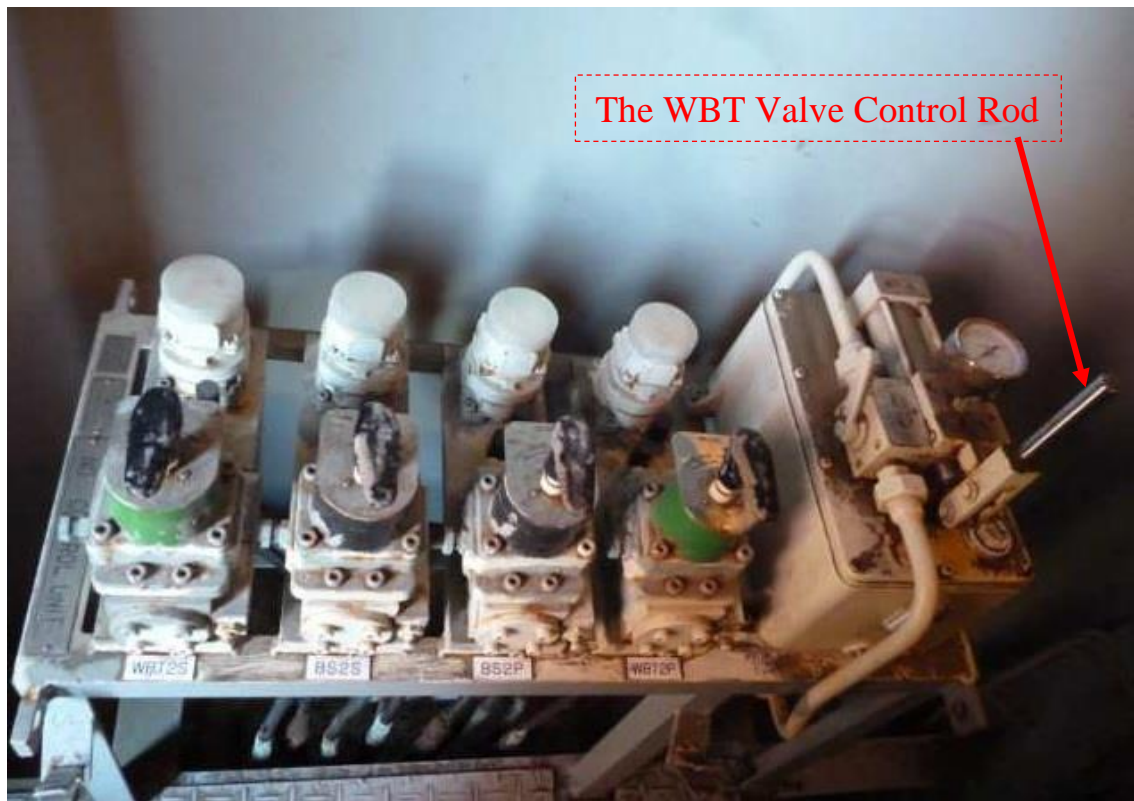
- 5.12 There was no witness to the accident. The crane operator was found lying on the bottom of the trunk of the No.2 ship crane and sustained fatal injuries. There was a water ballast tank valves control block located at the bottom of the trunk beside the vertical ladder.
- 5.13 It was deduced that the crane operator lost his grabbing on the ladder and fell sideways to the bottom while climbing down the internal vertical ladder. He hit against the water ballast valves control block and was killed (Refer to Fig.5).

Fig.5- Beside the vertical ladder, the water ballast tank valve control block located on the bottom of the access trunk of the No.2 ship crane.

- 6.3 There was no witness to the accident. It was deduced that the crane operator lost his grabbing on the ladder and fell down to the bottom of the crane trunk, while climbing down the internal vertical ladder. He fell to his death as he hit against the water ballast tank (WBT) valves control block.
