**Report of Investigation  
into the injury of a crew  
on board Hong Kong  
Registered Ship  
“BREVIK BRIDGE” in  
Singapore on 30 August  
2015.**

The Hong Kong Special Administrative Region  
Marine Department  
Marine Accident Investigation Section

29 August 2016

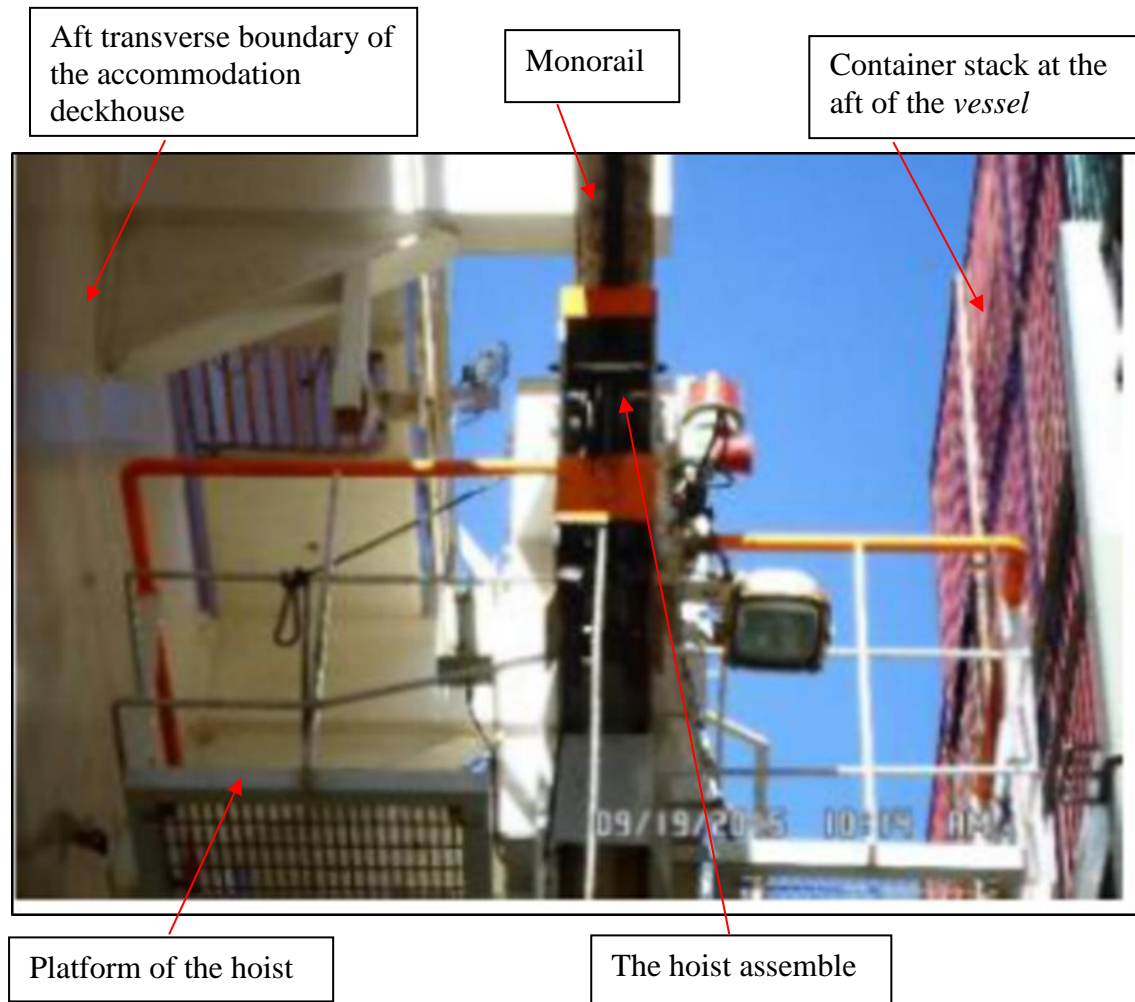
- 4.7 Electrician A was testing the function of the local controller (Fig.6) while Electrician B was removing the canvas cover of the control panel box. Electrician A could lower down the portside hook block by about half a meter by operating the local controller. He then asked the bosun to rise up the portside hook block using the remote controller to see whether the hoist could be reset. However, the hook block still could not be operated by the remote controller. Electrician A then repeatedly and quickly pressed the “Up” button on the local controller and the hook block hoisted up quickly. At about 1820, when the hook block was about to reach its parking socket fitted within the frames on the monorail of the hoist, the steel wire of the hook block parted. The hook block dropped down from a height of about 7 meters and hit the fitter who was staying on the main deck underneath of the hook block (Fig.2, Fig.3 & Fig.4).

Fig.2- View beneath the monorail hoist (portside hook assemble but without hook)

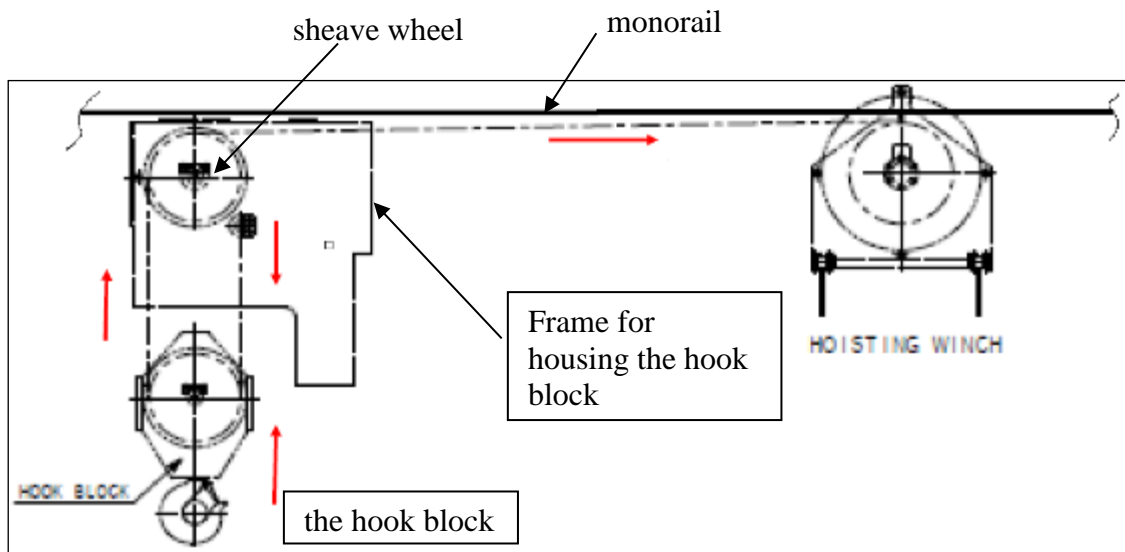
Fig.3- Arrangement of the monorail transverse hoist (portside hook)

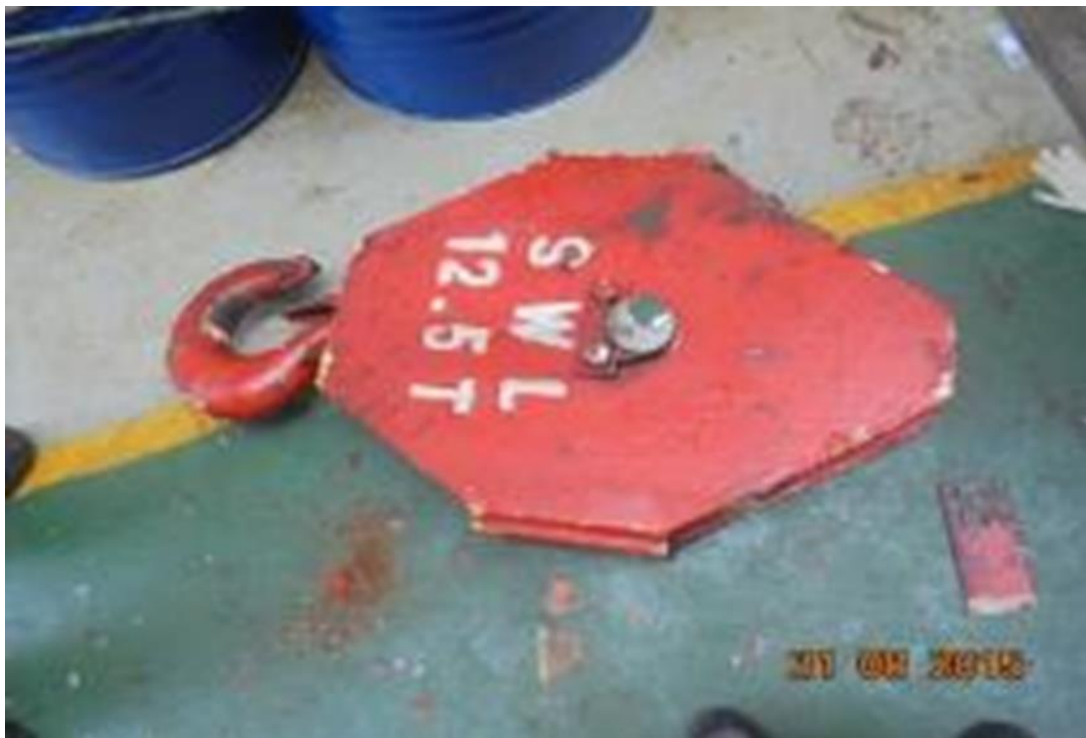
- 1.4 As a result, the hook block dropped and knocked on the fitter. The fitter was seriously injured in unconscious state with serious bleeding. An ambulance was called by the master and the fitter was sent to a local hospital immediately. After surgery and intensive care, the fitter’s condition was stabilized and made recovery.

Fig.4- The hook block fell down on the deck

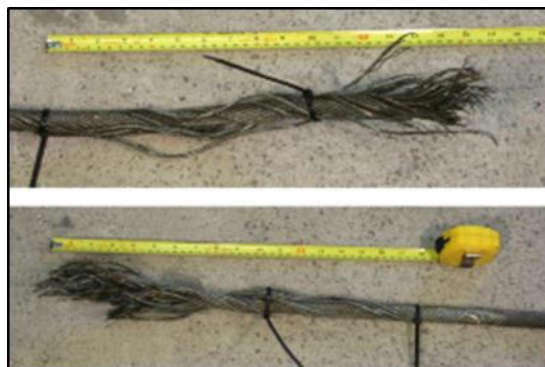
Fig.5- the parted hoist wire

5.12 Samples of the parted wire (Fig.5) were collected for micro analysis in laboratory and the results were as follows:

- a) the parted steel wire whose nominal diameter of 20mm with a breaking strength of 33.83 tons did satisfy the maker's specification requirement. As the maximum pulling force provided by the winch motor and transmitted to the wire was about 9.9 tons, the steel wire matched the requirement of the manufacturer of the hoist. Under normal operating condition, the steel wire should not part;

- b) there was no sign of damage to the steel wire due to, for example, corrosion, pre-existing crack; and
- c) inspection of the fracture ends of the parted steel wire revealed that the majority of the wire strands was yielded under excessive shearing force applied to the materials while the remaining wire stands yielded under excessive tensile force. This was supported by the bend in small radius on the steel wire in adjacent to the parted section. Steel wire failed prematurely due to excessive shearing force (typically at about 50-60% of the maximum tensile force).

- 5.16 According to the micro analysis report, the parted steel wire was jammed during the upward movement of the hook block that in turn induced excessive shear force to part the wire. Therefore, it was probable that when Electrician A kept pressing the “UP” bottom on the local controller to bring up the portside hook block, the hook block snagged on the frame without the awareness of Electrician A. It caused the majority of the steel wire strands yielded under excessive shear force and finally it parted.

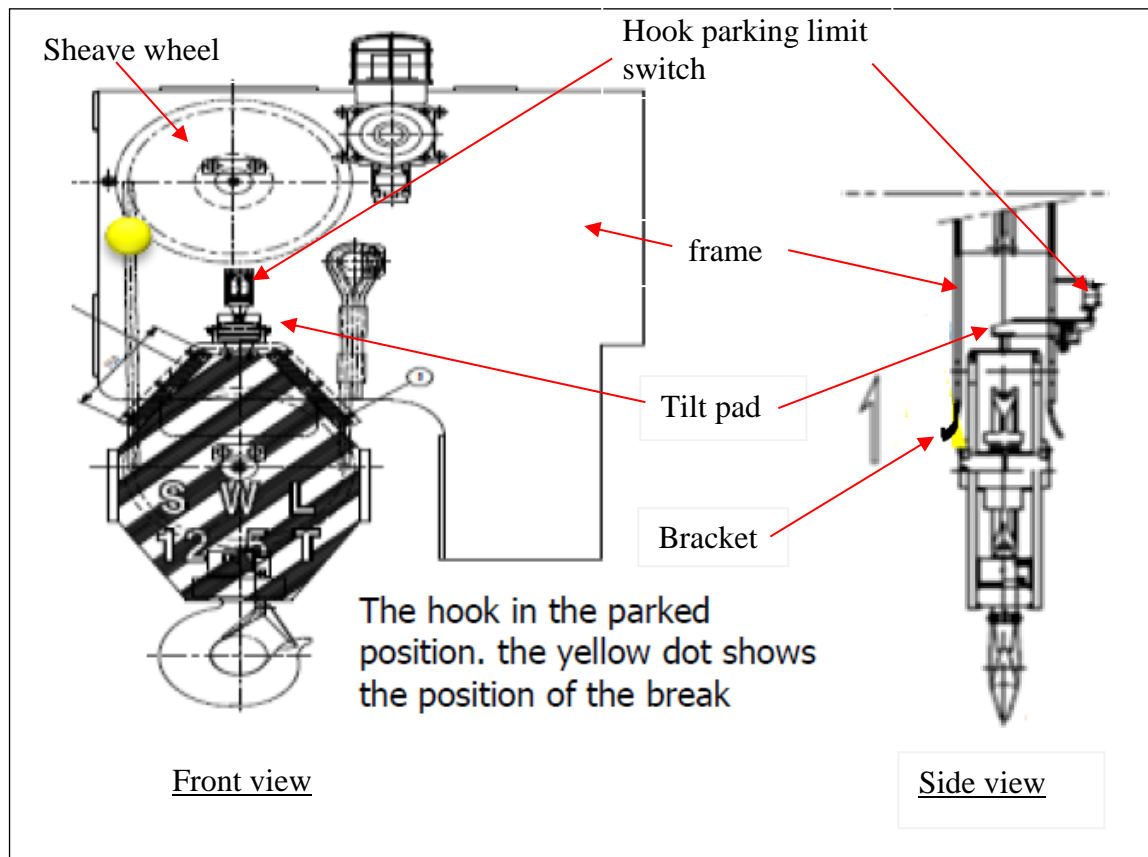
- 5.15 It was found out that the wire parted at a position close to the sheave wheel (the yellow spot in Fig.7) when the hook block was about to reach its parking socket. The hook block could probably snagged on the frames on the monorail at either of the two points marked “A” or “B” (Fig.9), especially when it was swinging during parking. The crew reported that they kept on encountering difficulties in parking the hook block before the accident happened.

Fig.7- The hook in parking socket

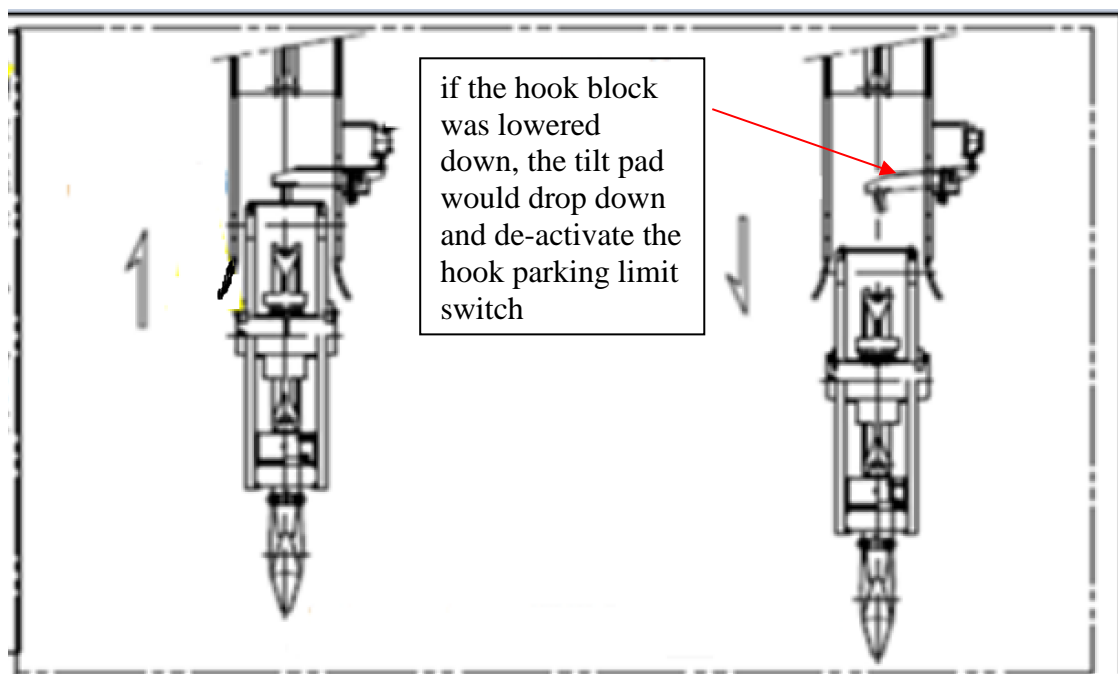
- 5.17 Under normal operation, the hook block would be seated in the parking socket and stopped when it pressed against a tilt pad, which in turn triggered a limit switch in the control circuit and stopped the movement of the hoist.
- 5.18 After the accident, it was found that the tilt pad was not free to move due to excessive painting work. It may render the safety control system of the hoist not reliable.

Fig.8- Side view of the hook block in the frame, showing the mechanism of the tilt pad and the hook parking limit switch.

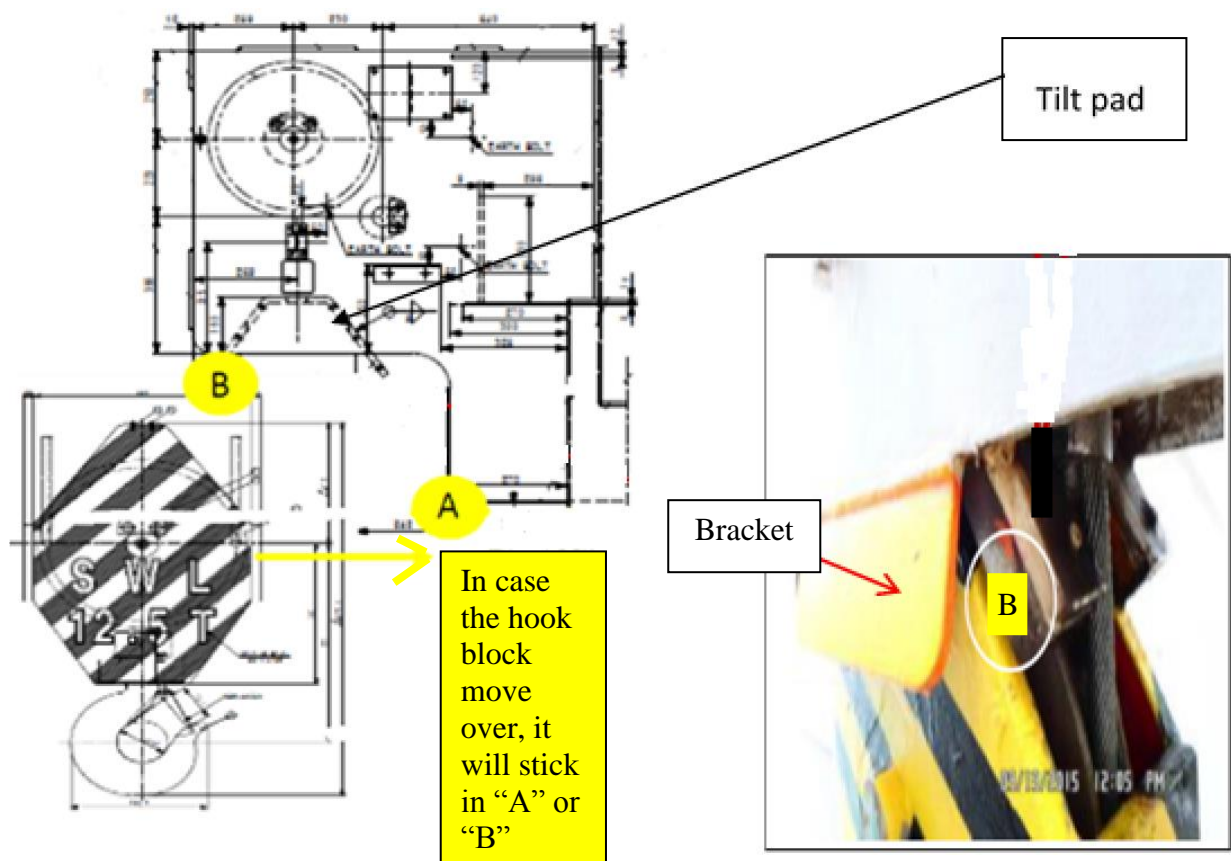
Fig.9- The frame of the hoist. (A: the edge of the assembly; B: the edge of bracket)

- (a) to verify all vessels fitted with similar monorail hoist that the hoist wires, hook blocks, limiting switches and other parts are in good working condition;
