Report of investigation into the
fatal accident of an ordinary
seaman on board the Hong Kong
registered bulk carrier “*Ocean
Gold*” at Calaca, Philippines on 12
September 2015

The Hong Kong Special Administrative Region
Marine Department
Marine Accident Investigation Section

28 December 2016

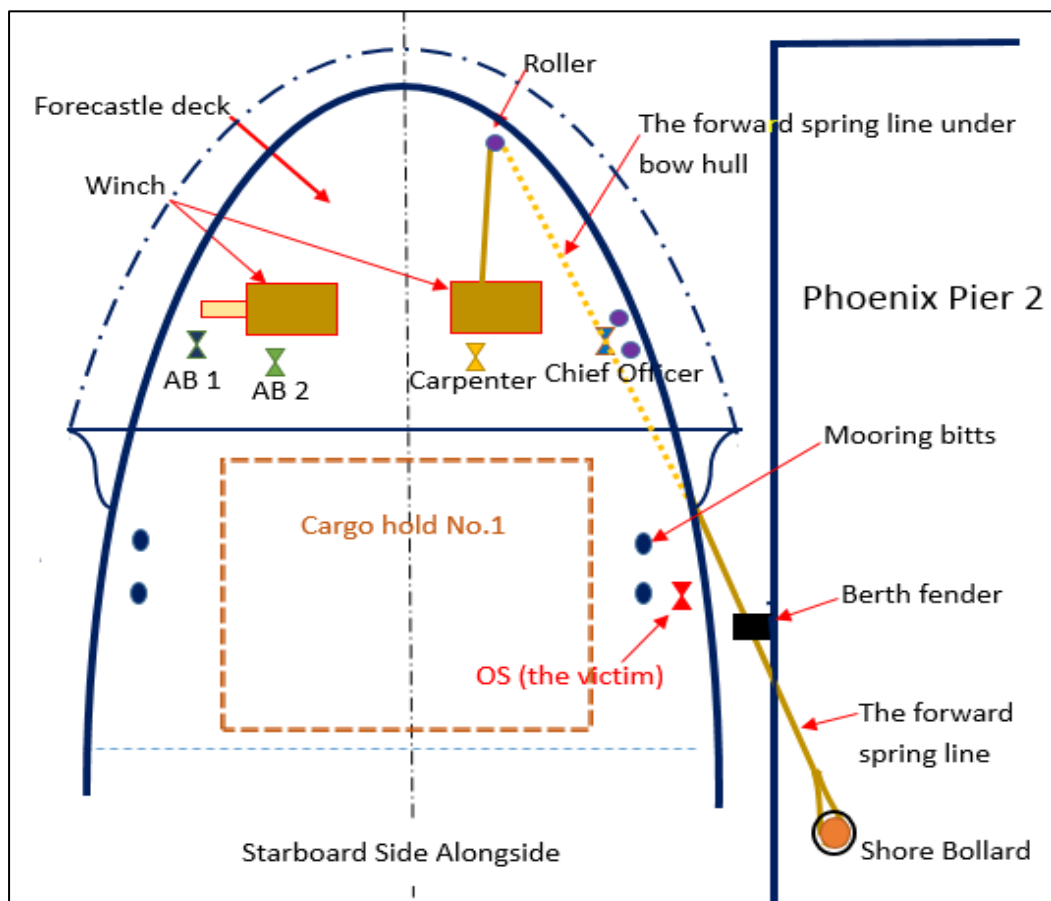
Fig.2 -berthing operation sketch plan when the accident happened.

the shore mooring team. While *the vessel* was moving closer to the berth, the forward spring line was slackened and passed beneath a berth fender. The forward spring line was then stuck beneath the berth fender when *the vessel's* hull contacted with the berth fender (Fig.2).

- 4.5 According to the statement taken, the chief officer noticed that the forward spring line was stuck beneath the berth fender but he did not report the situation to the bridge team (i.e. the master and the pilot). In order to hold *the vessel* in position, at the instruction of the pilot, the forward spring line was tightened up even though under such situation.

- 4.6 At about 0832 hours, *the vessel* swung out a short distance from the berth and moved forward. The forward spring line was stretched further and subjected to higher tension. Suddenly, the forward spring line bounced off from beneath the berth fender hitting the left side neck of the OS. The OS was bleeding and unconscious with his safety helmet fell on the ground. At the time of the accident, the level of the main deck of *the vessel* was slightly below that of the berth (Fig.3).

- (b) review the relevant safety procedures and guidelines in the Safety Management System in order to ensure that:
 - (i) effective communication among the various mooring teams should be maintained during mooring operation and any abnormal situation must be immediately reported to the master of the vessel for consideration;

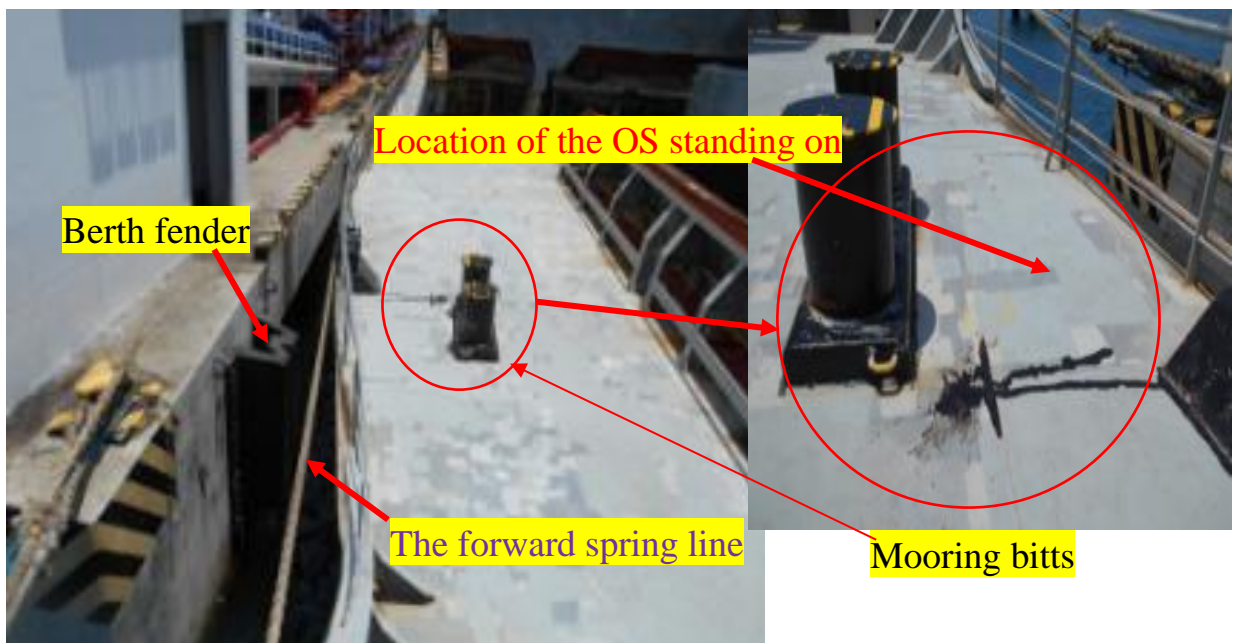
Fig.3 -The relative levels of the main deck and the berth at the time of the accident.

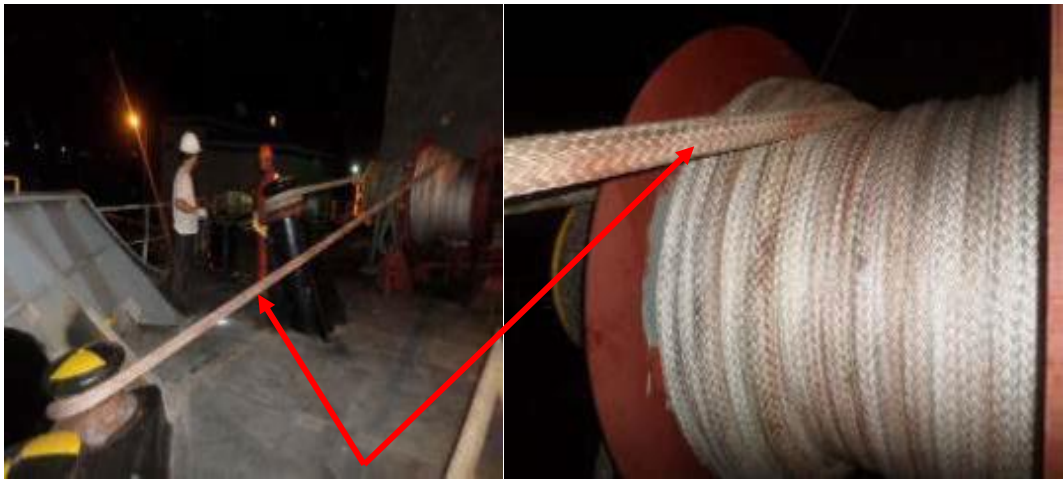
- 5.12 The forward spring line used in the mooring operation was a nylon rope of 65 mm in diameter with a nominal breaking load of 903 KN. The forward spring line was in a good condition (Fig.4).

Fig.4-The forward spring line was in good condition.
