**Report of investigation into
the missing of auxiliary
powered yacht “141839”
in the South China Sea
on 3rd October 2015**

The Hong Kong Special Administrative Region
Marine Department
Marine Accident Investigation Section

16 January 2019

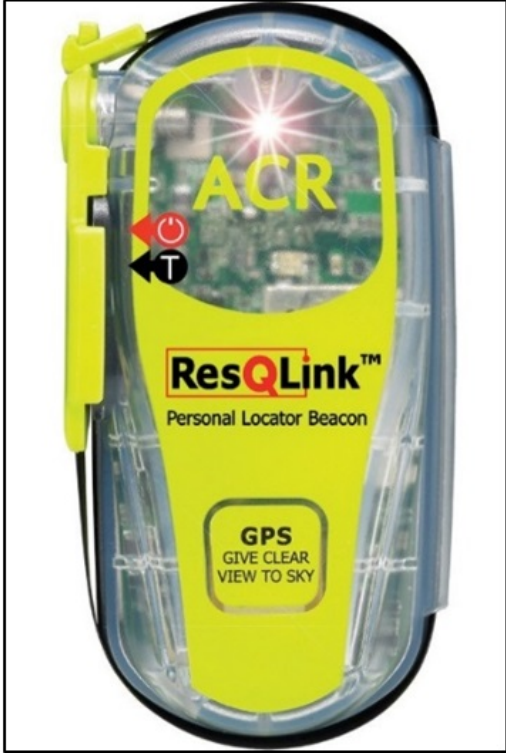
<p>Figure 3 Similar PLB</p>	
8	Spot tracker (no particulars)	1
9	Liferaft (6 persons) Lifejacket	2 unknown

- 5.6 It was known that one of the sailors carried a PLB (Figure 3) which could only be activated manually and its power could normally work for 24 hours continuously. As confirmed by the Office of the Communications Authority of Hong Kong, a data licence with a station No. 0001-PPPL1 was issued for this equipment. No transmission was received since departure until the first transmission from a beach of Thailand months later on 11 February 2016 but the investigation carried out by Bangkok RCC reached no conclusion.

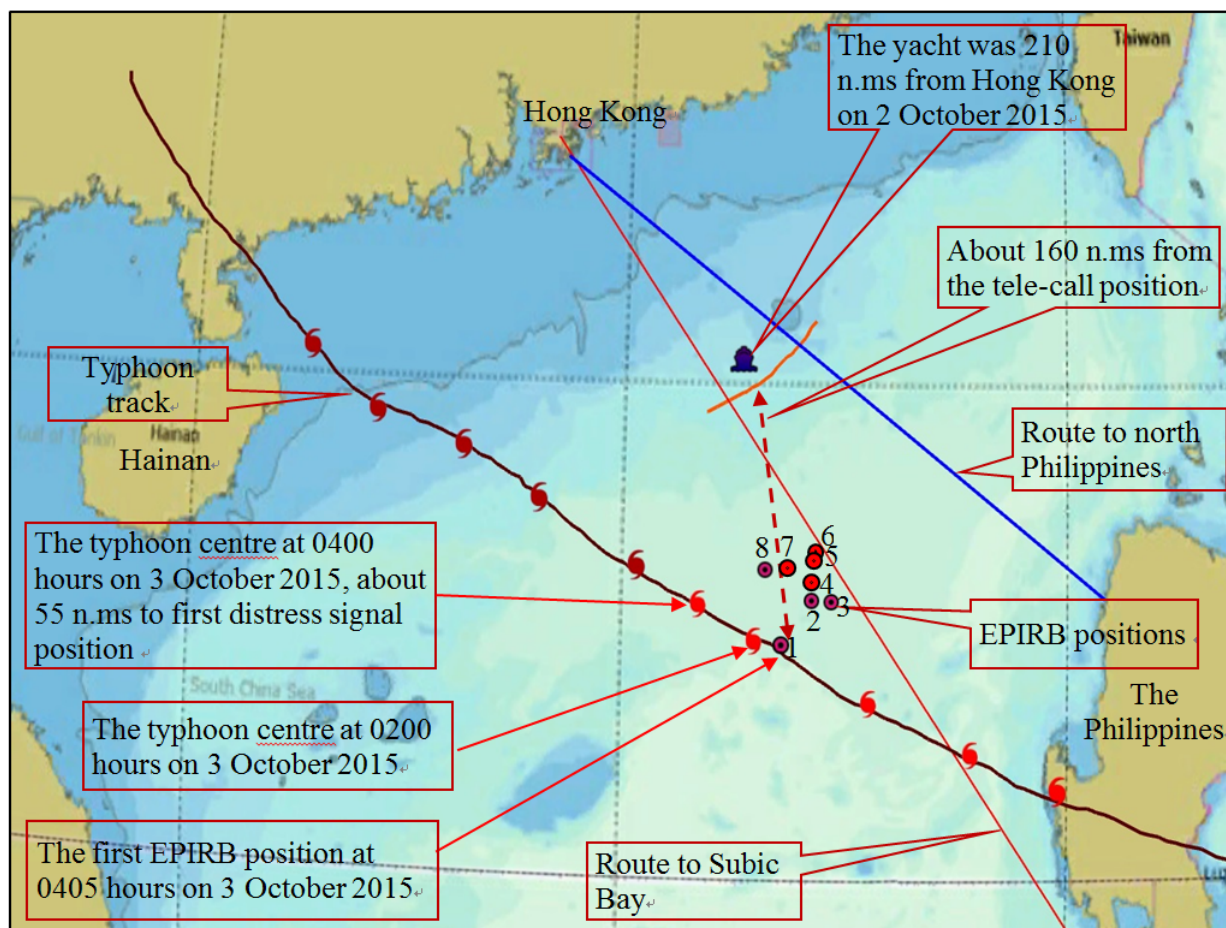
Figure 4 Illustration of the track of typhoon "Mujigae" and the EPIRB distress signal position

- 5.12 In the report submitted by the representative of the family of the skipper, no information was available with regard to the yacht’s final movement. Since her departure, the only telephone call communication between shore persons and the yacht was made on 2 October 2015 before the first distress signal was emitted 17.5 hours later. At the time of the communication, it was reported that the yacht was about 210 n.ms away from Hong Kong, and was adjusting her route to the north of the Philippines to avoid typhoon. The communication did not make any information exchange with regard to the exact position of the yacht and the weather condition (Figure 4).

- 5.14 The time sequence of EPIRB distress signal received was plotted on the chart against the track of typhoon “Mujigae” (Figure 4). It indicated that the yacht was very likely at the east side (right hand) of typhoon “Mujigae” at the time of the incident. Although the Friend A reported that the yacht had changed her course to the northern Philippines as mentioned in the telephone call communication on 2 October 2015, it was however, doubtful that whether the yacht had really succeeded to adjust her route to the northern Philippines.

- 5.15 The centre of severe tropical storm “Mujigae” was at the position 18°N, 116°07'E at that time of first distress signal received, which was about 55 n.ms west of the EPIRB position (Figure 4).

- 5.16 Based on the estimated movements of the yacht and the track of the typhoon, it was considered that the time when they were closest (less than 30 n.ms) to each other was at about 0200 hours on 3 October 2015. The yacht would be within the right semicircle of the typhoon facing very severe weather condition with wave height much more than 2 metres and strong wind of more than 50 knots in accordance with the weather report shown in Annex I. Being overwhelmed by the sea and weather conditions, it could be deduced that the yacht might have capsized and sunk. All sailors might have fallen into the sea or sunk with the yacht without traces.
