**Report of investigation  
into fatal accident on board  
Hong Kong registered ship  
“*Alpine Mystery*” in Mossel  
Bay anchorage of South  
Africa on 30 October 2015.**

The Hong Kong Special Administrative Region  
Marine Department  
Marine Accident Investigation Section

6 April 2017

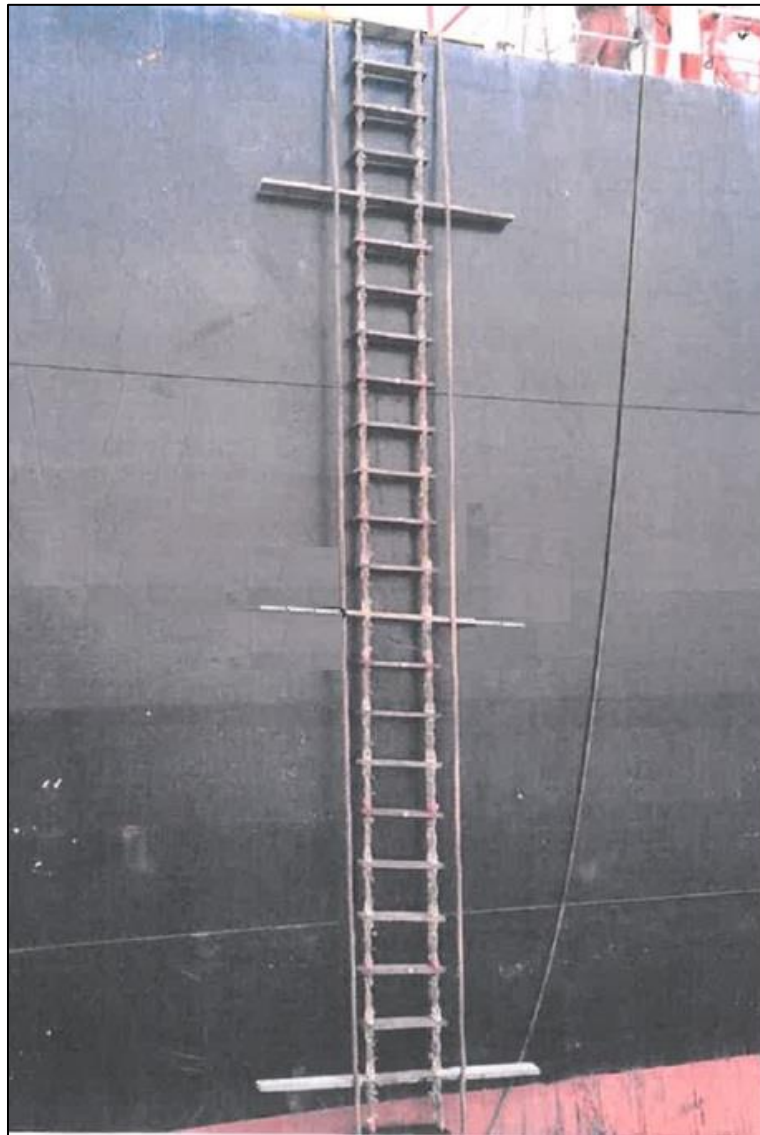
Figure 2 - The pilot ladder

- 5.9 The pilot ladder (Figure 2) was a wooden ladder made of manila rope and wooden steps. The lowest spreader step was the fifth step from the bottom of the ladder. Then, there was a spreader step at each interval of nine steps to prevent the ladder from twisting and to increase its stability along the ship's side. The construction of the pilot ladder conforms with SOLAS standards.

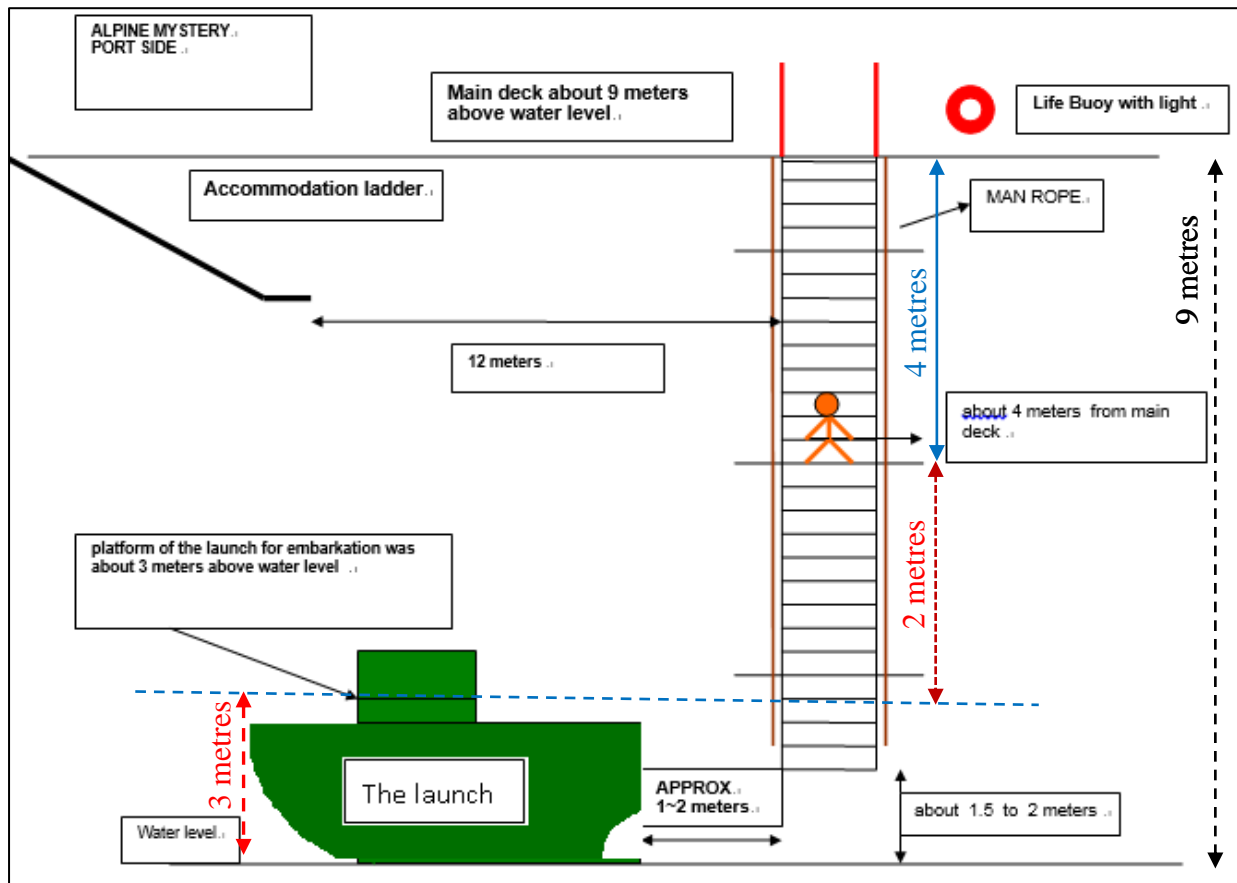
Figure 3 - The pilot ladder arrangement to board the launch.

- 5.10 In accordance with the International Convention for the Safety of Life at Sea (SOLAS), Chapter V - “Safety of navigation”, Regulation 23 - “Pilot transfer arrangements”, paragraph 3.3 - “safe and convenient access to and egress from ship,” the pilot ladder shall not require a climb of more than 9 meters. Otherwise, it is necessary to use accommodation ladder in conjunction with the pilot ladder as a combination arrangement.

- 5.11 Since the distance between the disembarkation point on *the vessel’s* main deck and the launch was not more than 9 metres, the shipboard disembarkation arrangement of using pilot ladder solely was technically correct in meeting the SOLAS requirement (Figure 3). If a proper risk assessment had been carried out by taking into account the chief engineer’s obese body and his health conditions as well as the prevailing weather and sea conditions, however, special consideration of providing pilot transfer might have prevented the chief engineer from falling into the sea.

- 7.2 The management company of *the vessel* should review the relevant risk assessment requirements in the safety management system. For embarkation or disembarkation, proper risk assessment should be carried out by taking into account the prevailing weather and sea conditions as well as personnel's body and health condition, so as to determine the most appropriate arrangement (such as the use of pilot transfer combination arrangement).

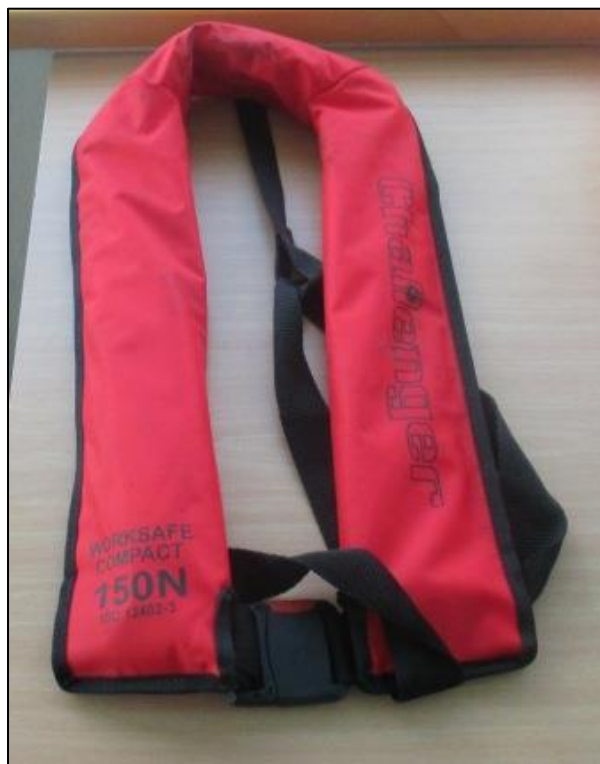
Figure 4 - *the vessel's* inflatable lifejacket

- 5.13 *The vessel* was provided with inflatable lifejackets (Figure 4) which were meant as the “life vest” stated in the Guidelines. These inflatable lifejackets were less bulky and easier to don when compared to the use of conventional inherently buoyant lifejackets. More importantly, these inflatable lifejackets had “EC<sup>1</sup> type - examination certificate”, and were tested to:

- a) meet the basic health and safety requirements of Council Directive 89/686/EEC; and
  - b) comply with the relevant requirements of the technical specification of EN ISO 12402-3:2006+A1:2010 for lifejackets of performance level 150.

As such, these shipboard inflatable lifejackets are capable of providing sufficient buoyancy

to a wearer with foul weather clothing and will turn an unconscious person into a safe position with his mouth and nose clear of water surface. However, the chief engineer did not use the shipboard inflatable lifejacket for his disembarkation.

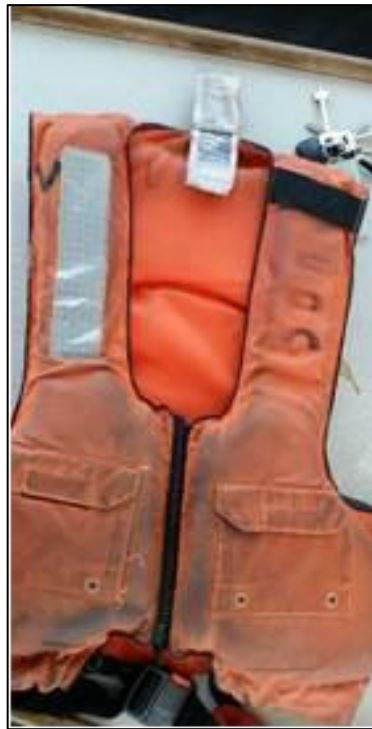
Figure 5 - The life vest used by the chief engineer

- 4.4 At about 0730 hours when the launch arrived, a motorman of *the vessel* lowered the luggage of the chief engineer by a rope to the launch. The crew of the launch then passed a life vest (Figure 5) to *the vessel* for the chief engineer to wear before boarding the launch.

5.15 Instead of donning a shipboard inflatable or SOLAS lifejacket of certified performance standard, the chief engineer chose to wear a life vest of unknown performance standard provided by the launch (Figure 5). Given the chief engineer was in an unconscious face down position when found and drowned, it appeared that the said life vest was not the one that could turn an unconscious person into an upright safe position.

- b) the chief engineer did not wear shipboard inflatable lifejacket or SOLAS lifejacket in accordance with the requirements of the shipboard safety management system. Instead, the chief engineer had wrongly donned a life vest provided by the launch and the life vest was of unknown performance standard. Given the chief engineer was found in an unconscious face down position and drowned, it appeared that the life vest was incapable of turning an unconscious person into upright safe position.

- 7.1 The management company of *the vessel* should issue safety instructions to vessels under its management, requesting all crew to follow the procedures of safety management system strictly, i.e. wearing certified inflatable lifejacket or SOLAS lifejacket for disembarkation and embarkation through gangway and pilot ladder on seaside of the ship.
