Report of Investigation into the Man Overboard from the Hong Kong Registered Oil Tanker “C. Dream” at Ulsan, Korea on 12 November 2015

The Hong Kong Special Administrative Region
Marine Department
Marine Accident Investigation Section

28 December 2016

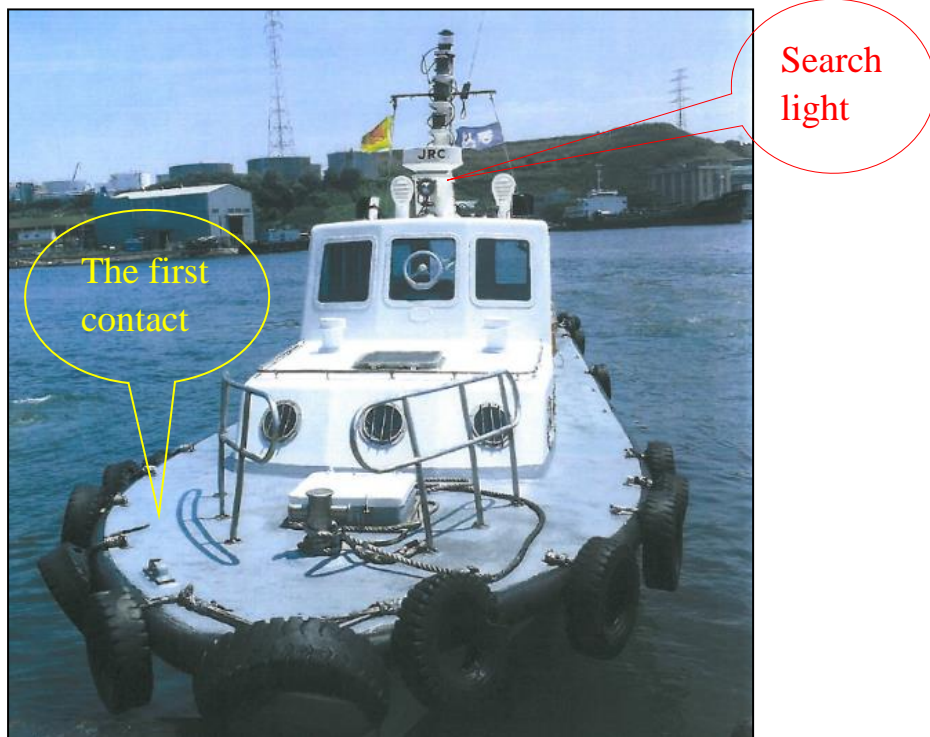
- 4.4 At about 0315 hrs, the service boat "*EUN SEONG*" (*the boat*) arrived. The shore personnel were getting down through the accommodation ladder one by one for disembarkation. The cargo supervisor, with his own inflatable lifejacket donned, was the first one. While the cargo supervisor jumped from the lower platform of the accommodation ladder and landed on the forward deck of *the boat*, he lost his balance and fell into the water (Fig.3).

Fig. 3- The first contact point of the cargo supervisor with *the boat* and the position of the search light installed.

- 5.16 *The boat* was built in November 1994 and was a common service boat to transfer personnel between shore and anchorage. Her forward open deck was fitted with handrail for safe access of personnel on/off board. Rubber tires fitted as fender around the open deck side edge of the boat to avoid any friction or clash. One search light was mounted on the top of the bridge for illuminating the forward deck boarding area.

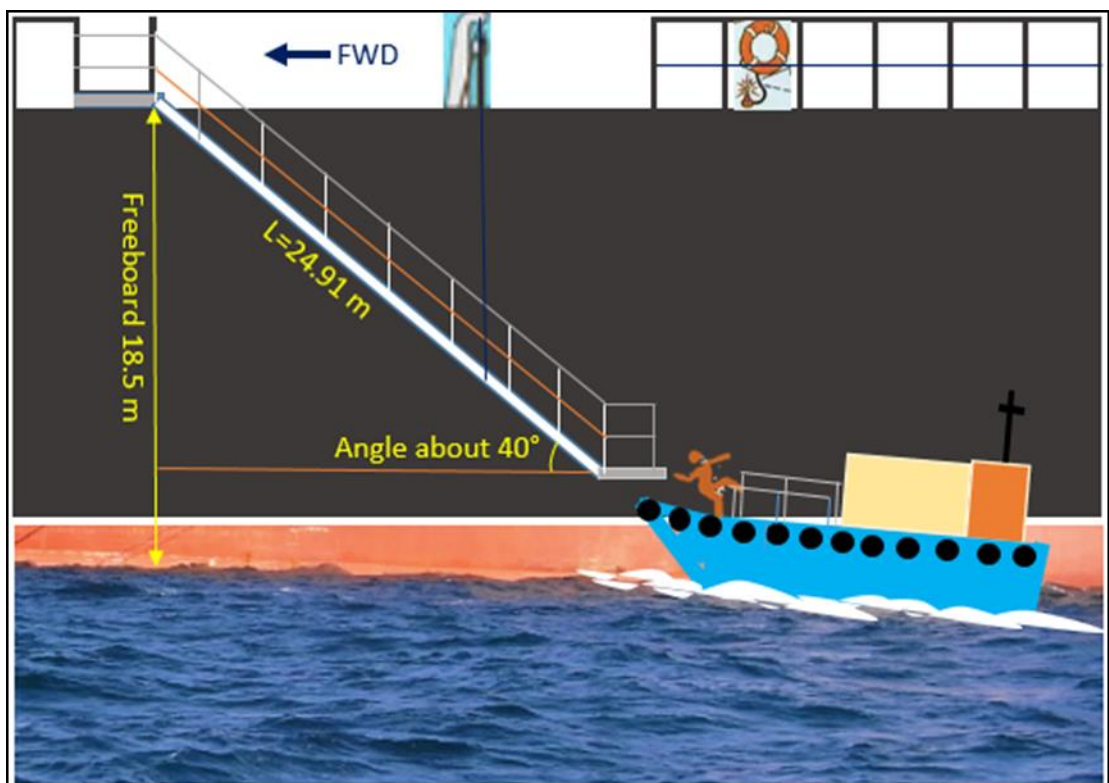
Fig. 4- The sketch of accessing arrangement.

- 5.5 Accommodation ladders at both sides of *the vessel* were load tested on 30 and 31 August 2015 and the results were confirmed satisfactory by the inspector. A Ship-Shore Safety Check List was completed and signed with positive results for all applicable items before *the vessel* discharged her cargo commencing at 1220 hrs on 11 November 2015. Item No.1 in the checklist confirmed that safe access was available through *the vessel's* port and starboard accommodation ladders which were considered in good working condition and accepted as the accessing arrangement.

- 5.6 At time of the accident, the freeboard of *the vessel* was about 18.50 metres. The distance from the surface of the water to the point of access to *the vessel* was therefore much more than 9 metres. The requirements of the SOLAS Regulation V/23.3.3. for pilot accessing arrangement, an accommodation ladder in conjunction with the pilot ladder (i.e. a combination arrangement), or other equally safe and convenient means should be arranged. However, for personnel other than pilot disembarkation, the ship's crew arranged accommodation ladder only as requested

- 5.7 Based on the freeboard of *the vessel*, the length of the accommodation ladder (24.91 meters) and the height of *the boat stem* (1.62 meters), the accommodation ladder's angle of slope was about 40° which was less than the limit of 45° recommended by the Resolution A.1045 (27). As such, the use of the accommodation ladder for shore personnel disembarkation could be considered as a safe accessing arrangement.

- 5.8 According to the statements and clarifications from the company, adequate fixed lighting had been provided on the accommodation ladder and the bridge front to illuminate the accessing arrangement over side and the vicinity area for embarkation or disembarkation. Safety net was properly rigged to the accommodation ladder to prevent anyone from inadvertently falling in-between the shipside and the accommodation ladder. A lifebuoy was kept near the accommodation ladder for immediate use. Hence, accessing arrangement did not contribute to the accident.
