Report of investigation into the
fatal accident on board Hong Kong
registered chemical tanker “*Alpine
Magic*” at sea on 14 November
2015

The Hong Kong Special Administrative Region
Marine Department
Marine Accident Investigation Section

6 March 2018

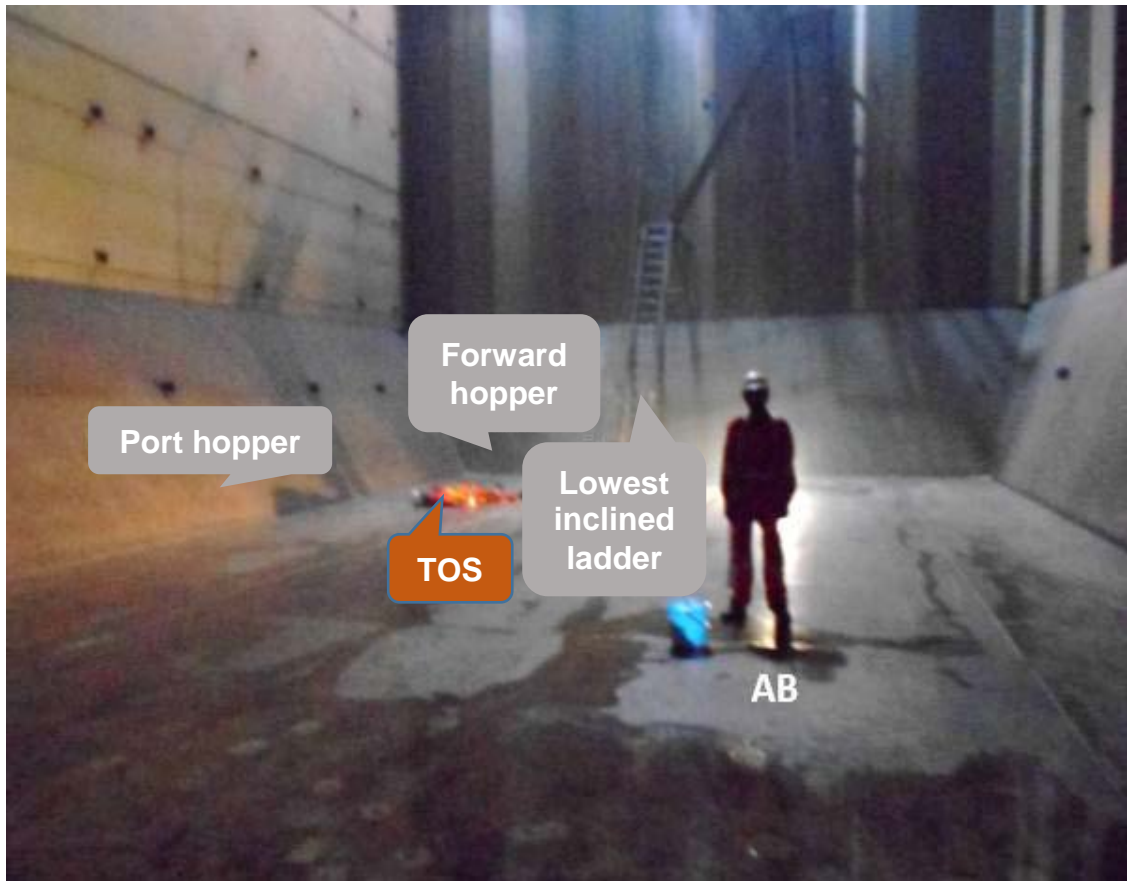
- 4.8 Shortly afterwards, the AB heard a loud scream and a thud. He saw the TOS lying on the forward port side tank top of 3P COT near the access ladder. The AB immediately rushed towards the TOS and reported to the chief officer over radio that the TOS had fallen from the access ladder. The AB tried to assist the TOS and assured him that rescue was on the way.

Fig.3-(Re-enactment) Scene with approximate positions of the fallen TOS and the AB.

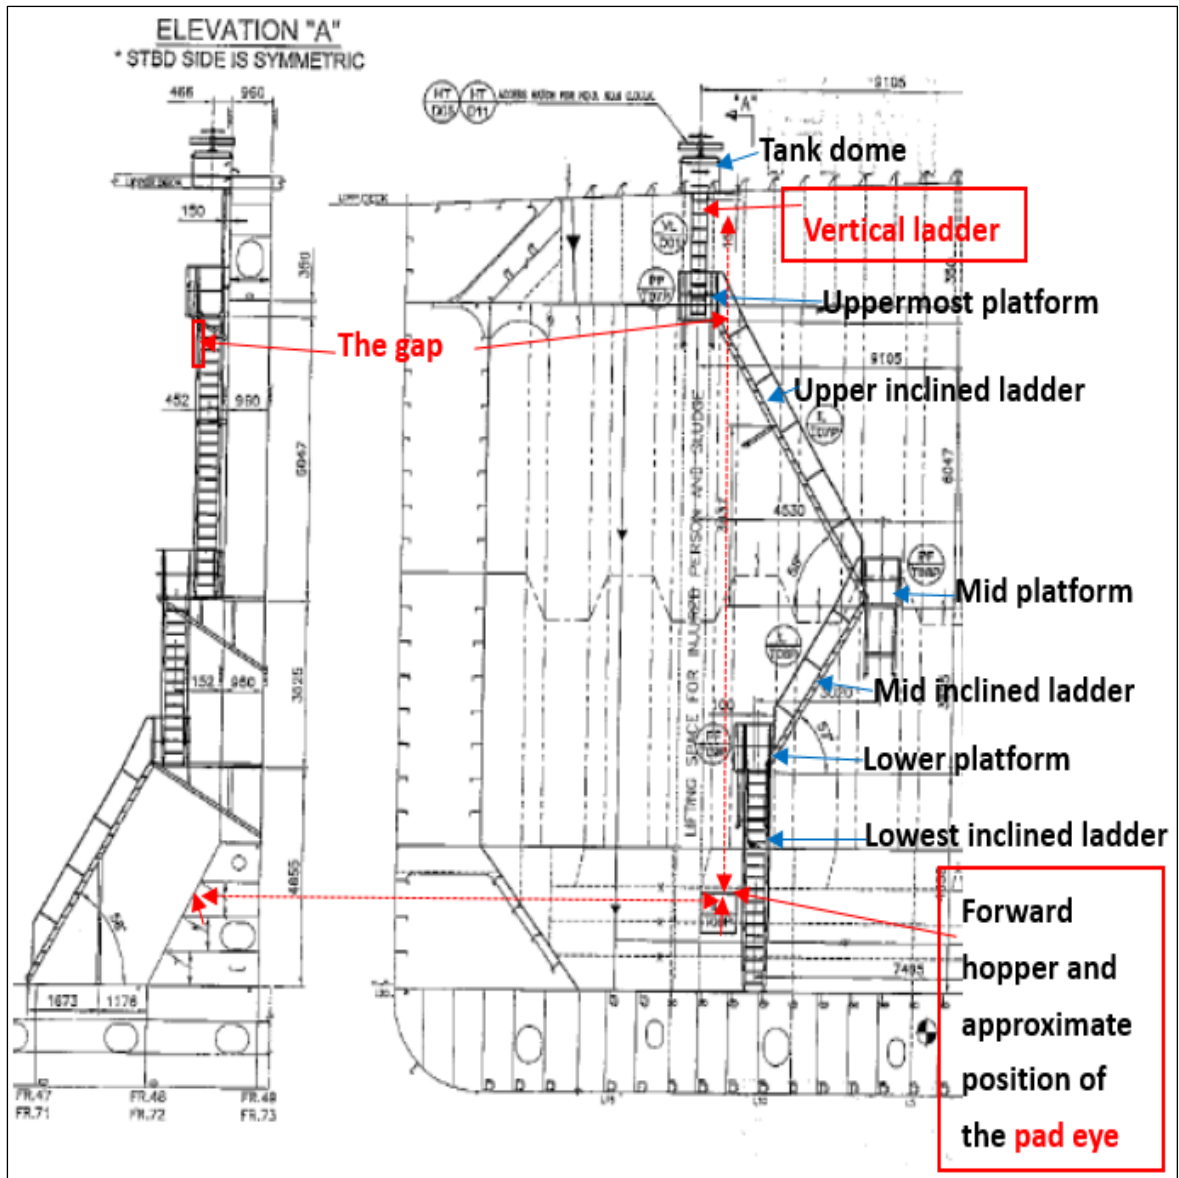
- 5.18 The configuration of the access ladder of the 3P COT comprised of several sections of fixed steel ladder (figure 4) with a total height from the deck to the bottom about 16.81 metres. The top section of the access ladder was a vertical ladder, followed by three inclined ladders at angle about 57 to 58 degrees in different directions to reach the tank top floor. There were a total of forty-seven steps for the inclined ladders and nine steps for the vertical ladder, and three platforms between the 4 ladders.

- 5.19 The access ladder was maintained in good condition with no sign of damage or corrosion.
- 5.20 Ascending along the 3 inclined ladders from the bottom, it was the uppermost platform connecting to a vertical ladder. This uppermost platform was fitted with two horizontal railings located at height of 1.0 metre and 0.5 metre above the platform floor respectively. For the purpose of rescue of persons from the tank, the grating plate of the platform floor was openable to its upside direction only and hinged on forward end, and provided with a toggle safety pin to prevent accidental opening (figure 5). No evidence was found that the grating plate was opened before the accident.

Fig. 4- Schematic and details of the access ladder for 3P COT

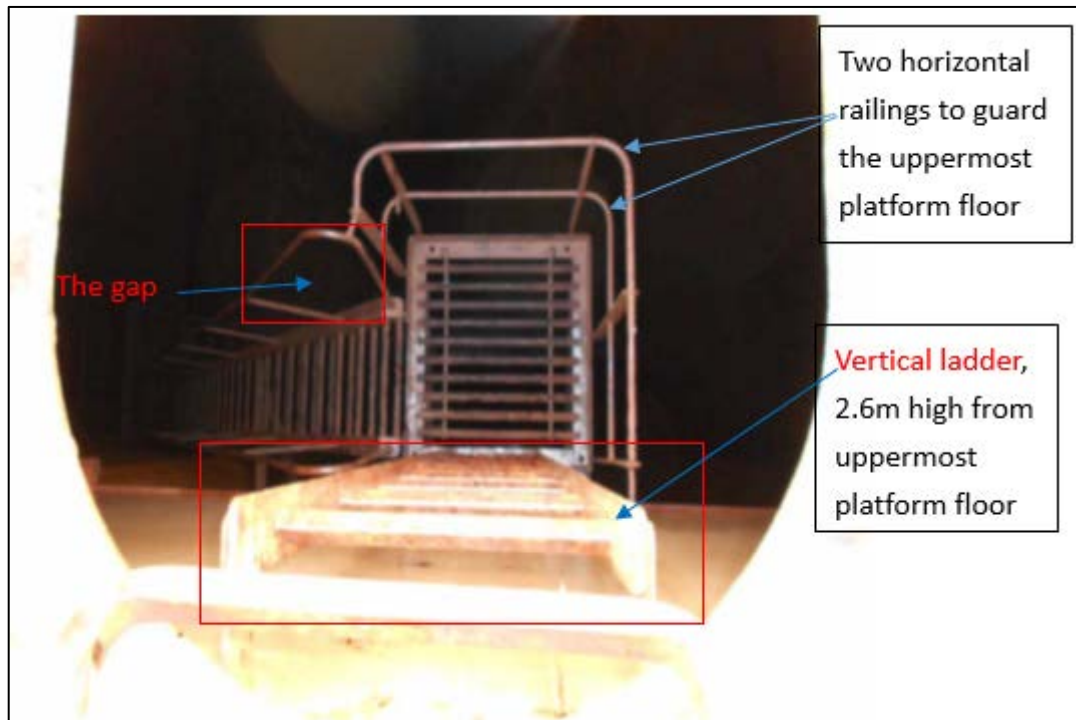
- 5.21 Figure 5 also shows that the side railing and vertical stanchions of the upper inclined ladder on the end connection to the uppermost platform had an opening of ultimate dimensions of 1.33 metres high x 1.2 metres wide (the gap). There was no intermediate bar to reduce the gap size (figure 6).

Fig. 5- Viewing down from tank dome at the vertical ladder, uppermost platform floor and the inclined ladder.

- 7.1 The ship management company should consider fitting arrangements, such as guard rings on the vertical ladders and intermediate bar for the inclined ladder, inside cargo oil tanks on all vessels in order to prevent recurrence of similar accident.
- 7.2 The ship management company should review its Safety Management System (SMS) and relevant procedures or guidelines to include the element of ladder access in risk assessment.
- 7.3 To avoid any lapses when implementing SMS, the ship management company should issue safety instructions to remind all its officers and crew members that the company's procedures or guidelines should be strictly followed. Particularly that fall arrestor devices should be used mandatorily while using first vertical ladder of any COT.
- 7.4 A Hong Kong Merchant Shipping Information Notice is to be issued to promulgate the lessons learnt from the accident.

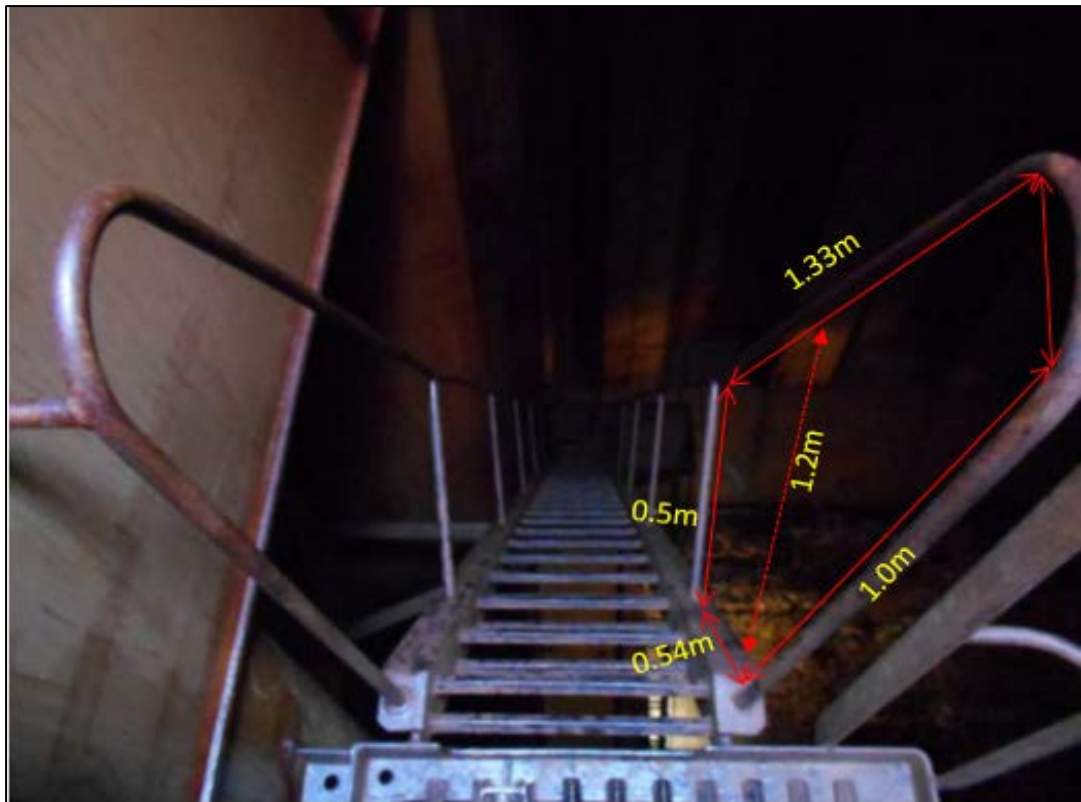
Fig. 6- Photo taken from uppermost platform to show the opening dimensions (i.e. the gap).

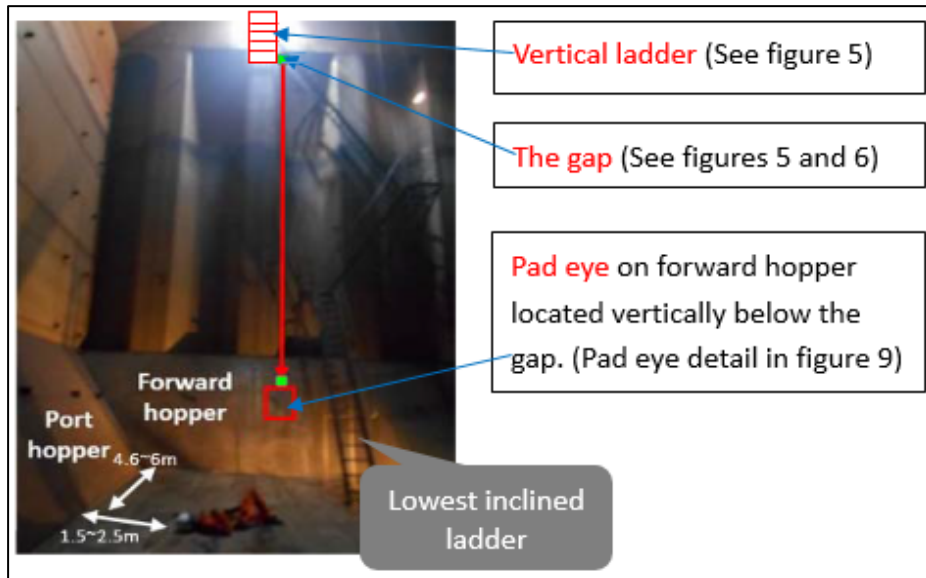
- 5.22 There was no eye witness to confirm how and where the TOS was fallen from the access ladder, but he was found lying on the port side forward tank top near the lowest inclined ladder (figure 7).

Fig. 7- Relative position of the casualty, vertical ladder, the gap and the pad eye.

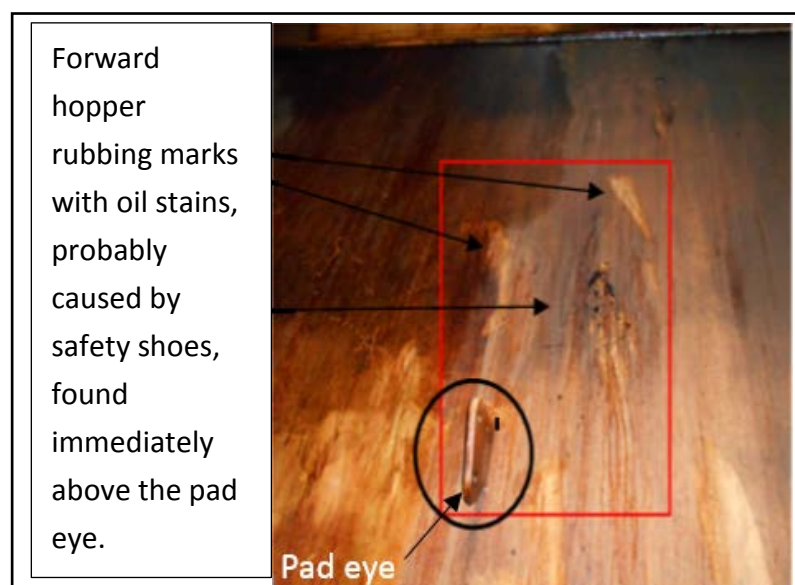
- 5.23 There was one pad eye welded on the forward hopper at a height of about 2 metres above tank top. This pad eye was directly below the vertical ladder and the gap (figure 7).
- 5.24 Some rubbing marks and oil stains were found above the pad eye and that the edge of the pad eye was adhered with filth appearing as blood stains (figures 8 and 9).

Fig. 8- Forward hopper had marks indicating body contact.

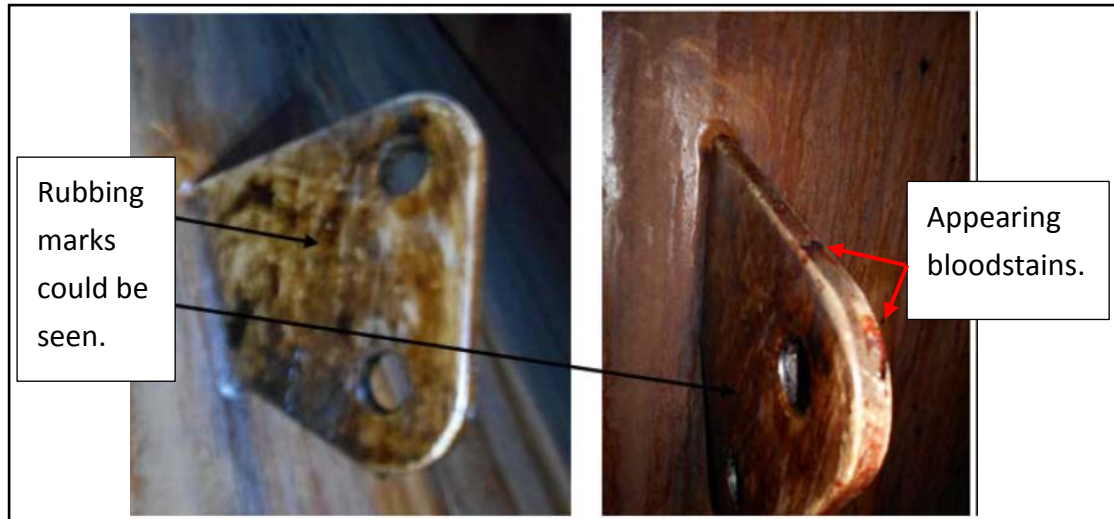
Fig. 9- Pad eye close up - Located vertically below the gap.

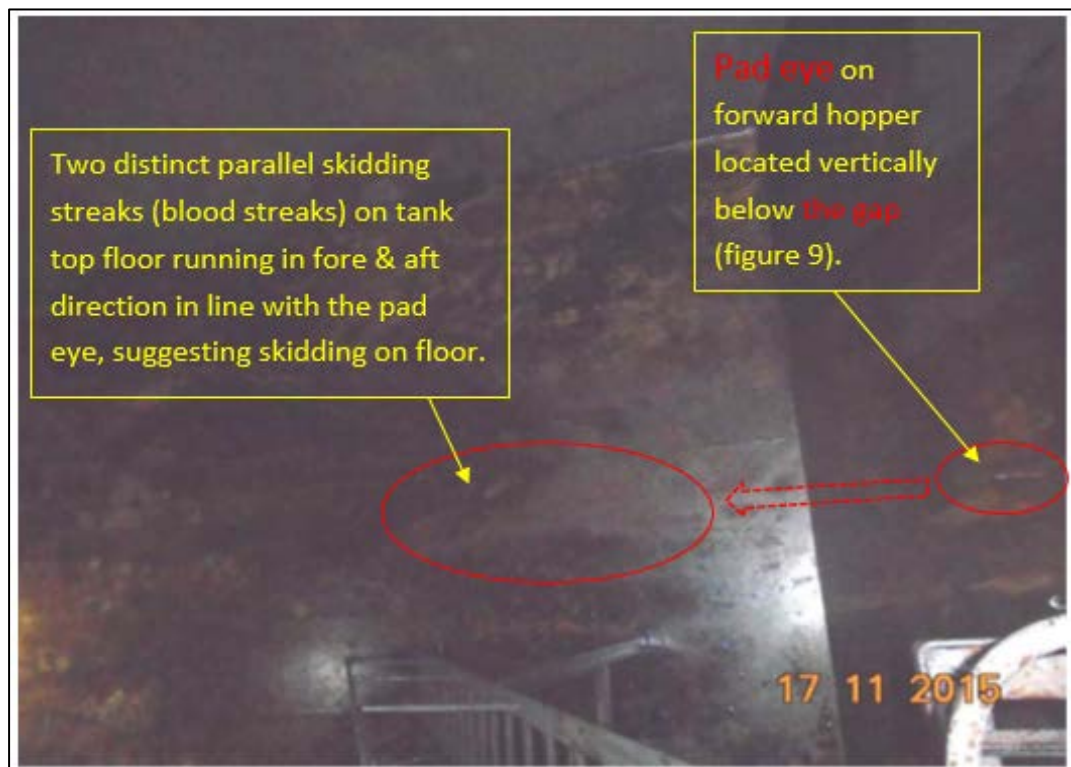
- 5.25 From the pad eye to the lying position of the injured TOS, two distinct parallel skidding marks (blood streaks) running in a fore-and-aft direction from the pad eye were found (figure 10). The finding evidenced that the body of the TOS during the fall had hit the pad eye thus causing the fatal lacerating to his abdomen upon landing on the tank top. The landing force had caused the TOS to slide on the floor to his final lying position.

Fig. 10- Photo taken showing the parallel skidding marks on tank top floor.

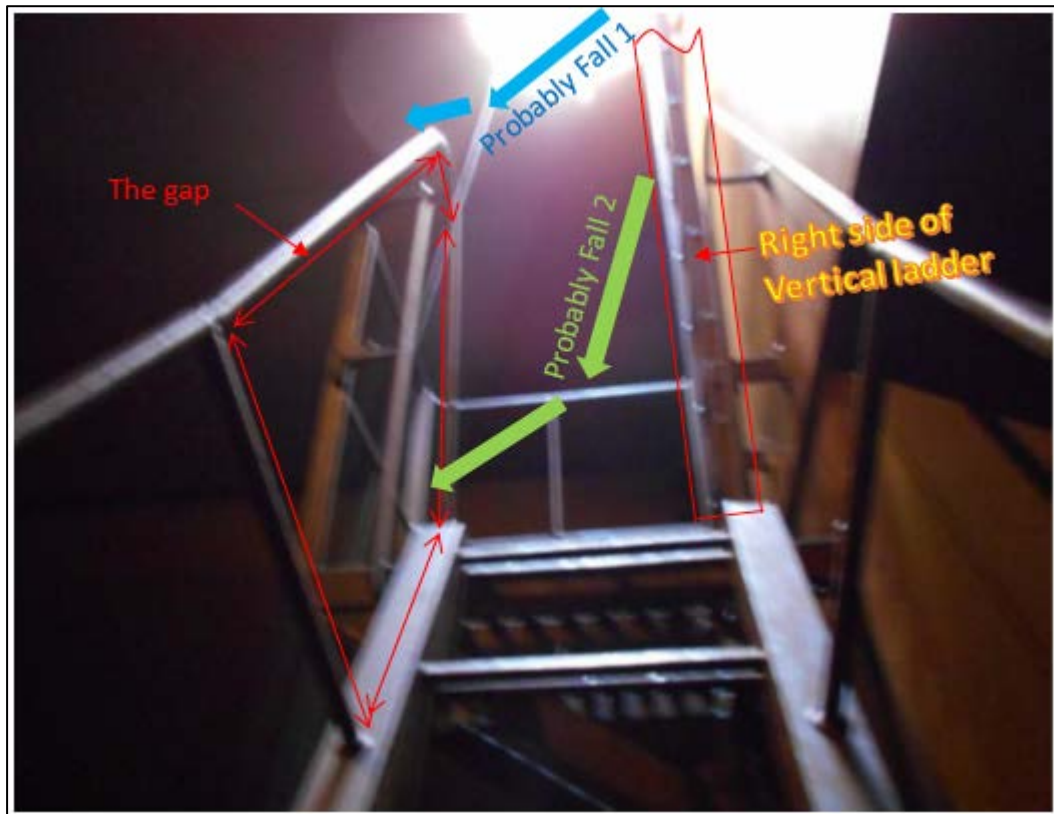
- 5.26 About one to two minutes before the accident happened, the chief officer saw the TOS had started to ascend the lowest inclined ladder. Given the age of the TOS and the time elapsed, the chief officer considered that the TOS could have reached the uppermost platform and been climbing the vertical ladder.
- 5.27 It was therefore deduced that the TOS might have fallen either through the gap or directly from the vertical ladder with the result of hitting the pad eye and finally, landed and slid on the tank top. (figure 11)

Fig. 11- View looking up from uppermost inclined ladder- probably falling manners.

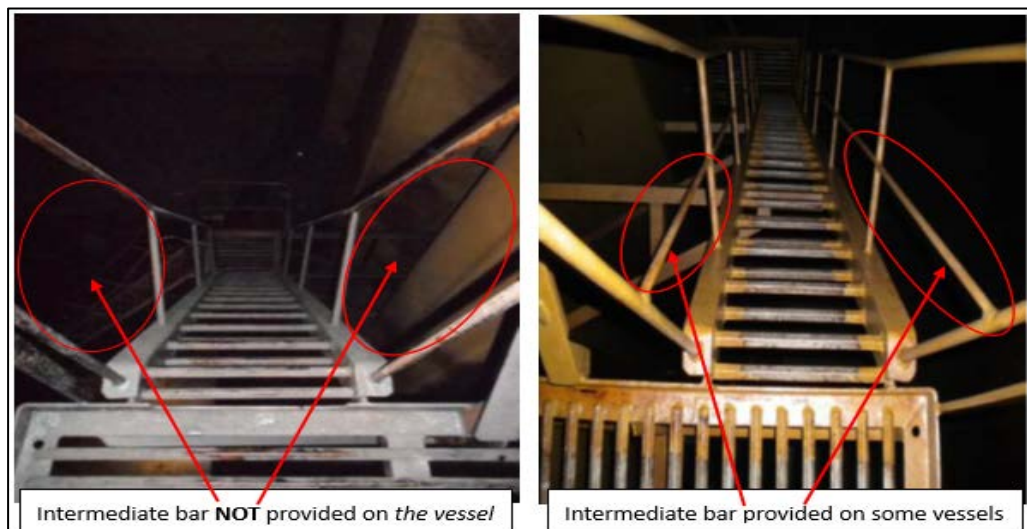
- 5.38 SOLAS regulation II-1/3-6 requires that applicable oil tankers and bulk carriers shall comply with the technical provisions for means of access to cargo and other spaces under the resolution MSC.133(76) as amended. The said resolution specifies that guard rails shall be 1000 mm in height and consist of a rail and an intermediate bar 500 mm in height and of substantial construction. Although *the vessel* was not an oil tanker or bulk carrier, consideration should be given to adopt the principle of the said resolution whereby an intermediate bar should be provided between the stringer and top handrail of the inclined ladders to reduce the gap size.

Fig.12- The gap on uppermost inclined ladder -some vessels are fitted with intermediate bar to reduce gap.
