**Report of Investigation into the  
Accident of Man Overboard from  
a Locally Licensed Dumb Lighter  
“Winsmart” (B21658V) under  
Towing on 27 January 2016**

Marine Accident Investigation Section  
Marine Department  
The Hong Kong Special Administrative Region

25 August 2017

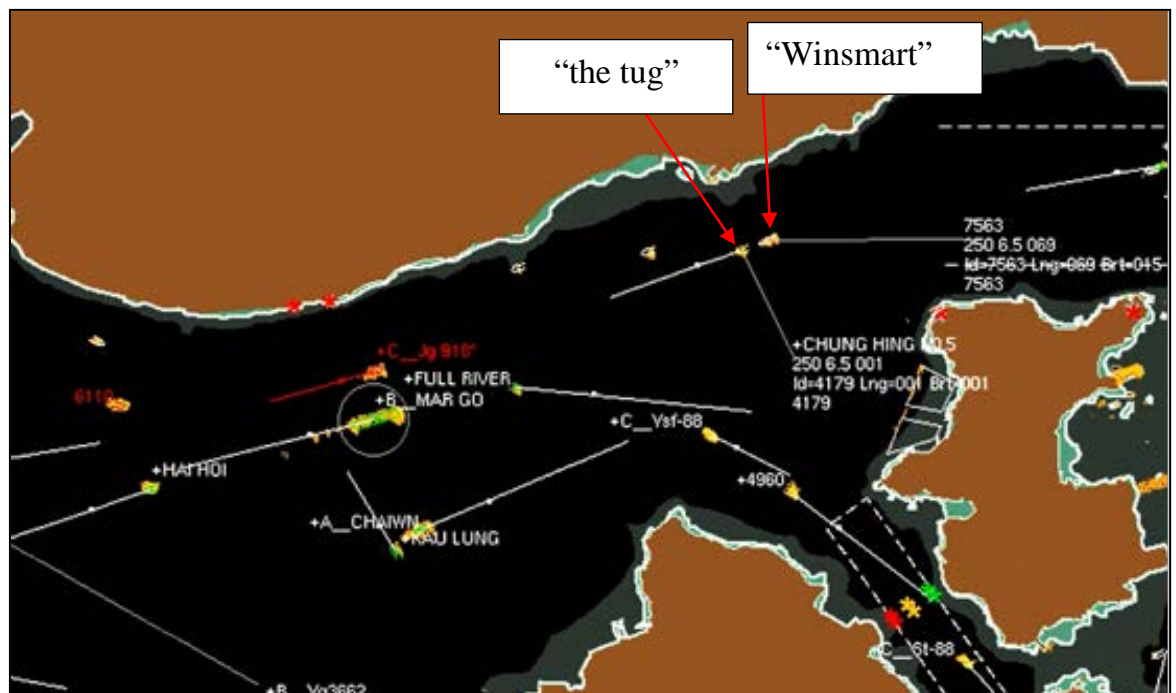
- 4.3 Around 1530 hours, “the tug” was towing “Winsmart” and navigating in the waters off the north of Lantau Island and the south of Tsing Lung Tau at a speed of 6.5 knots and on a course of 250° (Fig. 3). The crane operator and the person in charge of works jointly moved a damaged water dispenser from the stern to the side of the vessel with no bulwarks nor railings installed for throwing it overboard. At that time, the person in charge of works wore loose clothes and a waist bag. When the water dispenser was thrown overboard, the power cord of the water dispenser accidentally got entangled with the waist bag of the person in charge of works, which came off instantly and fell overboard together with the water dispenser. At the time when the waist bag came off, the person in charge of works reached out his hand trying to catch the waist bag but instead he lost his balance and fell overboard.

Fig. 3 – Location where the person in charge of works fell overboard when “Winsmart” was in the waters off the south of Tsing Lung Tau

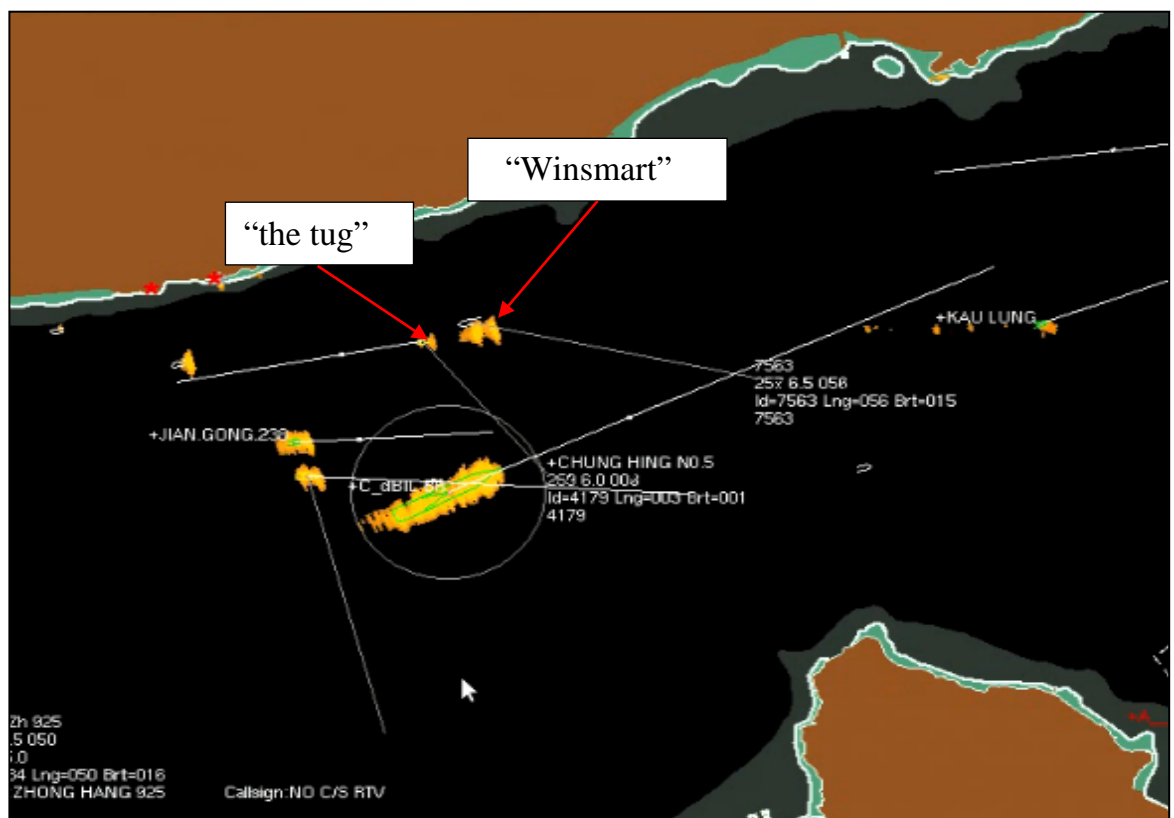
- 4.5 Around 1537 hours, the coxswain of “the tug” slowed down at once and reversed course to berth alongside “Winsmart” in response to the rescue call from “Winsmart” (Fig. 4). Around 1539 hours, the coxswain of “the tug” learnt that someone had fallen overboard and was carried eastward by the current. He then steered “the tug” away from “Winsmart” and reversed on an easterly course of about 070° at a speed of about ten knots and steered along the current to search for the person in charge of works who fell overboard.

Fig. 4 – Location where “the tug” received the rescue call
