**Report of investigation into
the fatal incident on board
the Hong Kong registered
chemical tanker “*Melati 5*”
on 12 February 2016**

The Hong Kong Special Administrative Region
Marine Department
Marine Accident Investigation Section

11 September 2018

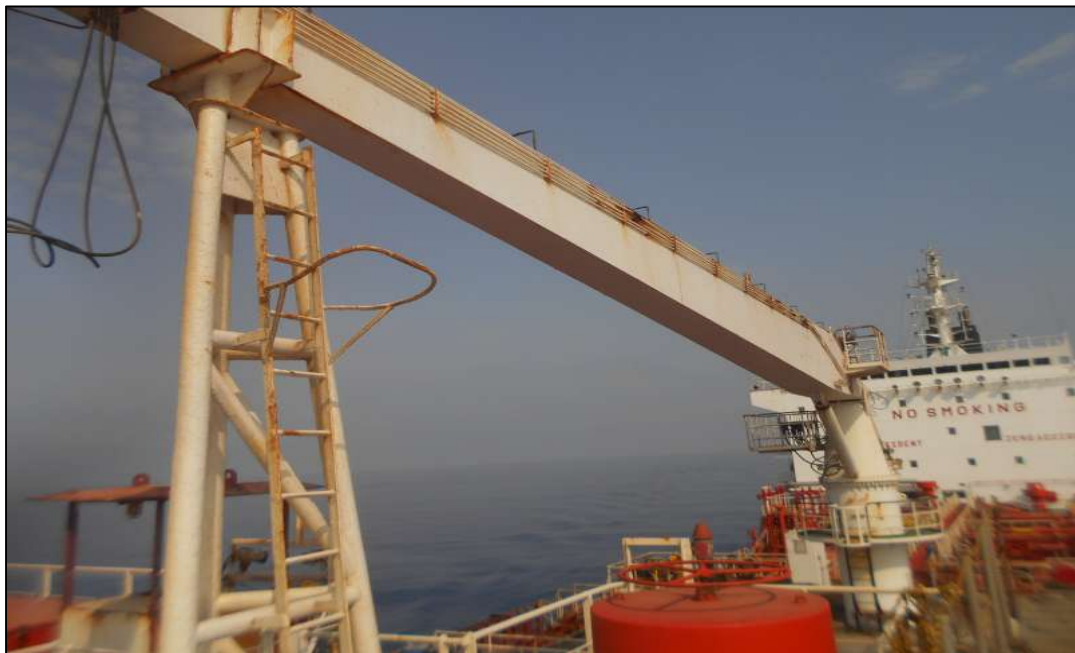
Figure 2 – The crane

- 4.3 About 15 minutes later, after the pilot had boarded *the vessel*, nine deck ratings led by the chief officer commenced to pick up the gangway for securing it on top of the deckhouse. The gangway weighed about 2.5 tonnes. The crane (Figure 2) at midship was used to lift up the gangway. The positions of the chief officer and the deck ratings were shown in Figure 3.

- 5.8 The crane is a hose handling crane with the primary purpose of lifting cargo hoses for the cargo manifolds located at about the midship section on both the port and starboard sides of the vessel. The pedestal of the crane is more or less along the same line of the transverse axis of the centre points of the port and starboard cargo manifolds. As the gangway could not be placed within the area of the starboard cargo manifold in order to give way to the cargo hose connection, the gangway had to be placed at a distance forward of the cargo manifold thus resulting in a situation that the crane's arm (of a maximum outreach of 21 m) could not reach the gangway's centre point (Figure 7). When lifting the gangway, the lifting would be under an asymmetrical centre line of hoisting thus causing the gangway being subjected to an inboard pulling force causing the hooked end of the gangway pressed hardly against and thereby stuck with the railing in a locking mode. Upon the gangway was lifted to a level where the hooked end was suddenly freed from the railing, the sudden release of energy had driven the gangway inboard in an uncontrolled manner and struck the chief officer who was standing in front of the hooked end of the gangway (Figure 8 and Figure 9).

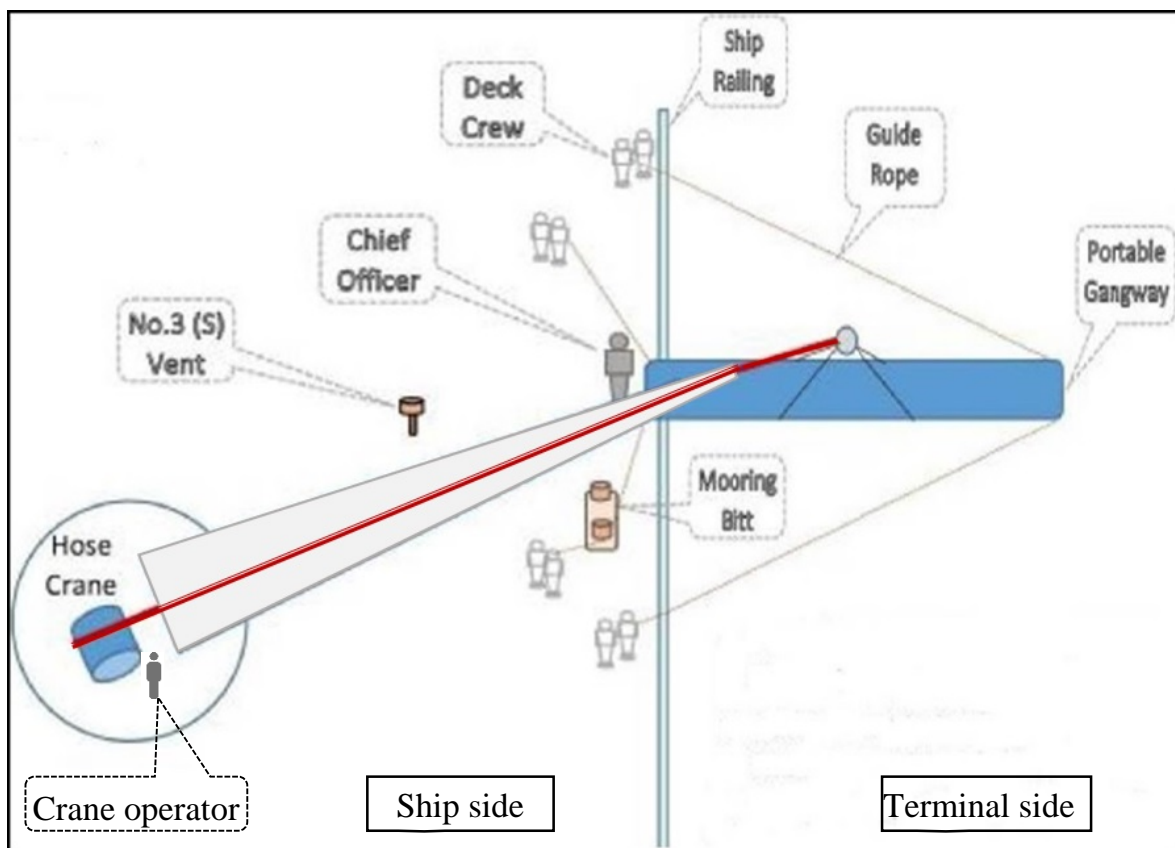
Figure 3 – Layout of the chief officer and deck ratings' positions

- 4.5 When the crane operator drove the crane above the gangway, one deck rating walked on the gangway and linked up the crane hook with the four lifting wire slings attached to the middle section of the gangway. The deck rating then returned to his position to hold the guide rope. At about 2235 hours, the chief officer ordered to hoist the gangway. When the gangway was about to be lifted up by the crane, the hooks at the hooked end of the gangway were stuck with *the vessel's* railing. The chief officer then moved closer to examine the problem. All of a sudden, the hooks were freed from the railing and the sudden release of energy had driven the gangway inboard in an uncontrolled manner and struck the chief officer's abdomen, pushing him towards the No.3 starboard water ballast tank vent head which was located at about 2.8 meters from the railing (Figure 3). The eight deck ratings could not stop the gangway's uncontrolled swing by the guide ropes.

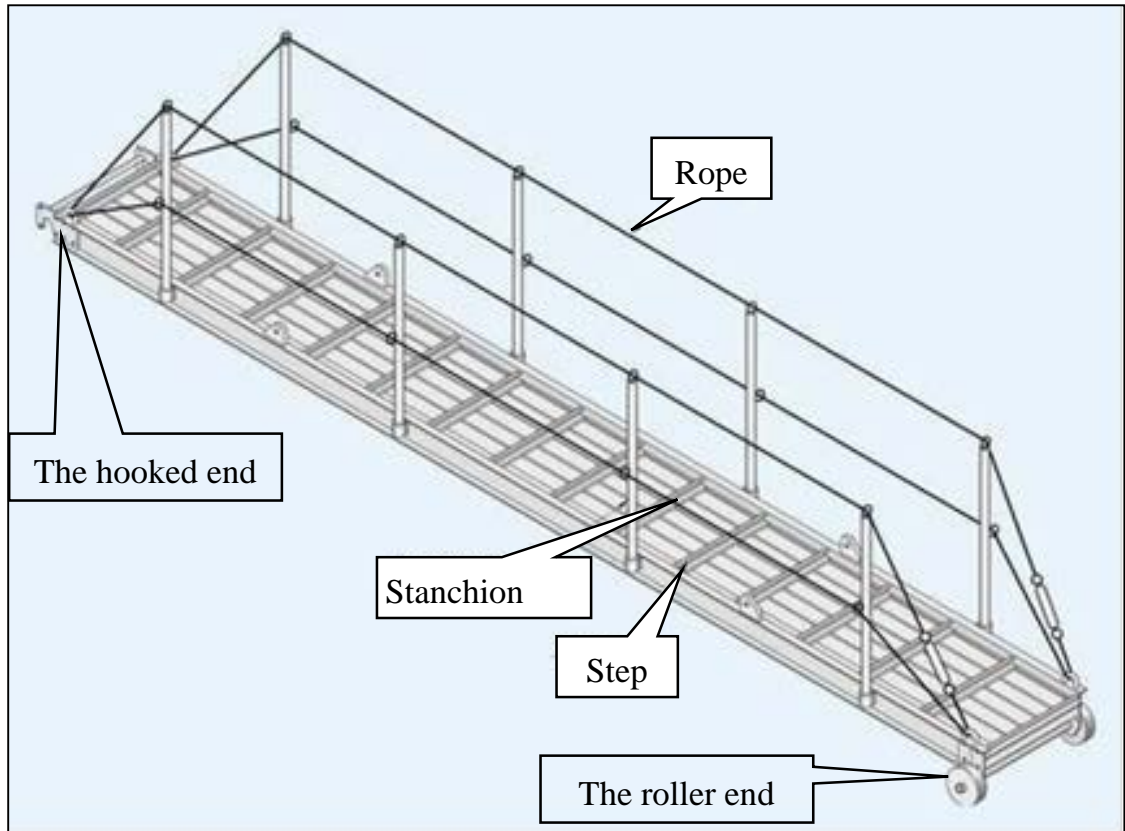
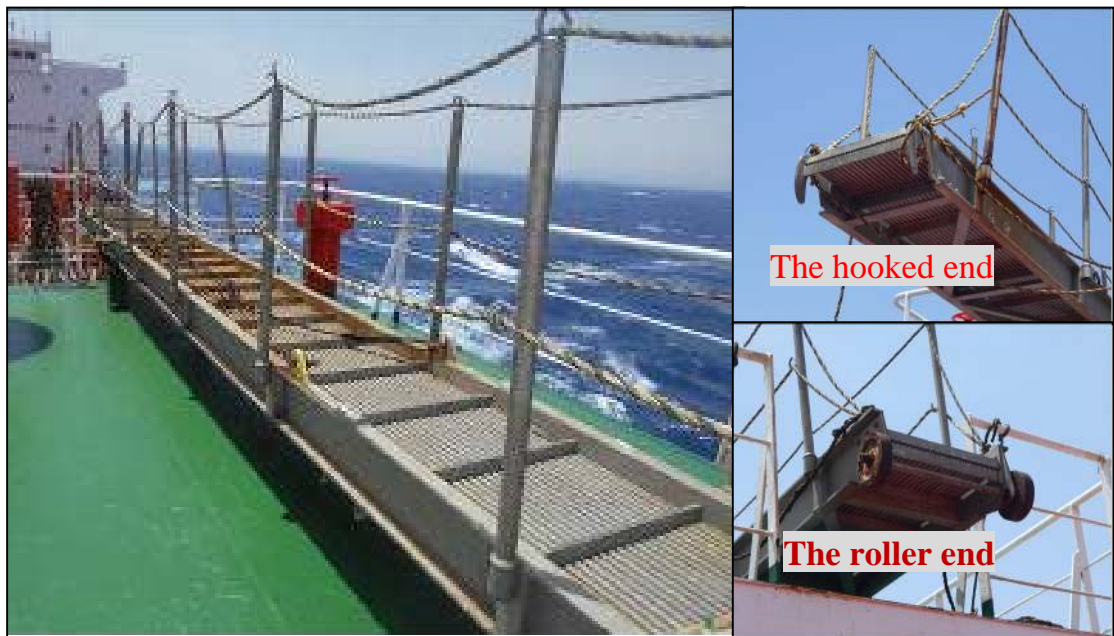
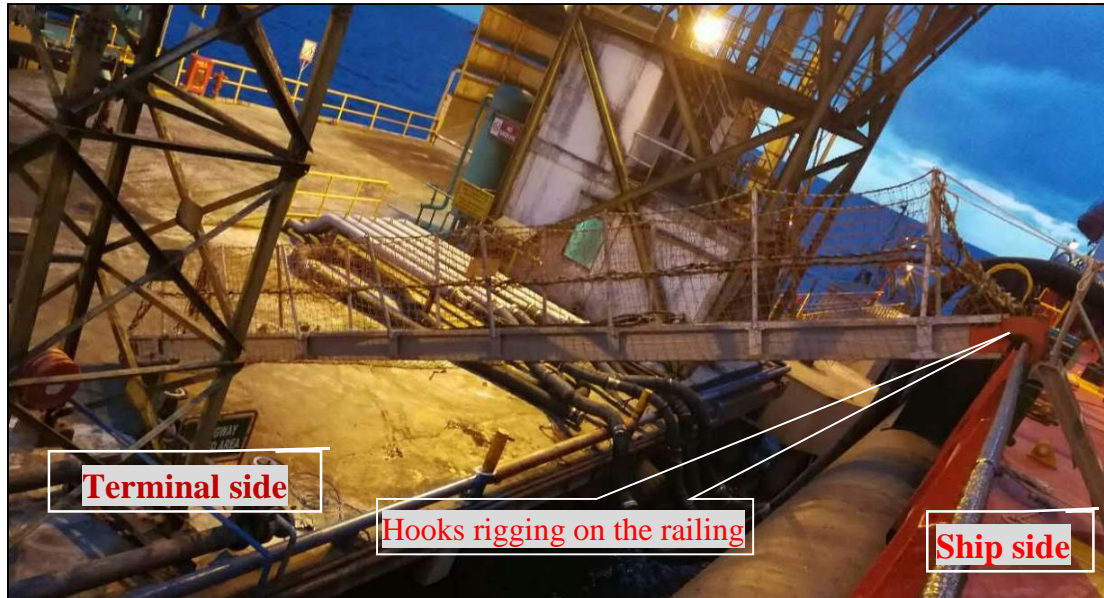
- 5.7 The gangway had the features of having two hooks on one end (the hooked end) for attaching to *the vessel's* railing, and two plastic rollers on the other end resting on the terminal to cater for the vessel's movement due to the change of vessel's draft in cargo operation and tides (Figures 4, Figure 5 and Figure 6).

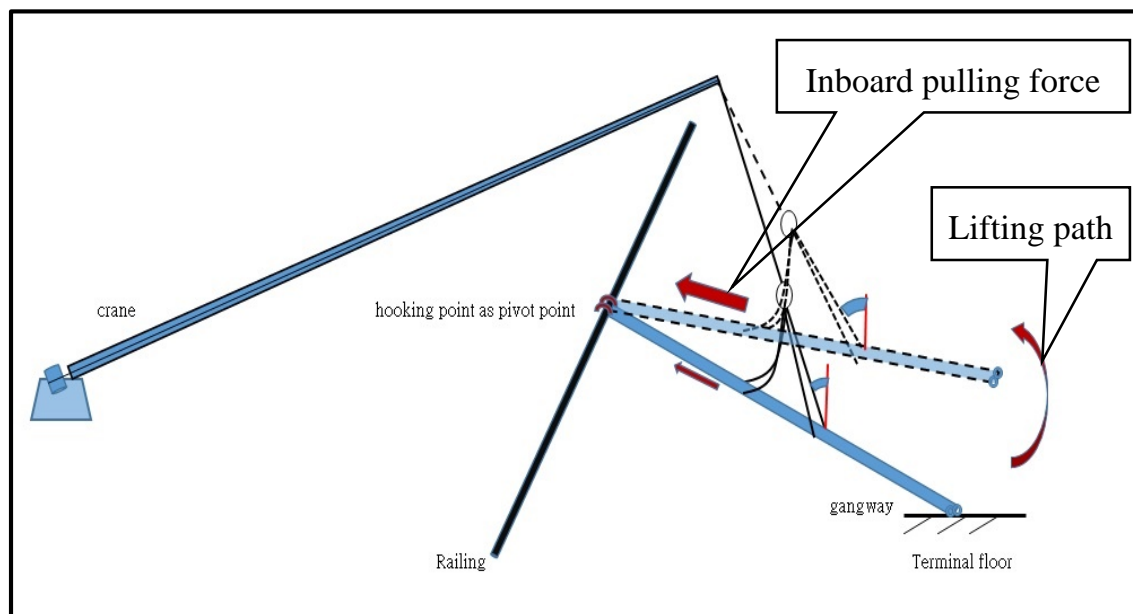
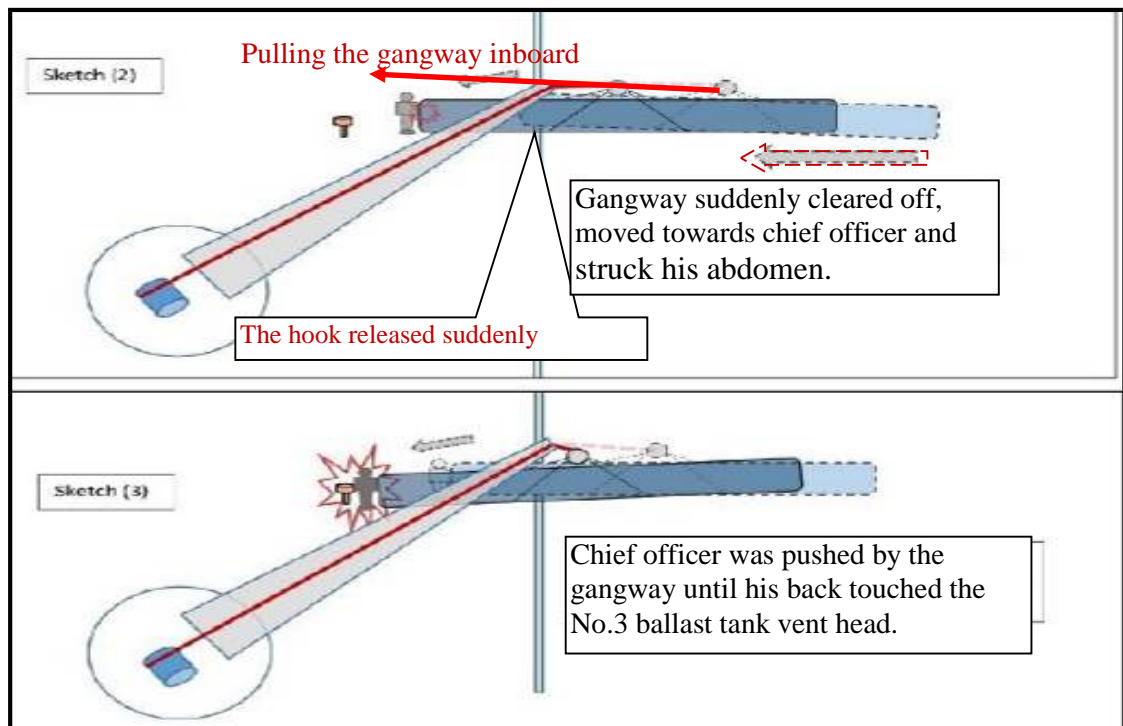
- 5.11 In accordance with the requirements for lifting operation of the “Code of Safe Working Practices for Merchant Seafarers”(COSWP), it is mentioned that *“The use of lifting appliances to drag heavy loads with the fall at an angle to the vertical is inadvisable because of the friction and other factors involved, and should only take place in exceptional circumstances where the angle is small, there is ample margin between the loads handled and the SWL of the appliance, and particular care is taken.”* It appears that Ship operation / procedure on lifting operation under asymmetrical centre of lifting should be avoided as far as practicable. Particular care should be taken to control the movement of lifting and to clear from the danger zone if an asymmetrical centre of lifting has to be taken.
