**Report of investigation
into the collision between the
Hong Kong registered
container vessel “*Shin Chun*”
and a Taiwanese fishing vessel
at waters close to Kaohsiung,
Taiwan on 29 February 2016**

The Hong Kong Special Administrative Region
Marine Department
Marine Accident Investigation Section

30 May 2019

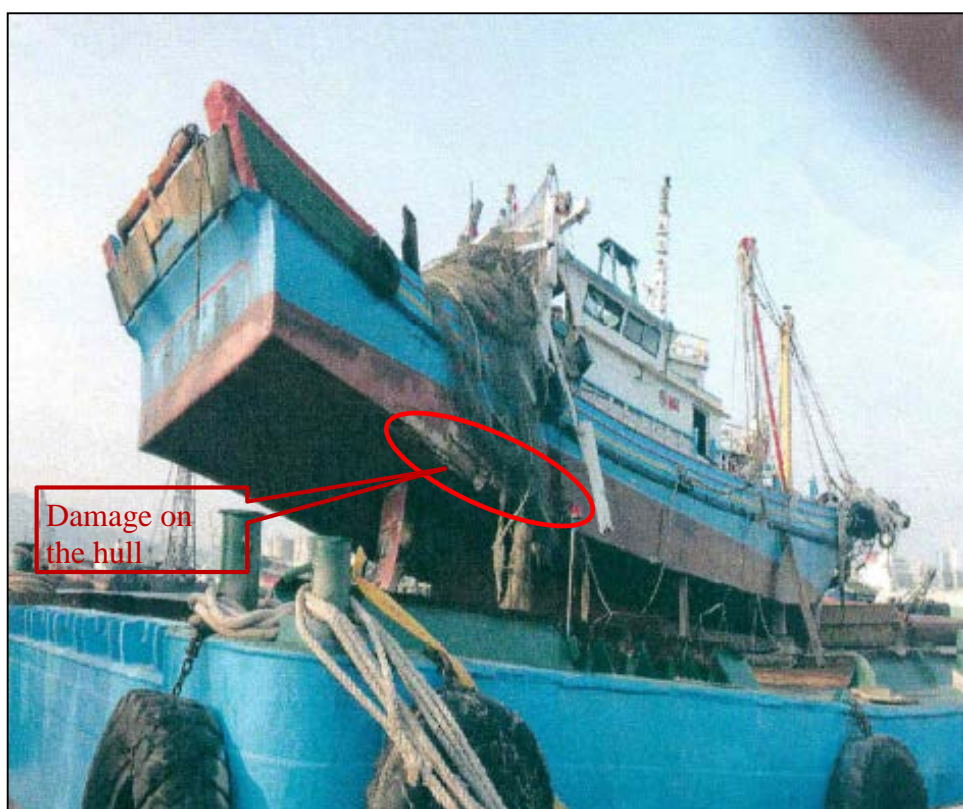
Figure 2 - *the fishing vessel* on the pontoon

- 4.11 Inspection on *the fishing vessel* was also conducted after she was lifted and placed on pontoon. A damage was found at the starboard quarter of the wooden hull under waterline (see also Figure 2). It could be deduced that the forward starboard part of the bulbous bow of *the vessel* collided with the starboard side of *the fishing vessel* as illustrated in Figure 10.

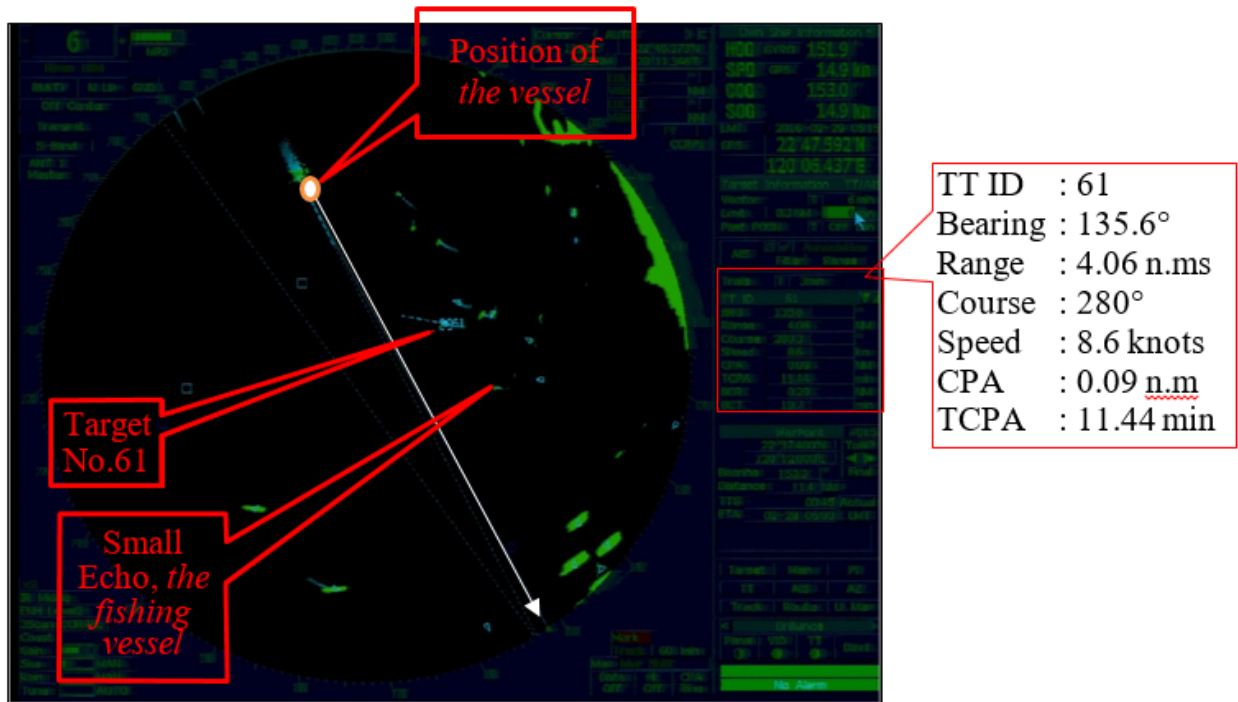
- 3.4 At about 0515 hours, *the vessel* was at position 22°47.6'N, 120°06.4'E, maintaining her planned course of 152° with a speed of about 14.9 knots. The No.1 radar indicated several ships' echoes on her port side forward. One of those echoes was plotted as target No.61 at a distance about 4.06 n.ms and a bearing of 135.6° proceeding on a west bound course of 281° at a speed of about 9 knots. Following target No.61, a small echo (confirmed to be *the fishing vessel* later) was also displayed on the screen at a further distance. *The fishing vessel* was not plotted by the duty officer and therefore, its bearing and distance were not indicated on the radar screen. (Figure 3)

- 4.13 As described in paragraph 3.4, a risk of collision existed between target No.61 and *the vessel* at 0515 hours. Target No.61 was in a crossing situation having *the vessel* on her starboard side. *The fishing vessel* behind target No.61 was in the same crossing situation with *the vessel*, but it was not plotted by the duty officer.

Figure 3 - The Radar screen at 0515 hours

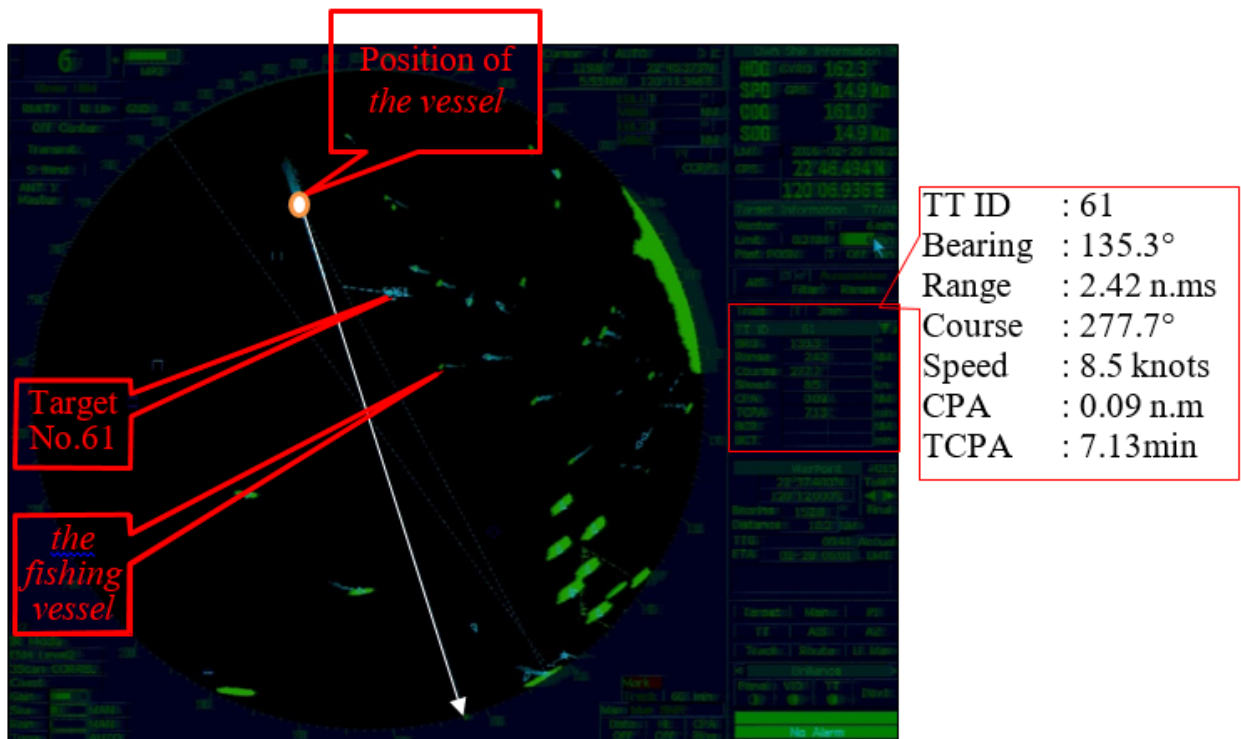
- 3.5 At about 0520 hours *the vessel* was at position 22°46.5'N, 120°06.9'E and altered course to starboard to 162° with a speed of 14.9 knots. Target No.61 was on the port bow of *the vessel* at a bearing of 135° and a distance of 2.4 n.ms. The movement of target No.61 was steady. On the radar screen, the plotting data of target No.61 indicated the Closest Point of Approach (CPA) as 0.09 n.m and Time of Closest Point of Approach (TCPA) as 7.13 minutes. *The fishing vessel* on the radar screen maintained the same trend, and no significant change on its relative position from target No.61. As the 3/O stated, when *the fishing vessel* on the radar was at about 4 n.ms away and a bearing of about 139°, he saw a weak light of *the fishing vessel* firstly by sight. (Figure 4)

Figure 4 - The Radar screen at 0520 hours

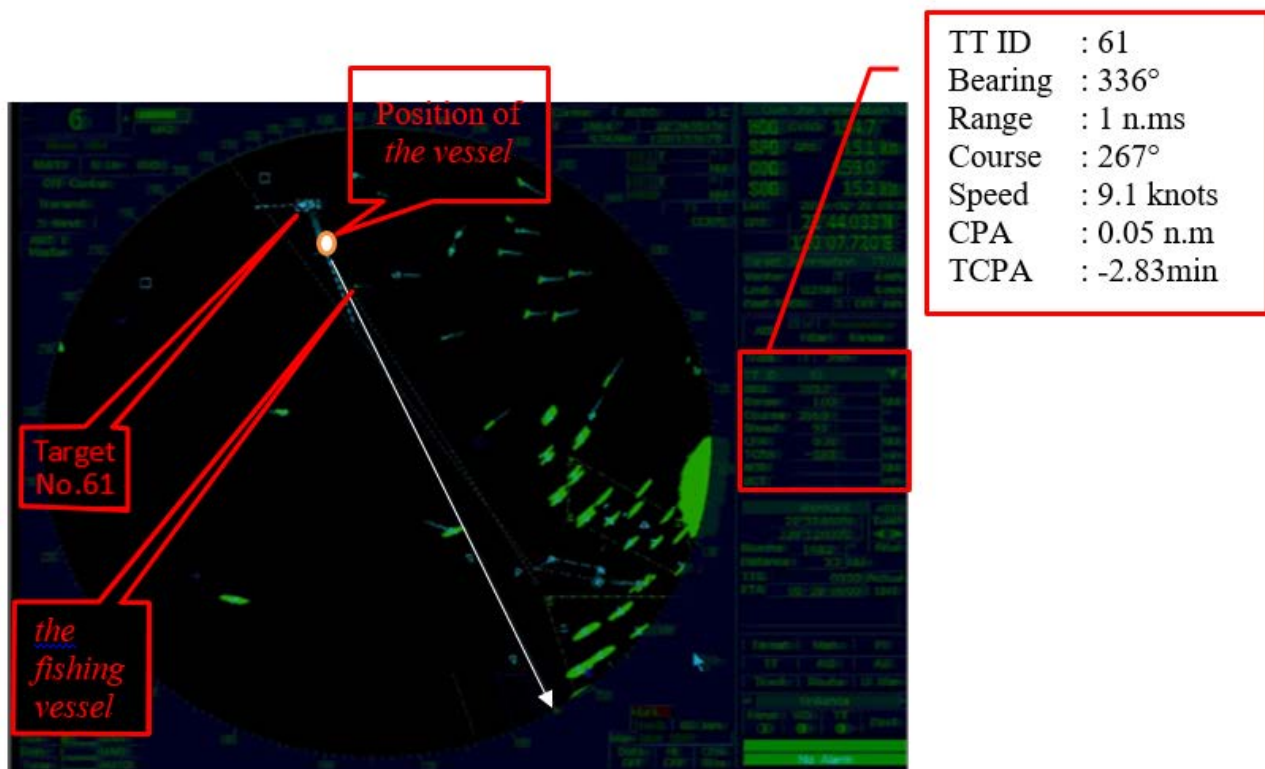
- 3.9 At 0531 hours, *the fishing vessel* was approaching too close to the port bow of *the vessel* at an estimated distance of 0.5 n.m. About 45 seconds later (i.e. 053145 hours), a voice was recorded by *the vessel*'s VDR that the 3/O talked to himself in Chinese “漁船(要)幹什麼?” (in English, “what does *the fishing vessel* intend to do?”). Then it was silent again on the bridge. The 3/O stated that after observing an imminent risk of collision with *the fishing vessel* in crossing, he altered course to starboard to 161°. (Figure 6)

Figure 6 – The radar screen at 0531 hours

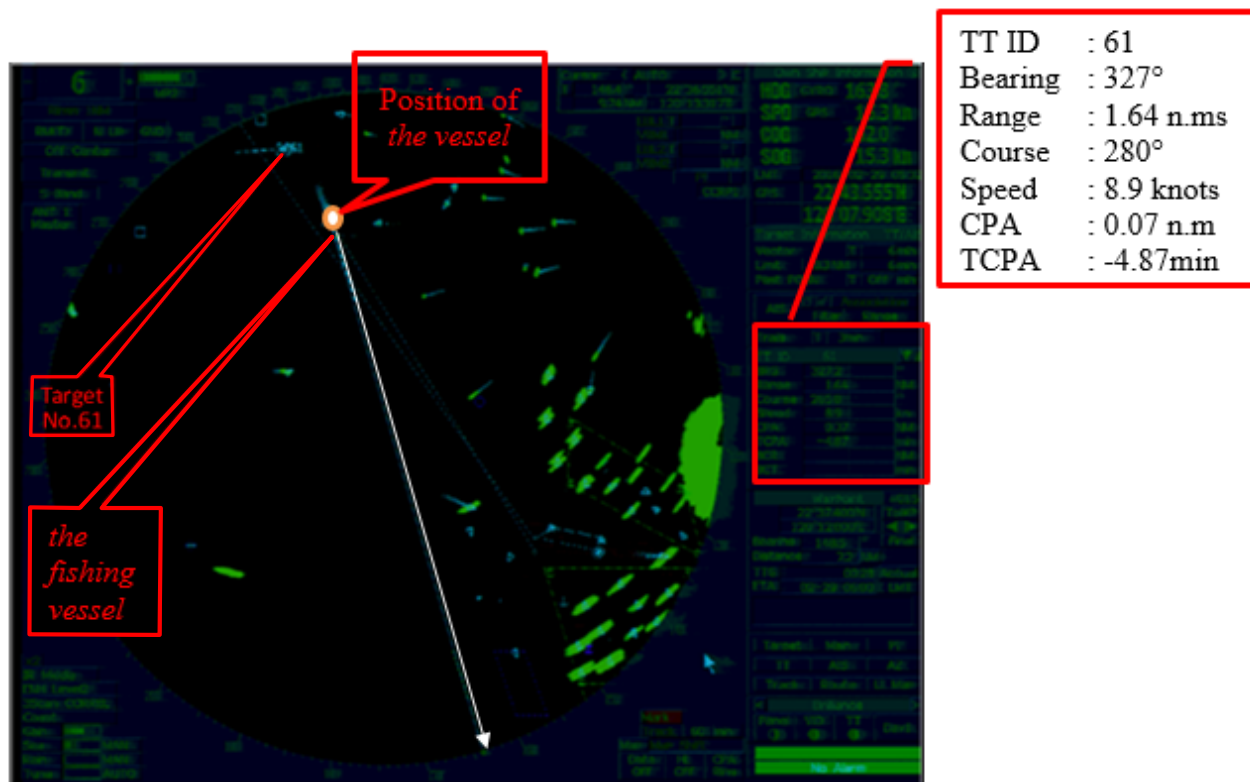
- 3.10 At 0532 hours, *the vessel* continued to alter course to 170° at a speed of 15.1 knots. *The fishing vessel* on radar screen was almost right ahead of *the vessel* at a distance of about 0.23 n.m. At 053209 hours, the 3/O found that *the fishing vessel* was still crossing ahead of *the vessel*. He ordered to change to hand steering and put hard starboard on the rudder. At about 053223 hours, the record of VDR indicated a weak noise of collision. It occurred at position 22°43.4'N, 120° 07.9'E. The heading of the vessel was on 175° with a speed of 15.2 knots. (Figure 7). The duty AB stated that the collision occurred less than one minute after the rudder order of hard starboard was given, and the A3/O stated also that a vibration was felt when the collision occurred.

Figure 7 – The radar screen at 0532 hours

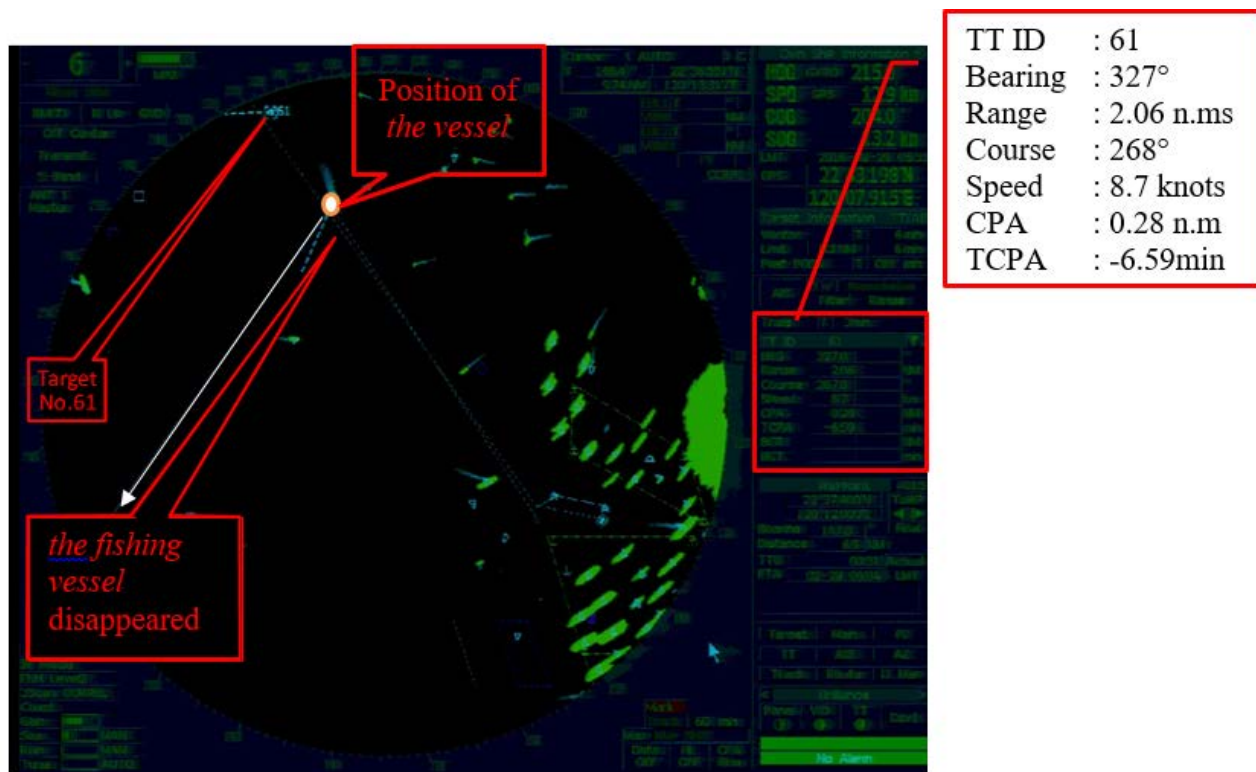
- 3.12 At 0533 hours, *the vessel* was at position 22°43.3'N, 120°08.0'E continuing to alter course to 204° and her speed dropped to 12.7 knots. A high turning rate was achieved by putting the

rudder to hard starboard. The echo of *the fishing vessel* disappeared on the radar screen (Figure 8).

Figure 8 – The radar screen at 0533 hours

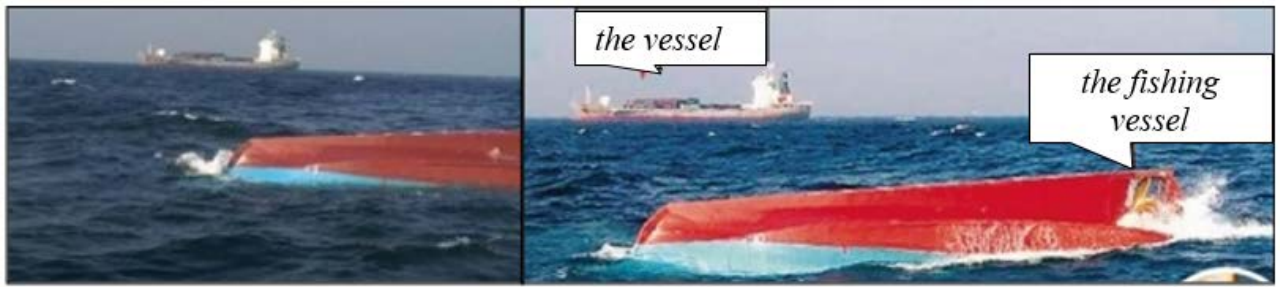
- 3.18 At about 0620 hours, *the fishing vessel* was found floating upside down on the sea surface (Figure 9). Fishing vessels in the vicinity were contacted and requested to assist in searching the area for man overboard. *The vessel* also continued the SAR in the vicinity.

Figure 9 - *the fishing vessel* floating upside down on the sea surface

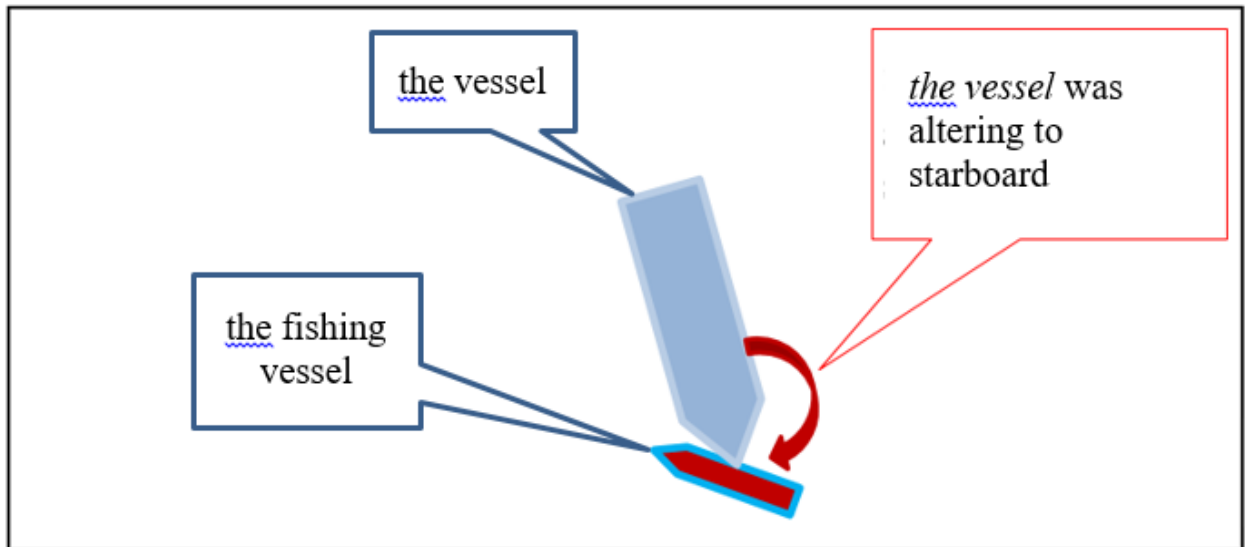
Figure 10 – Illustration of the collision between *the vessel* and *the fishing vessel*

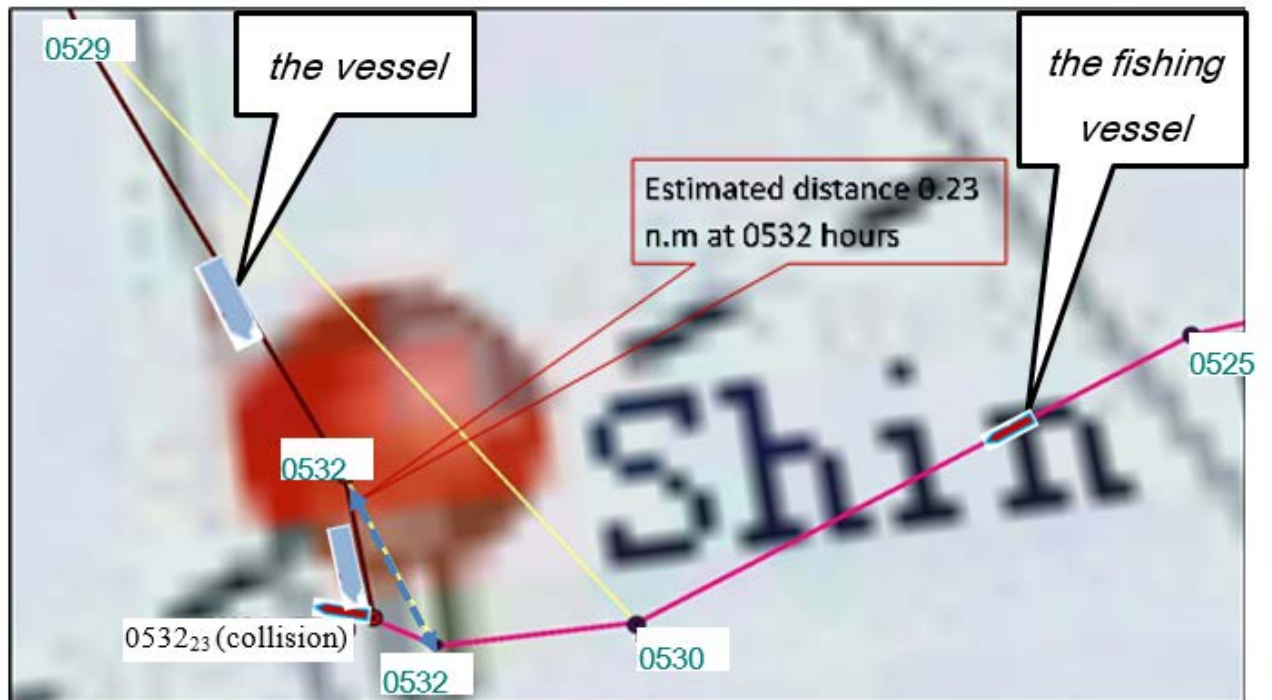
- 4.12 The tracks of both vessels were established by plotting their positions on the chart. It indicated that, at about 0532 hours, *the fishing vessel* was coming from port side of *the vessel* at a distance of about 0.23 n.m (426 metres) and bearing of about 160°, which was almost right ahead of *the vessel*. Considering the length of *the vessel* of 151 metres, and the size of *the fishing vessel*, the distance between them would be too short for avoiding collision. The collision occurred at about 053223 hours while *the fishing vessel* was passing ahead of *the vessel*, and *the vessel* was altering her course to starboard (Figure 11).

Figure 11 – The track of *the vessel* and *the fishing vessel* at last moment before collision
