**Report of Investigation
into the fatal accident on
board bulk carrier “*HONY
FUTURE*” in heavy weather
on 29 February 2016**

The Hong Kong Special Administrative Region
Marine Department
Marine Accident Investigation Section

18 January 2018

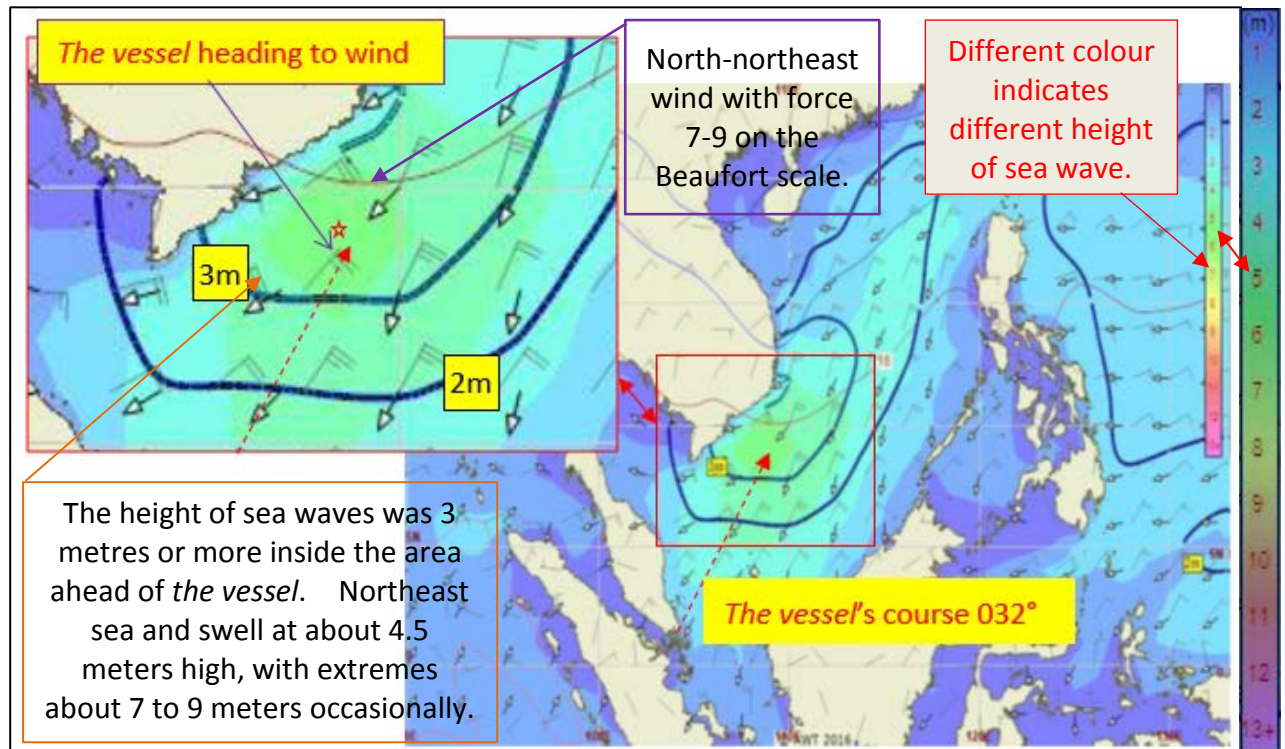
- 4.4 In the midnight on 28 February 2016, *the vessel* was sailing on a course of 032° against the north-northeast wind with force 8 on the Beaufort scale and encountered very rough sea (Figure 2). She rolled from side to side covering a range of about 20 to 40 degrees and pitched heavily. Sea waves washed on deck from port side forward and splashed around the area of cargo hatch No.2. The speed of *the vessel* was dropped to 5 knots.

Figure 2- The weather forecast received in the afternoon on 28 February 2016 showing the wind and sea wave conditions in the area ahead of *the vessel*.

- 5.7 The vessel had encountered rough sea after she entered South China Sea on 26 February 2016. The master, officers and crew members clearly noted that the weather condition would get even worse on the vessel's forthcoming passage as revealed by Navtex weather forecast received onboard one day before the accident happened. The forecasted sea waves would be 7 to 10 meters high which were much higher than the freeboard 5.2 meters of the vessel. The master and second officer had tried to improve *the vessel's* rolling and pitching condition by altering course and reducing her speed before the accident happened, but in vain.
- 5.8 At the time of the accident, the wind was north-northeast of force 8, gusts 9 on the Beaufort scale. Sea condition was very rough with northeast sea and swell at about 4.5 meters height, with extremes about 7 to 9 meters occasionally. (Figure 2)

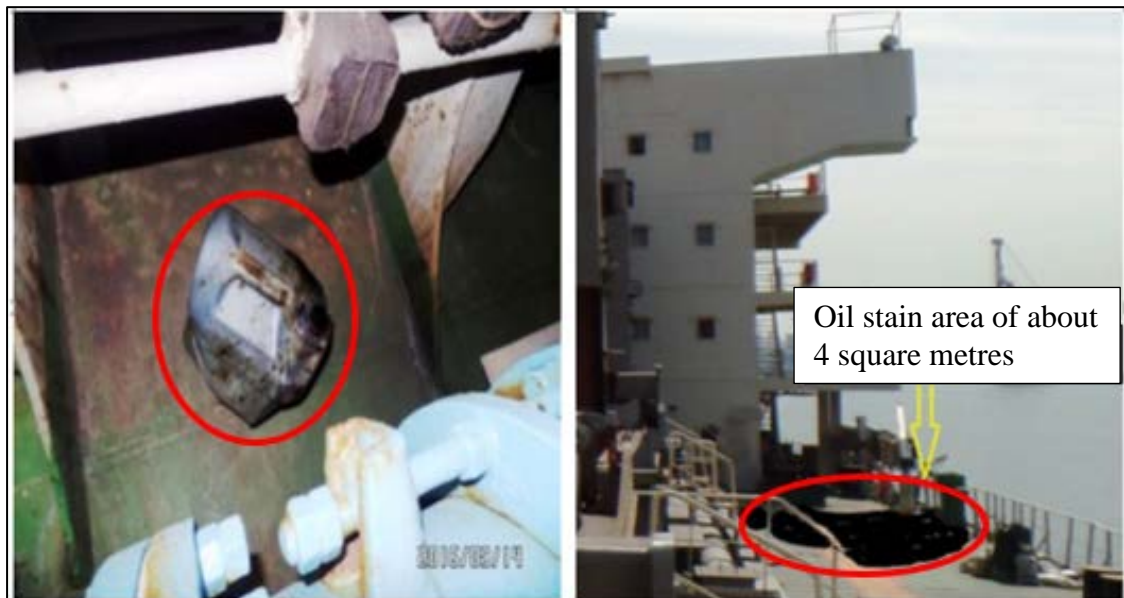
- 4.7 After the sky got bright at about 0700 hours, the second engineer went to the location of the oil stain again. He confirmed that a 4-liter capacity plastic fuel oil sample bottle was toppled to the deck due to ship movement or strong wind effect. Fuel oil sample leaked from the toppled bottle and spread to an area of about four square meters on the deck near the port side bunkering station (Figure 3). Being on the deck twice, the second engineer did not experience any sea waves washing over the port quarter bunkering station area.

Figure 3 –the toppled fuel oil sampling bottle and the sketch map of the oil stain location on the main deck

- 5.17 The shipboard "Bunker delivery, sampling & survey procedure" stipulated that a bunker sample "is to be retained on board in a safe place outside the accommodation (such as the protected paint locker)". The bunker oil sampling bottle of *the vessel* was left on open deck near the bunkering station for more than two weeks. The fuel oil sampling bottle had not been properly stored in an appropriate location in accordance with the shipboard procedure.

- (b) the effectiveness of shipboard training must be improved and verified/monitored; and
 - (c) bunker sample must be retained properly in accordance with the shipboard procedure of handling bunker samples.

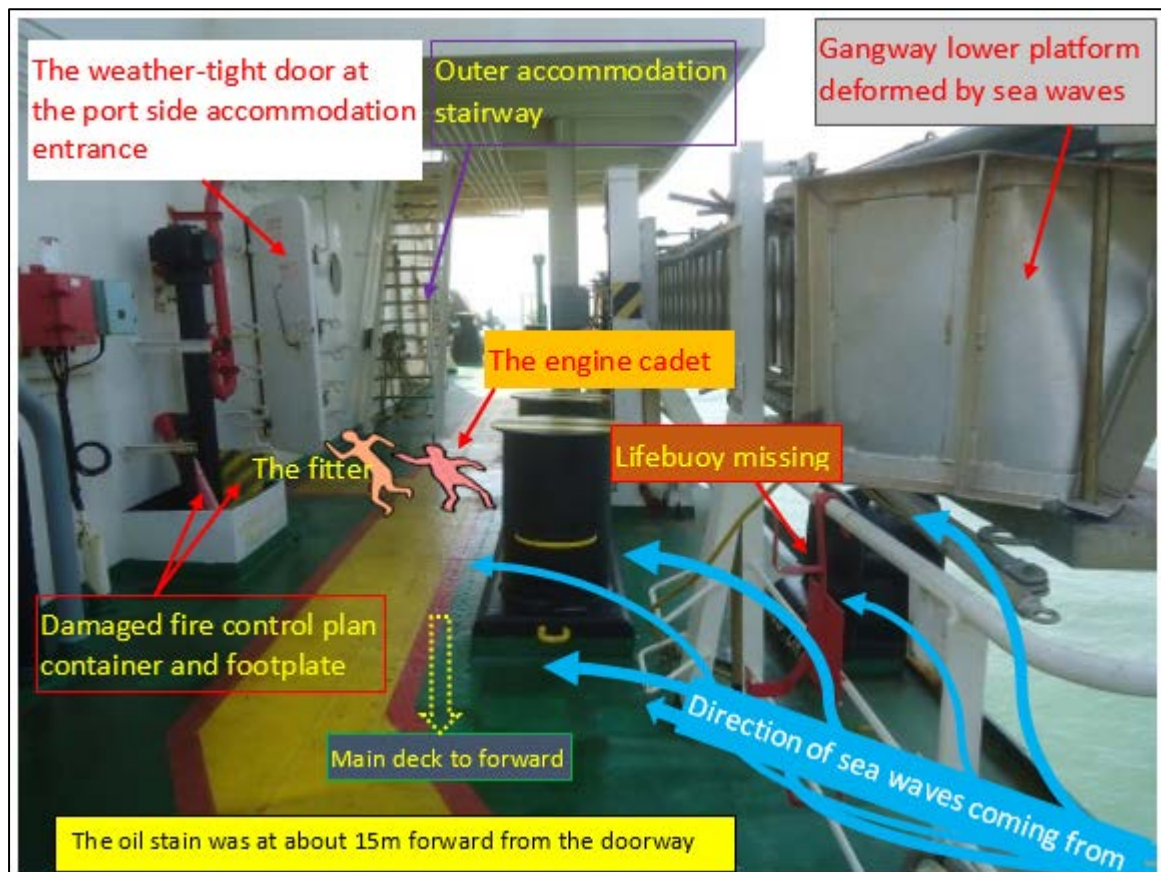
- 4.12 Almost at the same moment, the fitter opened the port side accommodation entrance weather-tight door and stood on the main deck trying to close the door from outside. The engine cadet, also on the main deck, was behind him carrying a bucket with cleaning materials inside. Suddenly, a heavy sea wave washed over the aft main deck with large amount of sea water flooded the deck area around the doorway. The fitter and the engine cadet were floated by the sea water flushing on the deck. The fitter tried to keep his balance by holding the weather-tight door's doorknob and a steel bar of a short ladder which was fitted on the bulkhead behind the door, but in vain. Both the fitter and the engine cadet were smashed immediately by another heavy sea wave and lost their balance. The fitter and the engine cadet hit heavily on deck fixtures. Their helmets and safety shoes were washed away. They were injured seriously and were unconscious. (Figure 4)

Figure 4 -the sketch showing the scene of the incident

5.9 *The vessel* was sailing on course of 032° as per passage plan, against the wind and seas. She rolled from side to side covering a range of about 20 to 40 degrees and pitched heavily. Sea waves were washing on deck from portside forward. When the fitter and the engine cadet passed the port side accommodation entrance weather-tight door and stepped on the main deck, they were knocked heavily against deck fixtures by sudden heavy sea waves which washed over them. The sudden extreme heavy sea waves caused the serious injuries to the fitter and the engine cadet. They had even no time to react to escape when the unexpected extremely heavy sea waves suddenly attacked.

- (a) when moving or working on open deck under adverse weather condition, the requirements of the shipboard safety procedures and the “Code of Safe Working Practices for Merchant Seamen” must be strictly followed. Particularly, a risk assessment should be undertaken;
