**Report of investigation
into the explosion on board
oil/chemical tanker “*NO.3
HEUNG-A PIONEER*” in
waters off Penang, Malaysia on
18 April 2016**

The Hong Kong Special Administrative Region
Marine Department
Marine Accident Investigation Section

20 July 2018

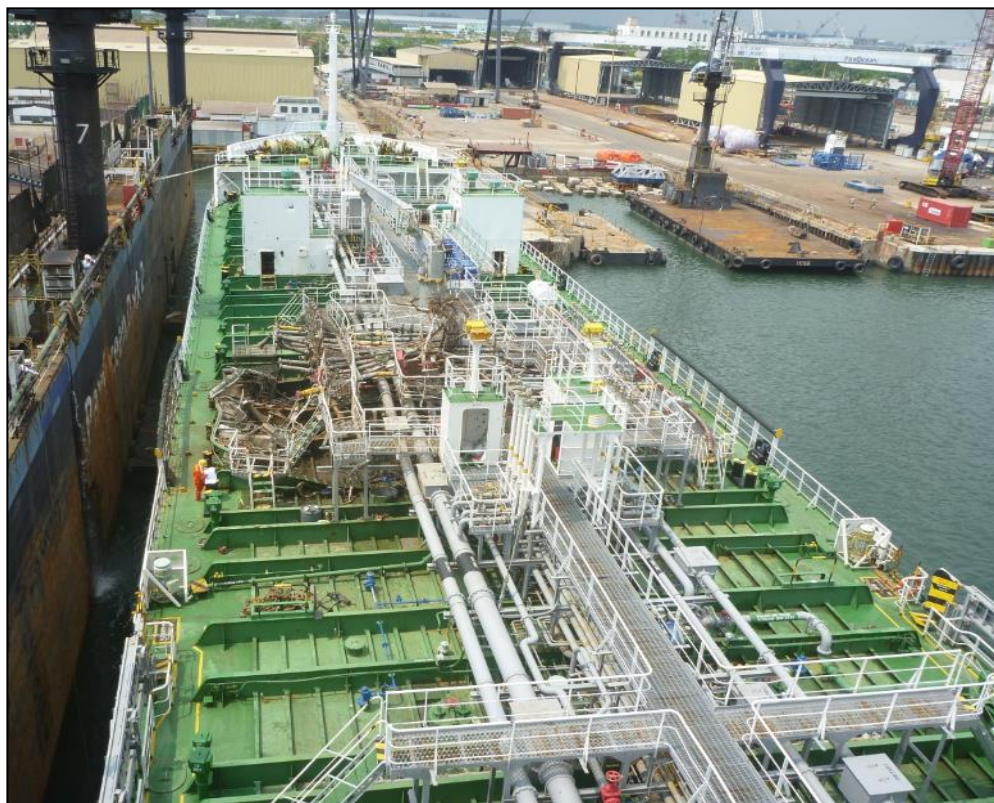
Fig. 2 - Damage of the port manifold

- 4.10 At about 2015 hours, when the *vessel* was sailing in approximate position of 5°30.89'N, 99°56.90'E in Malacca Strait, the OS1 together with OL1 went to open the drop valve of COT No. 8 P to allow washing water to pass through the drop line to the COT No. 8 P for cleaning the pipe lines. Suddenly a violent explosion occurred at port common manifold (Fig. 2).

- (i) The port common manifold was blown to pieces, leaving only a short piece of the aft end at its location. It was obvious that the explosion centre was in the port common manifold (Fig. 4);
- (ii) The main deck and attached structures underneath the port spill tray were buckled (Fig. 5);
- (iii) Windows on the forward bulkhead of the accommodation were holed or shattered (Fig. 6);
- (iv) The forward bulkhead of the accommodation was scattered with holes and mainly on the top part, e.g. the chief engineer's cabin on Captain Deck (Fig. 7); and
- (v) In the COTs No. 5 P&S under the manifold, extensive pitting damage to the bulkhead and bottom plate was found. Furthermore, there was also extensive damage to the heating coils (Fig.8, Fig.9).

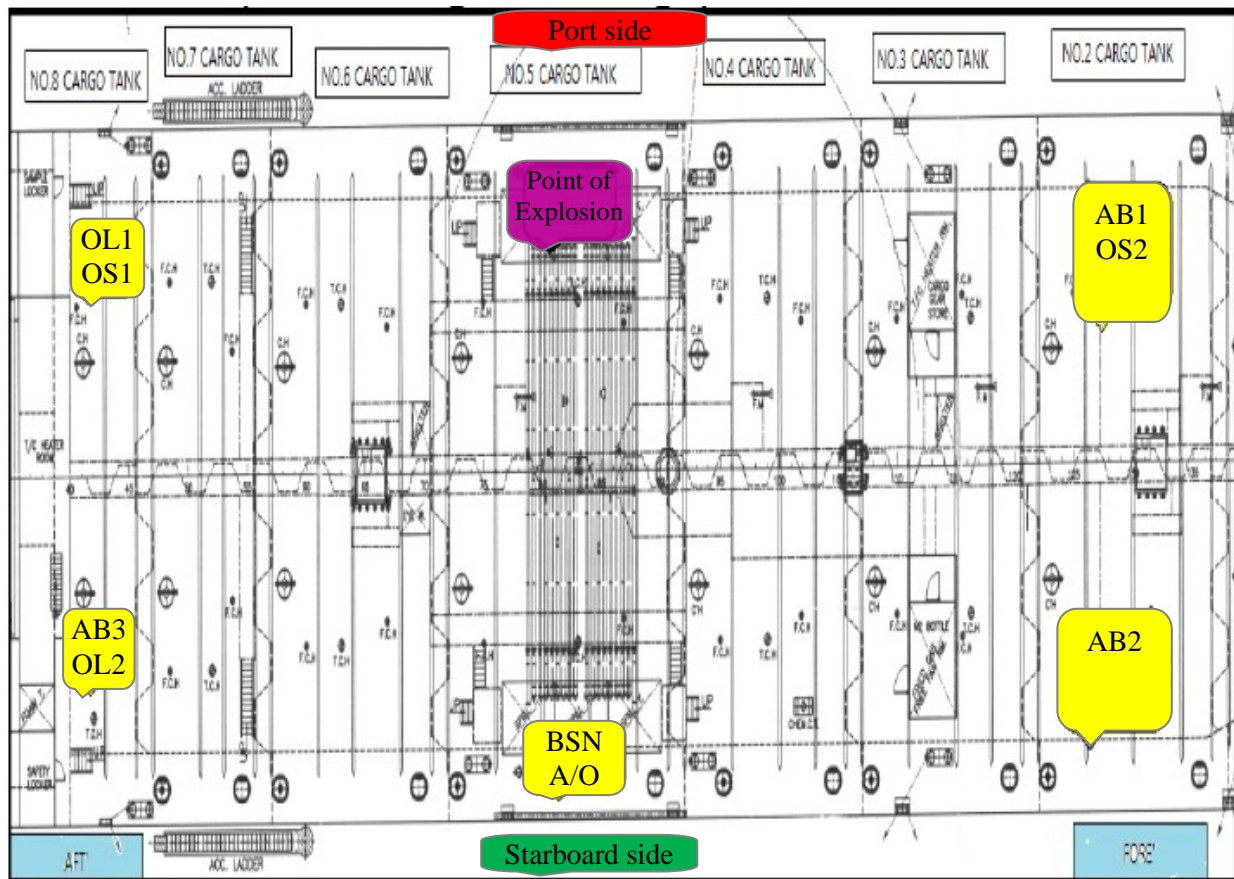
- 4.12 As the result of explosion, 6 out of the 9 crew members on the main deck were injured. The other 3 crew members (i.e. AB1, AB2 and OS2) on the forward deck at the COTs No. 2 P&S were not injured. Their locations on deck at the time of explosion are shown in Fig. 3. At about 2359 hours, the *vessel* arrived and berthed at Penang. At about 0005 hours on 19 April 2016, the shore paramedics arrived on board. The six injured crew members were sent to Seberang Jaya Hospital. However, OL1 was certified dead in the hospital on the same day. The other 5 injured crew members recovered in the hospital and one of them was able to resume his duty on board before the *vessel's* departure.

Fig. 3 - Locations of the crew members on deck at the time of explosion

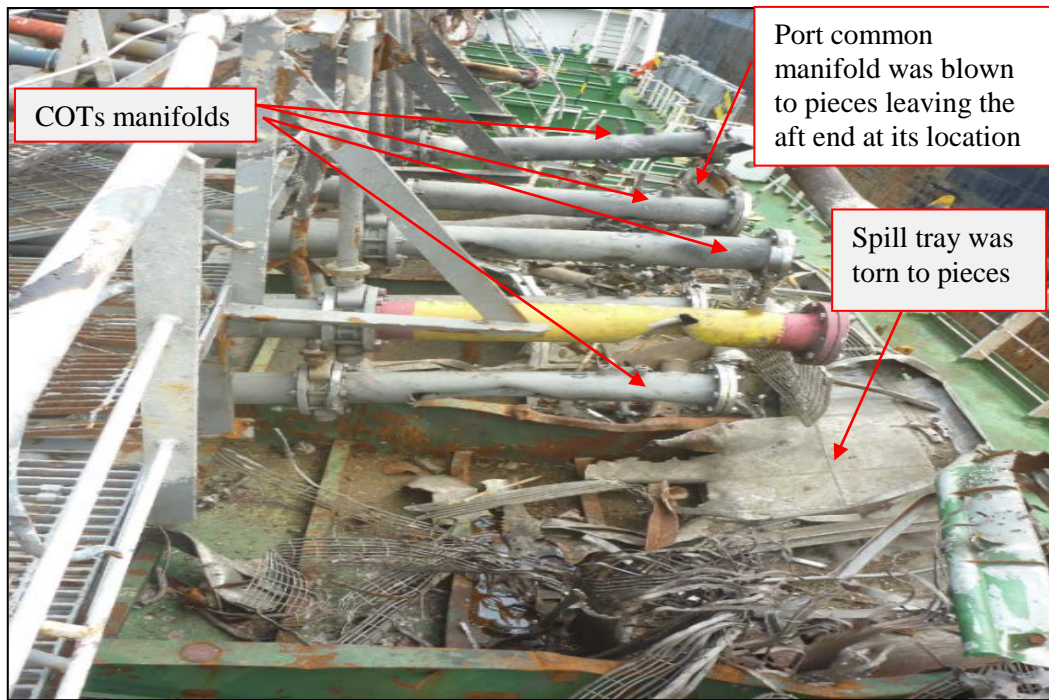
Fig. 4 - Port COTs manifolds at midship after explosion

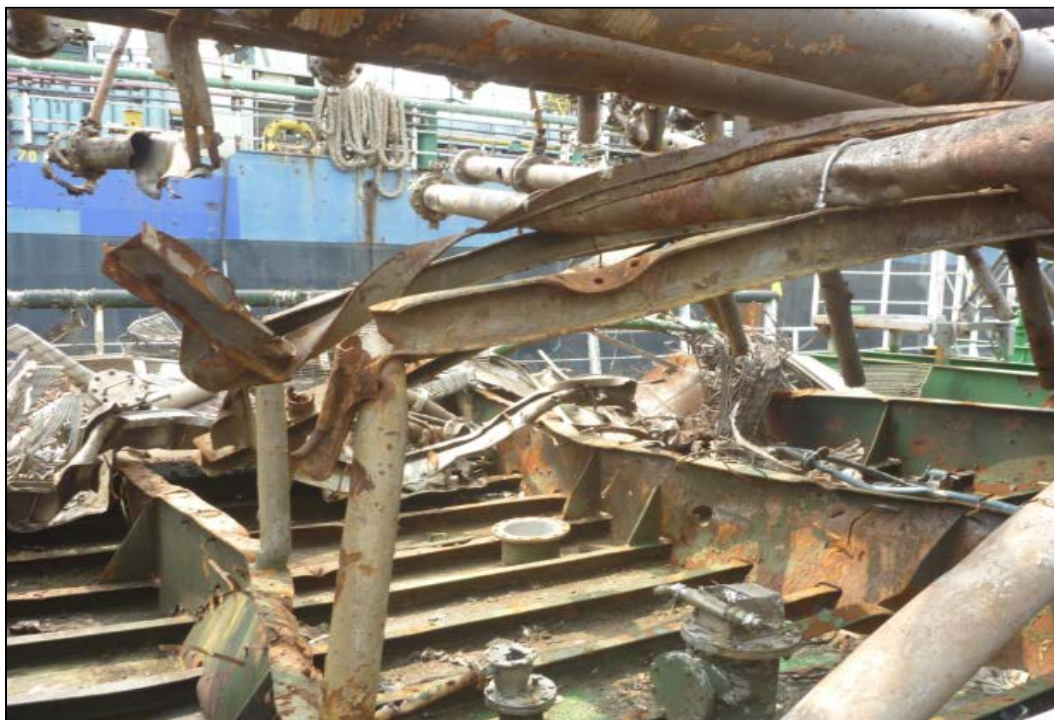
Fig. 5 - Main deck underneath port spill tray

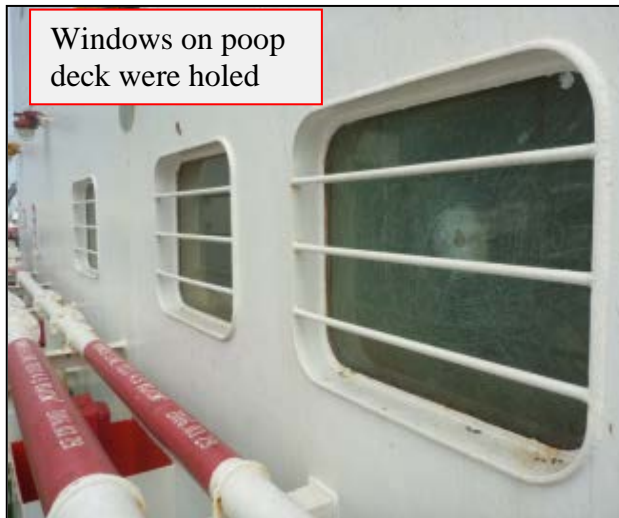
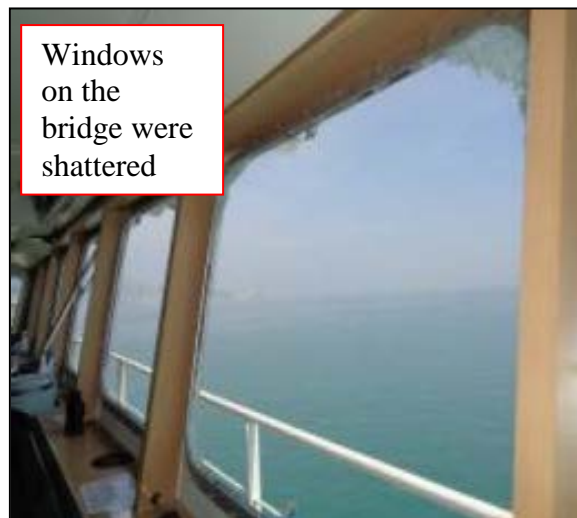
Fig. 6 - Windows on the accommodation forward bulkhead

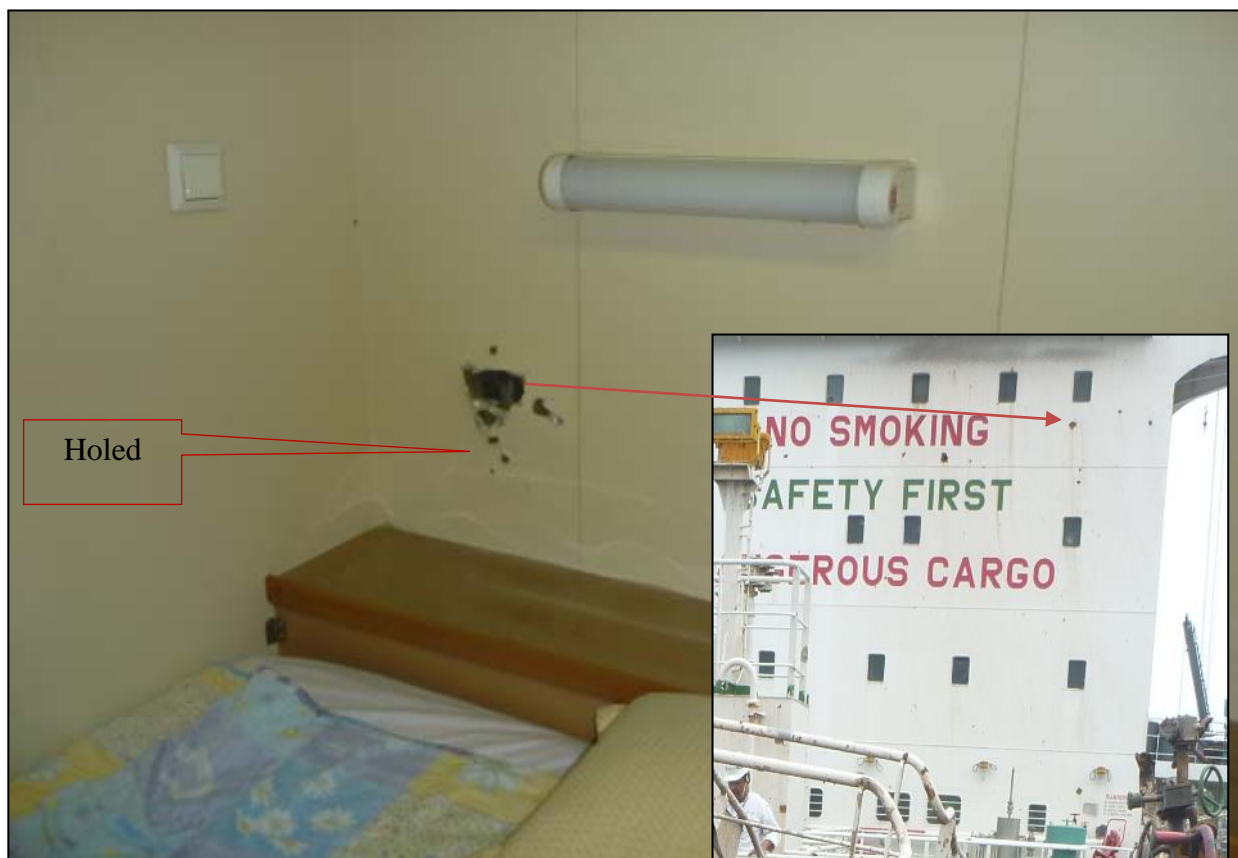
Fig. 7 - Accommodation forward bulkhead in Chief Engineer's Cabin on Captain Deck

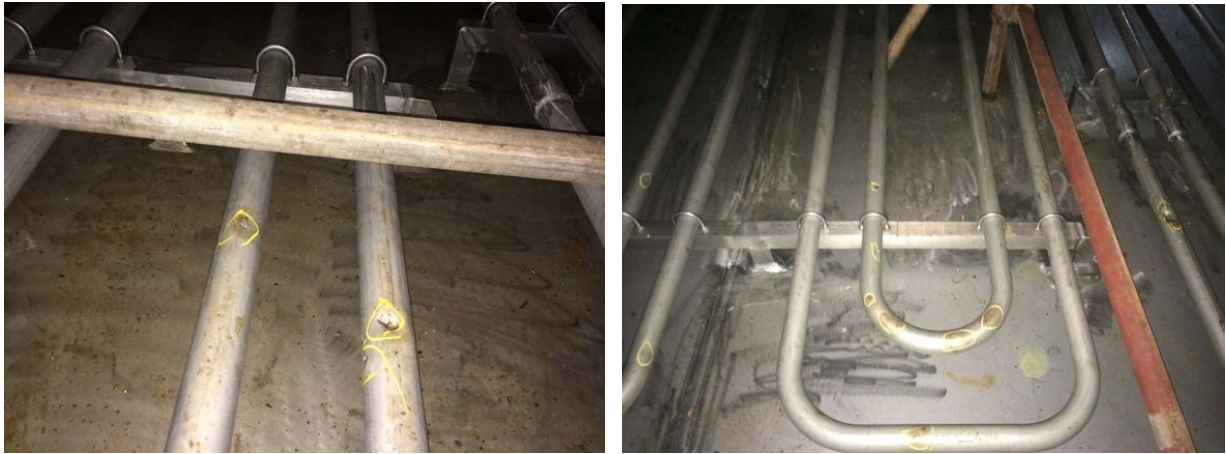
Fig. 8 – Damage on heating coils of COTs No.5 P&S

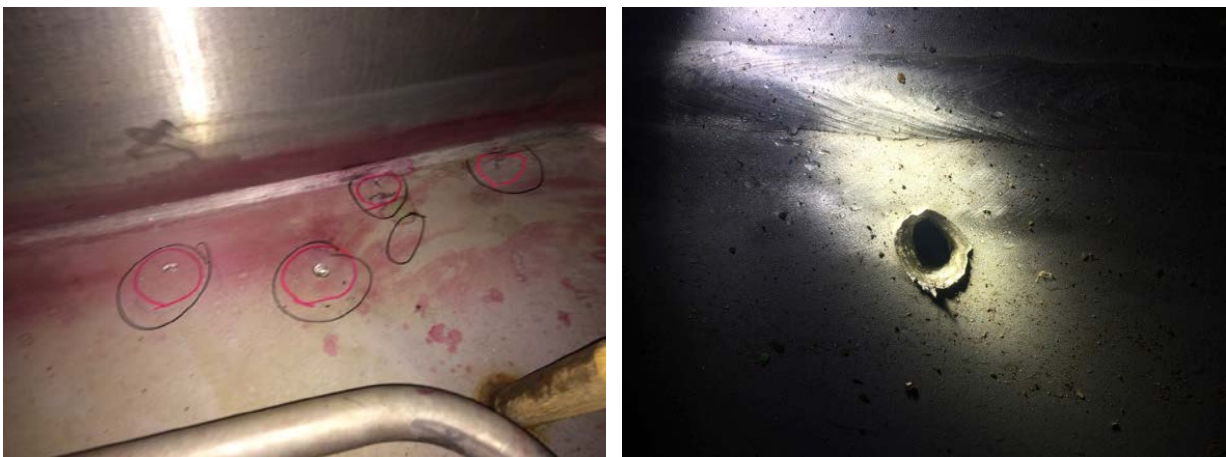
Fig. 9 – Pitting damage on bulkhead and bottom plate of COTs No.5 P&S

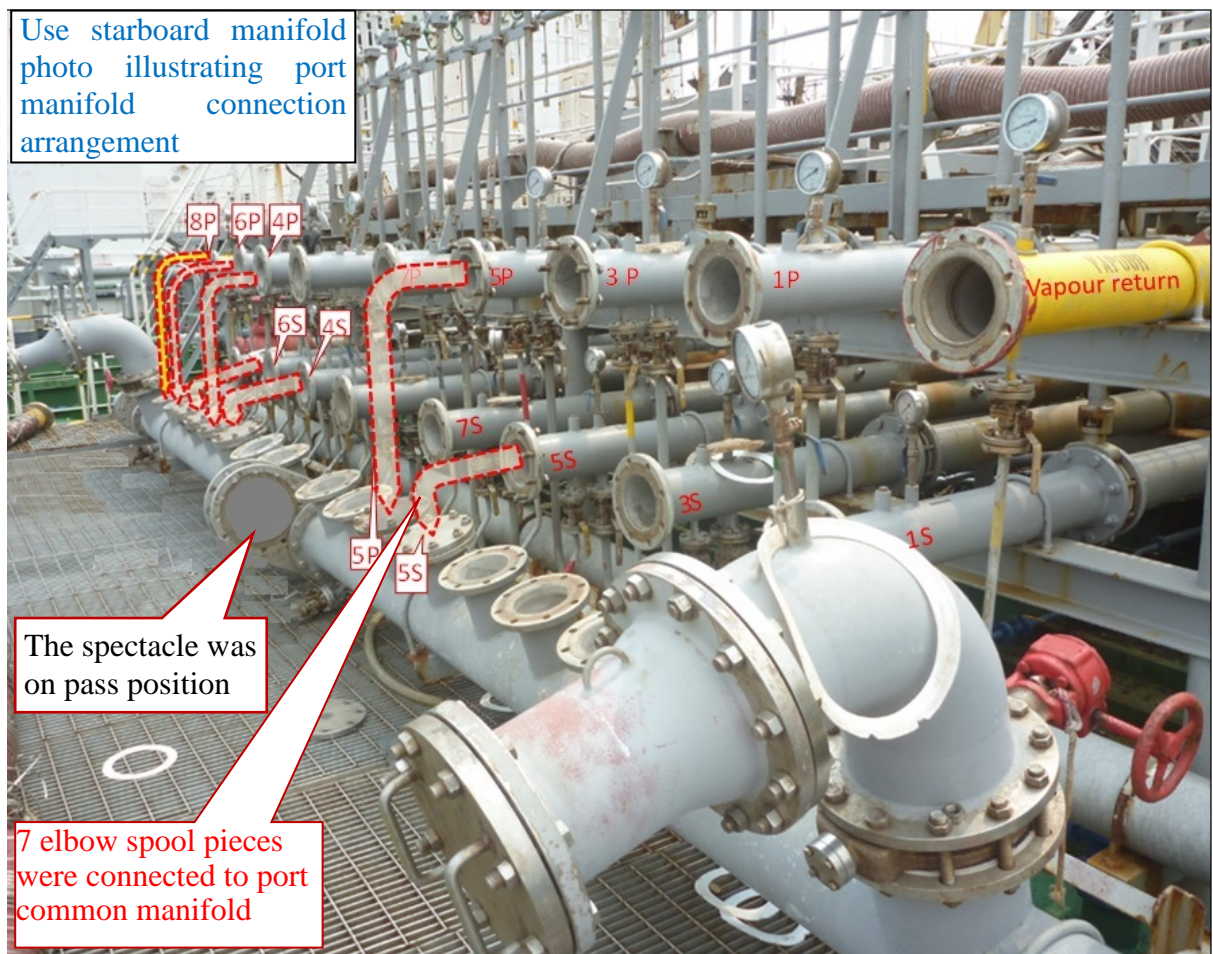
- 5.18 When AB1 used an elbow spool piece to connect the port individual manifold of COT No. 8 P with port common manifold as per the C/O's instruction, the port common manifold was connected with the individual manifold of No. 8P. Since the port side cut-off valve was leaky, any liquid in the individual manifold of COT No. 8 P and/or in the port common manifold could pass through the leaky valve and mix with each other.

Fig. 17 - Illustration of the port common manifold in connection with the manifolds of COTs No. 8P, No. 6 P&S, No. 4 P&S, No. 5 P&S by elbow spool pieces
