**Report of investigation into fatal accident
of an electrical engineer falling into sea
from Hong Kong registered bulk carrier
AMOY PROGRESS
at Ningde City of Fujian, China
on 30 May 2016.**

The Hong Kong Special Administrative Region
Marine Department
Marine Accident Investigation Section

24 May 2019

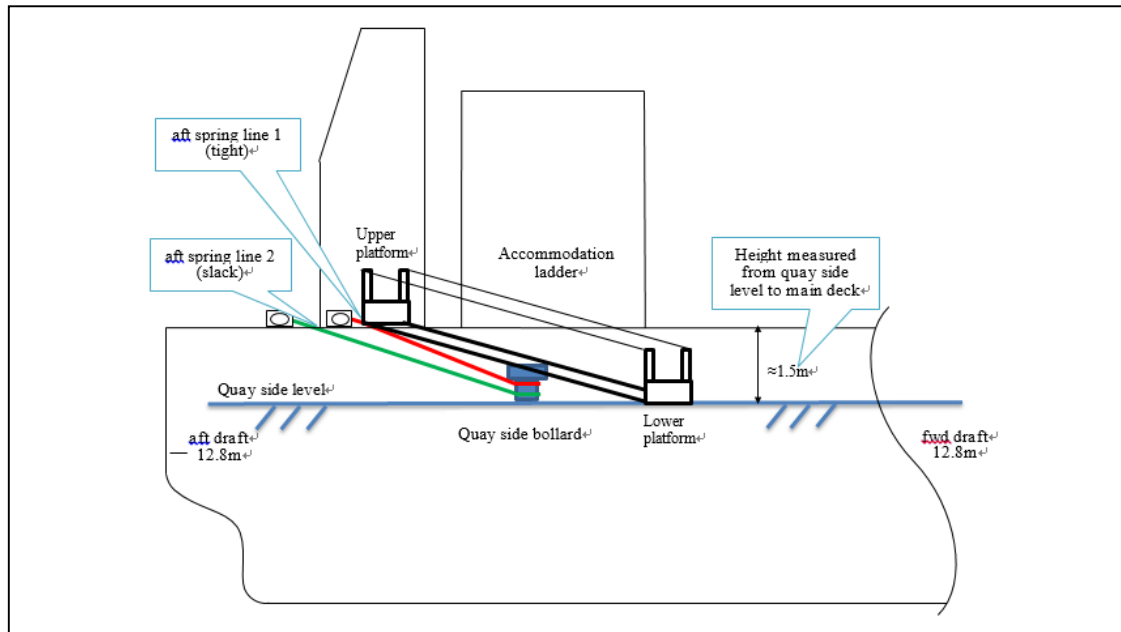
Figure 2: Two aft spring lines

- 4.7 As shown by the surveillance footage, the electrical engineer tried to board the *vessel* by attempting to climb to the upper platform of the accommodation ladder at main deck level from the quayside. The height between the upper platform and the quayside was about 1.5 metres. In the process of the climb, the electrical engineer placed his hands to hold the edge of the platform. His left foot then stepped on the "*aft spring line 2*", followed by his right foot stepping on the "*aft spring line 1*" (Reference to Figure 2). Suddenly the "*aft spring line 1*" slid thus causing the electrical engineer lost his balance

and fell. He failed to grip anything in the fall and dropped into the sea.

- 5.11 There were two aft spring lines (fiber ropes) running between the bollards at the *vessel's* main deck and the quay. The cargo operation and ship movement caused these spring lines stretching from time to time. Initially, one of the aft spring lines was in tension as it was stuck underneath the upper platform of the accommodation ladder. The other one was in slack condition. While the electrical engineer was stepping on these two spring lines, the tensioned spring line was released suddenly from its stuck position and the swinging effect had caused the electrical engineer to lose his balance resulting in falling into the sea.
