**Report of Investigation
into the fatal accident of two stevedores
on board a bulk carrier “PEKIN”
at Humen, China
on 31 May 2016**

The Hong Kong Special Administrative Region
Marine Department
Marine Accident Investigation Section

12 December 2018

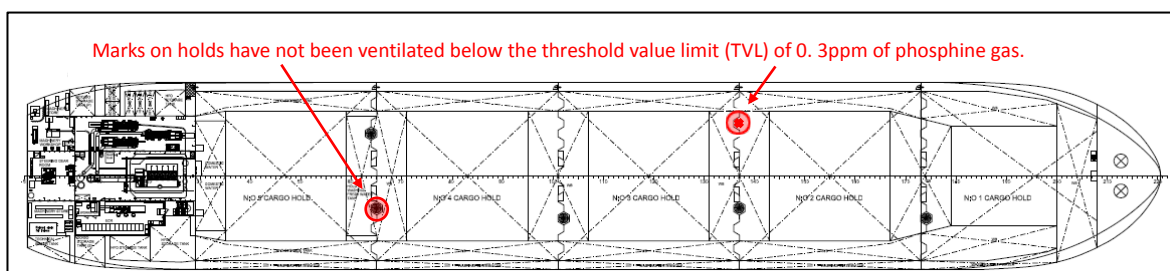
Figure 3 Gas Free Not Certificate Vessel Map

- 4.5 The third check was done by the fumigation officer on 27 May 2016 with traces of phosphine gas detected. Some cargo holds and areas that had not been ventilated to below TVL¹ of 0.3 ppm of phosphine gas were indicated by the fumigation officer on a “Gas Free Not Certificate Vessel Map” (**Figure 3**) with remarks “the concentrations (phosphine gas) will drop below the TVL once all holds are opened.” and recommendation “allow half an hour with holds open before anyone can enter the holds”.

- 5.17 The death medical proof inference indicated that the cause of their death was due to unidentified gas toxication.
- 5.18 The "Gas Free Not Certificate Vessel Map" indicated No.2 and No.5 cargo holds had not been gas freed. No.2 cargo hold and its access hatch were neither opened nor ventilated at the port of Humen. In this regard, No.2 cargo hold was an enclosed space with hazards of oxygen depletion and existence of toxic gas. The measurement of air composition (with results shown in the table of paragraph 4.20) in *the trunk* as conducted by the P&I Club surveyor together with the Chief Officer on 31 May 2016 revealed its fatal air quality. It could be deduced from the death medical proof inference and the air measurement result that oxygen depletion compounded with toxic gas had caused the death of Stevedore B and Supervisor A.

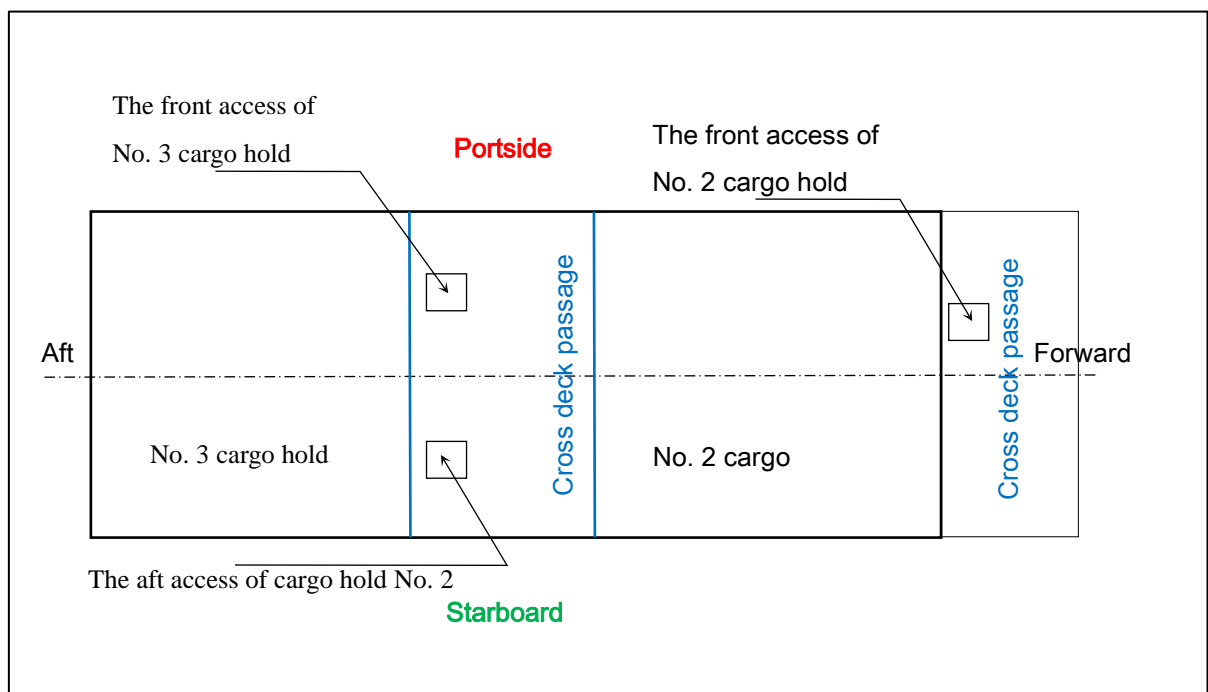
Figure 4 Access trunk arrangements for No. 2 cargo hold

- 5.8 There were two entries for No. 2 cargo hold: one at the portside for front access and the other one was at the starboard side for aft access. The front access of No. 3 cargo hold and the aft access of No. 2 cargo hold (the aft access) were located on the same cross deck passage (**Figure 4**).

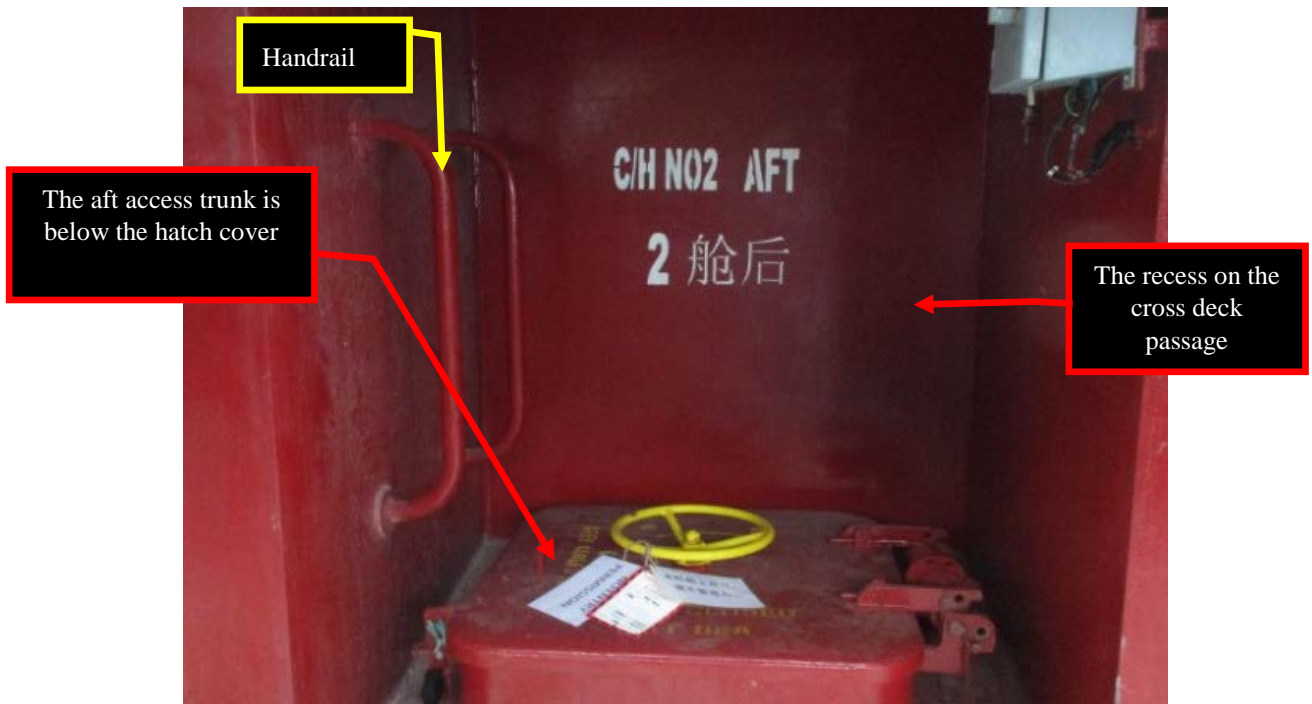
Figure 5 The aft access of No. 2 cargo hold

- 5.9 The entry of the aft access was located in a recess of the corrugated bulkhead (the recess) on the cross deck passage (**Figure 5**). The entry into the No. 2 cargo hold

- 5.14 The last contact with Stevedore B was at about 2356 hours on 30 May 2016 and his contact was lost at 0012 hours on 31 May 2016. It was believed that Stevedore B had mistakenly entered the aft access of No. 2 cargo hold instead of No. 3 cargo hold at about midnight.
- 5.15 It was observed that the aft access to No. 2 cargo hold was neither locked nor posted with any entry warnings (e.g. warning placard or stencils of warning signs) at the time of the accident. As a result, Stevedore B went into No. 2 cargo hold easily, perhaps inadvertently. It was hard to determine if the factor of working for 12 hours day shift work with only about three hours' rest before being called to attend a repair could induce fatigue and thus cause his misjudgment of entering into wrong cargo hold.

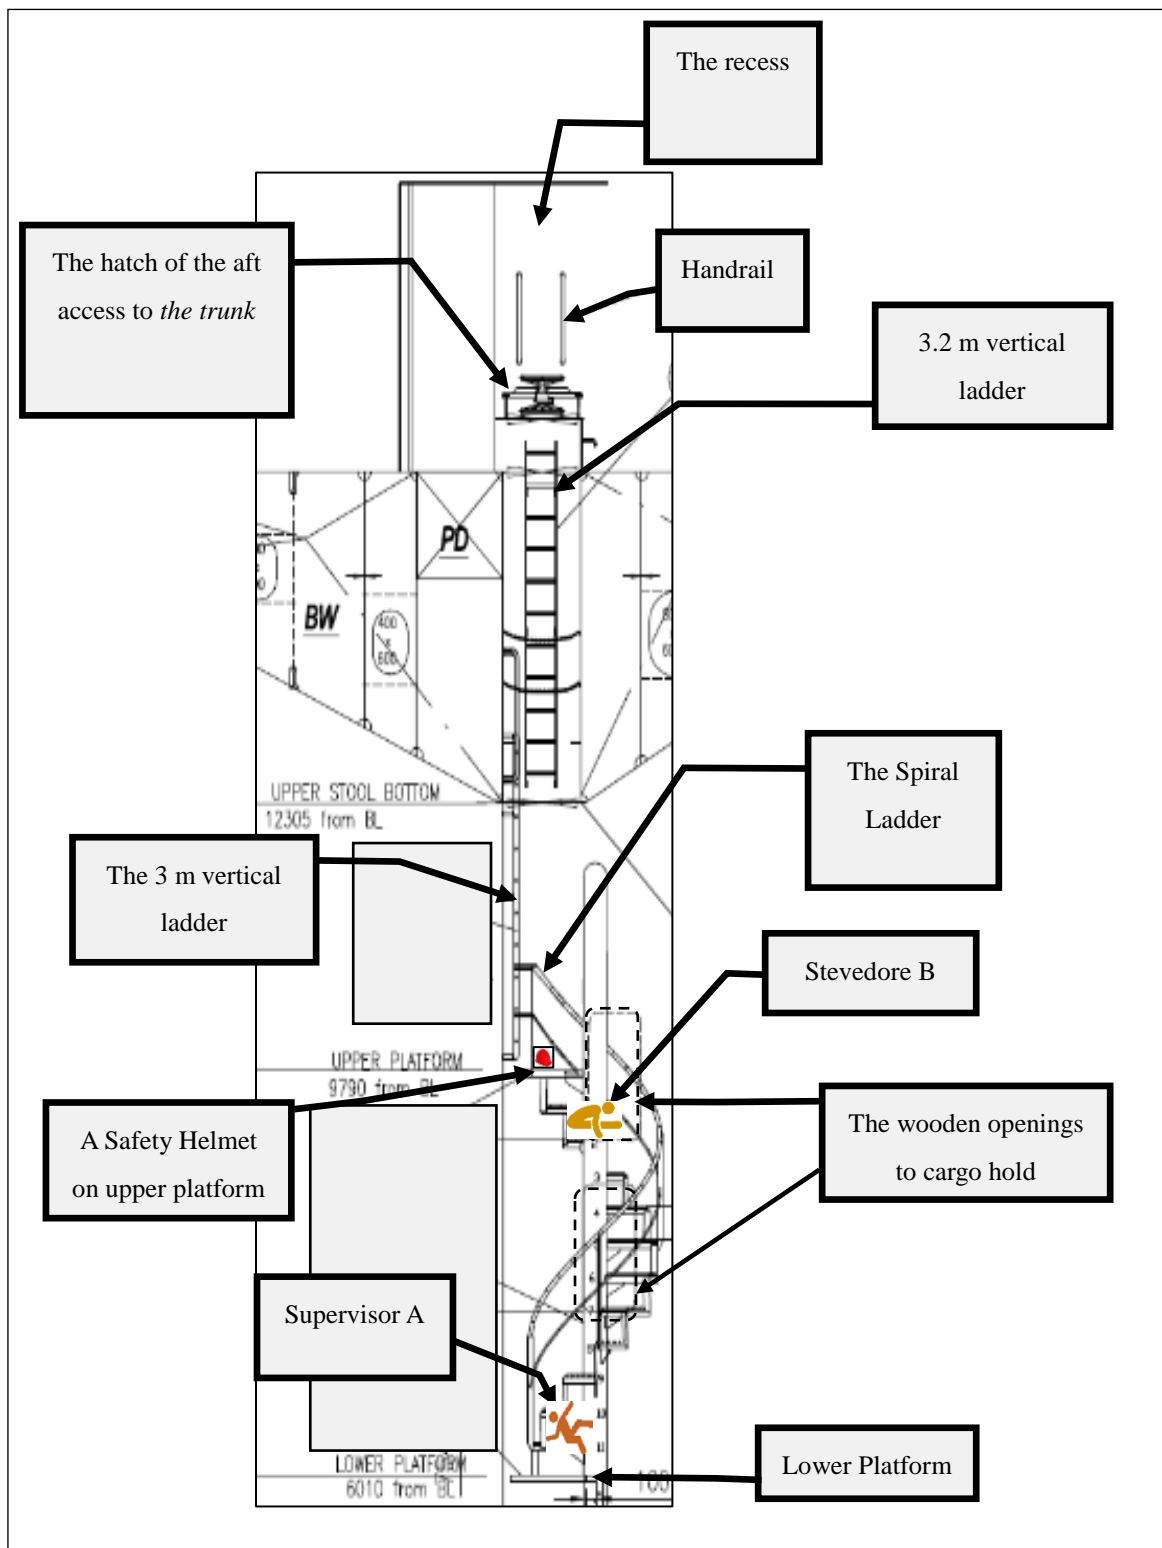
Figure 6 Casualties locations and the access trunk of No. 2 Cargo Hold

Air measurement of aft access trunk of No.2 cargo hold	Oxygen	Carbon Monoxide	Hydrogen Sulfide	Phosphine gas
	5.6%	307 ppm	67 ppm	Not measured
Composition of normal air	20.95%	0.25 ppm	Nil	Nil
TVL (TWA/STEL)	N.A.	35 / 200 ppm	1 / 5 ppm	0.3 / 1.0 ppm

was via a hatch cover and below the hatch cover was *the trunk*. The access of *the trunk* comprised two lengths of vertical ladders followed by a spiral ladder (**Figure 6**). There were two platforms, the upper platform and the lower platform, on the spiral ladder. There were openings with wooden covers inside *the trunk*. The wooden covers were not gas tight and therefore the air quality inside *the trunk* and the cargo hold was more or less the same.

- 5.16 Stevedore B's safety helmet was found on the upper platform and he was lying on the spiral ladder a few steps down from the upper platform. Supervisor A was found on the lower platform (**Figure 6**).
