Report of investigation into  
the fatal accident on board  
Hong Kong registered bulk  
carrier “*Tiger Pioneer*” at  
the North Pacific Ocean  
(49°15.7’N, 159°40.1’W)  
on 24 June 2016

Marine Department

Marine Accident Investigation Section

28 June 2018

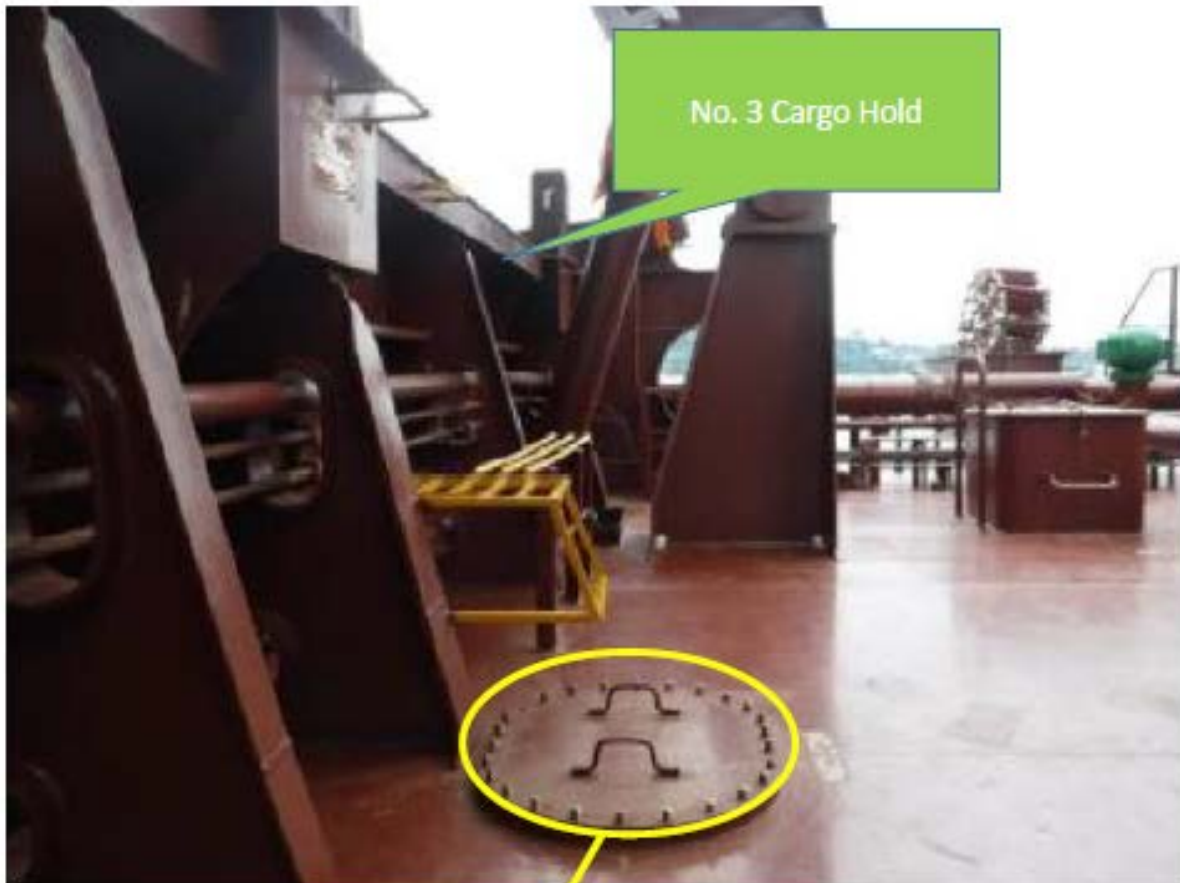
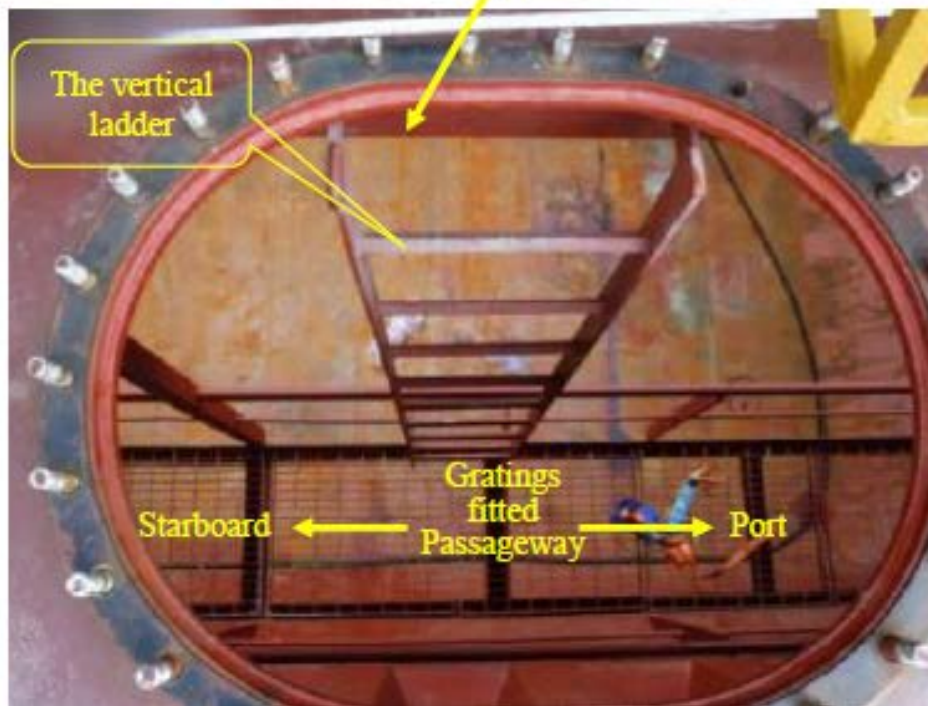
Figure 3 - Entrance manhole on the cross-deck of the Hold hatch forward (view from Starboard side) and birdeye view from the manhole opening

Hold for interior washing. (Figure 2 and Figure 3)

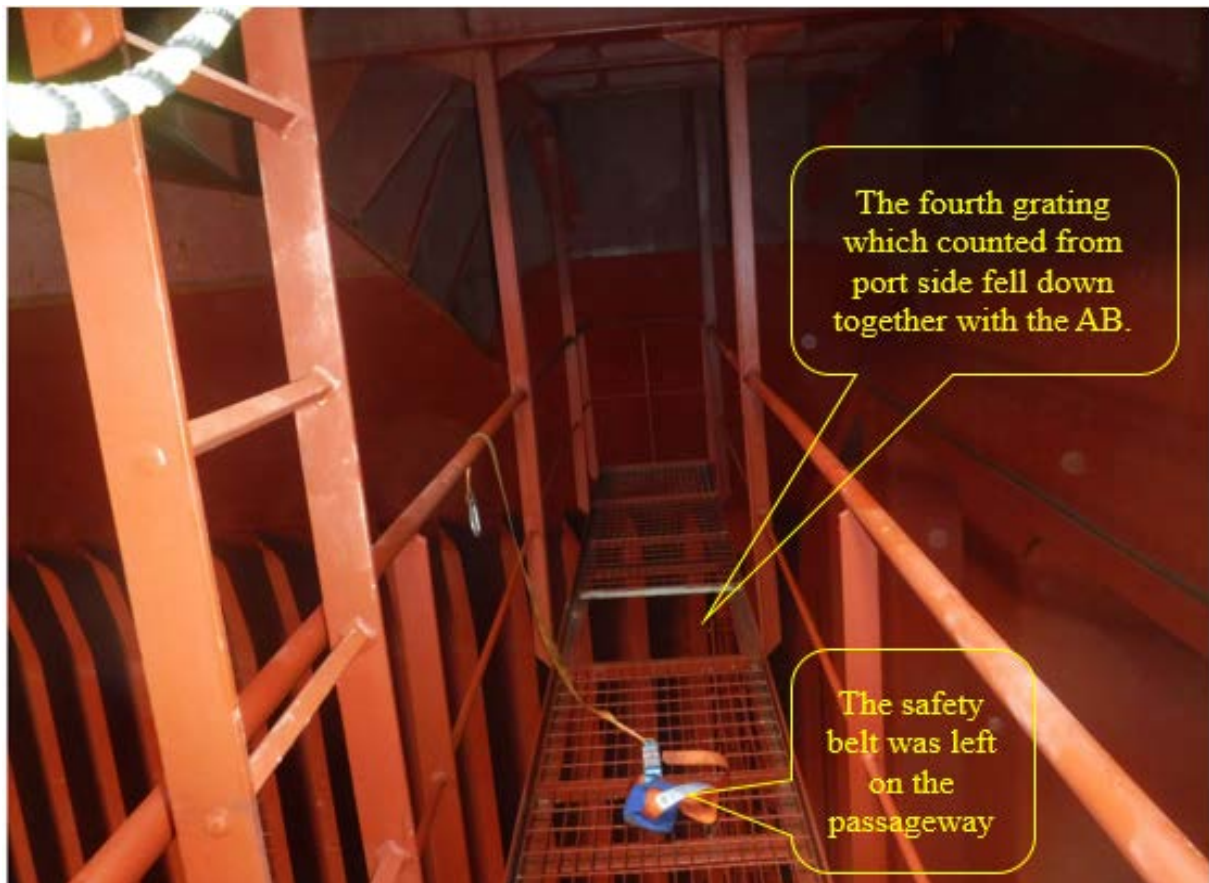
Figure 4 – The passageway on the fore PMA platform in the Hold (view from starboard side)

- 4.8 At about 0840 hours, by climbing down the vertical ladder through the aforementioned manhole, the deceased AB entered into the Hold and stepped on the elevated PMA platform receiving the water gun with hose and safety belt lowered by the two OS on the deck. The AB then brought the water gun with hose with him and walked on the gratings of PMA platform (Figure 4 and Figure 5) to port side but without wearing the safety belt.

- 5.13 The AB wore proper PPE, i.e. a coverall boiler suit, a safety helmet with chin strap, gloves, rain coat and rain boots which were appropriate for working on deck.
- 5.14 When the AB prepared to work inside the Hold for the cleaning operation, a safety belt had been provided for him. Without any reason known, however, the AB did not wear the safety belt as per the requirement of safety control measures stipulated in the risk assessment. The safety belt was just put on the PMA passageway when the AB walked to the port side to commence the washing (Figure 4).

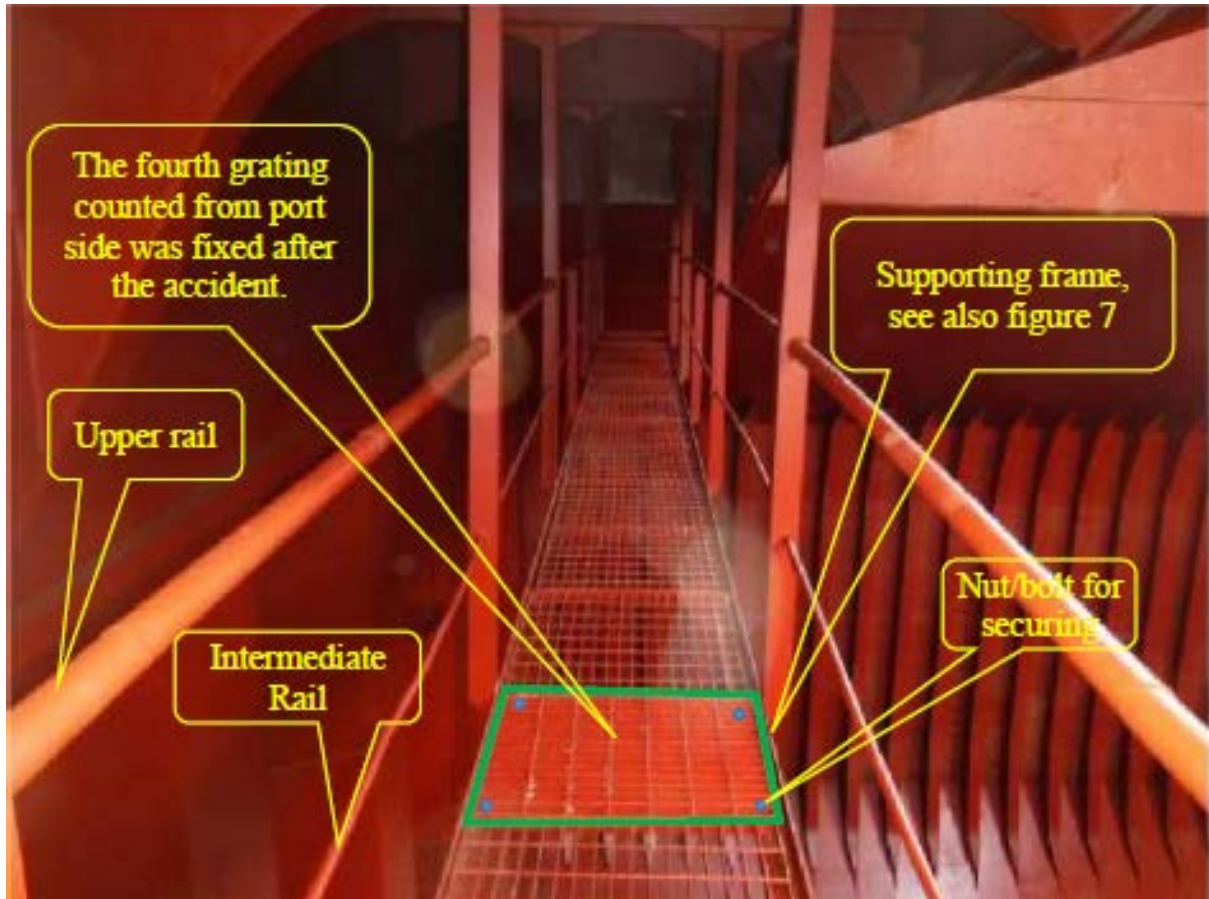
Figure 5 – the passageway on the fore PMA platform in the hold (view from port side)

- 5.16 The PMA platform at about 14.4 metres above the tank top was assembled with guardrails, stanchions and rectangular gratings. The guardrails consisted of an upper rail at a height of 1 metre and an intermediate rail at a height of 0.5 metre. (Figure 5)

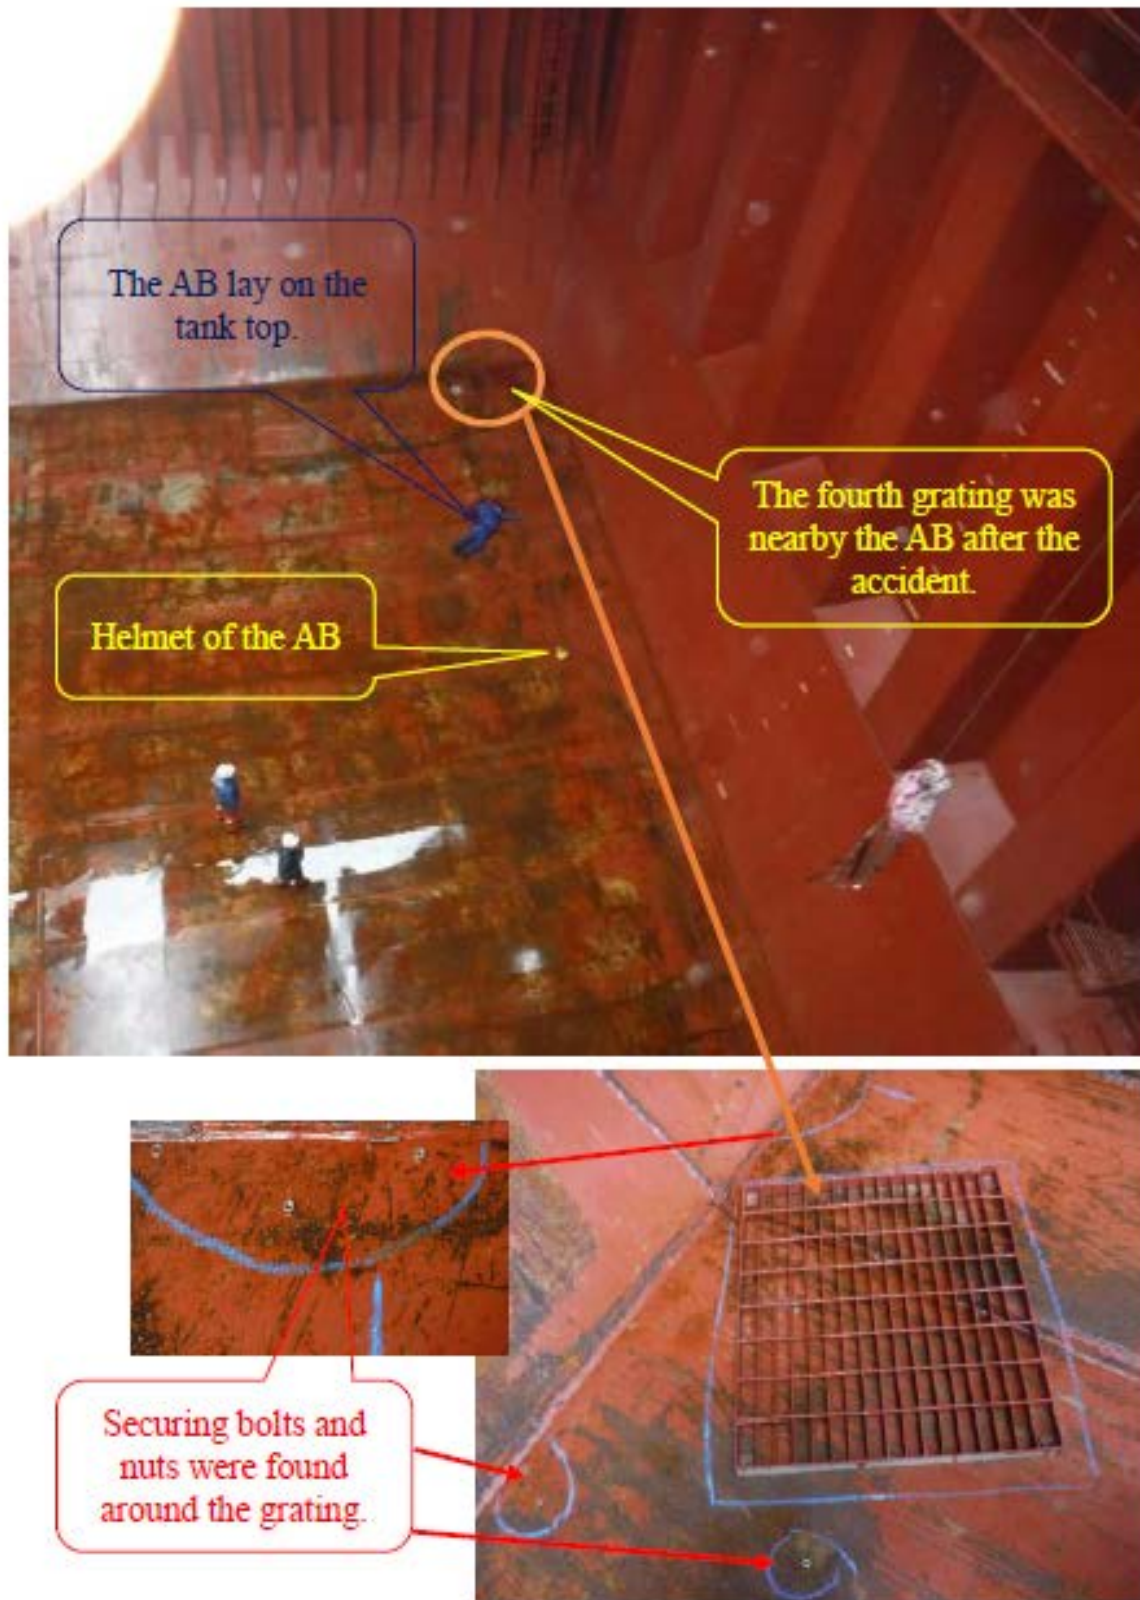
Figure 6 - The on-scene photos after the accident

- 4.9 When the deceased AB stepped on the fourth grating counted from port side, the grating detached from its support frame. As such, the AB lost his balance and, together with the detached grating, fell onto the tank top which was about 14.4m below the PMA platform. The two OS on deck heard a clear clash sound from the Hold. They went to the hatch coaming immediately and found that the AB lay on the tank top (Figure 6).

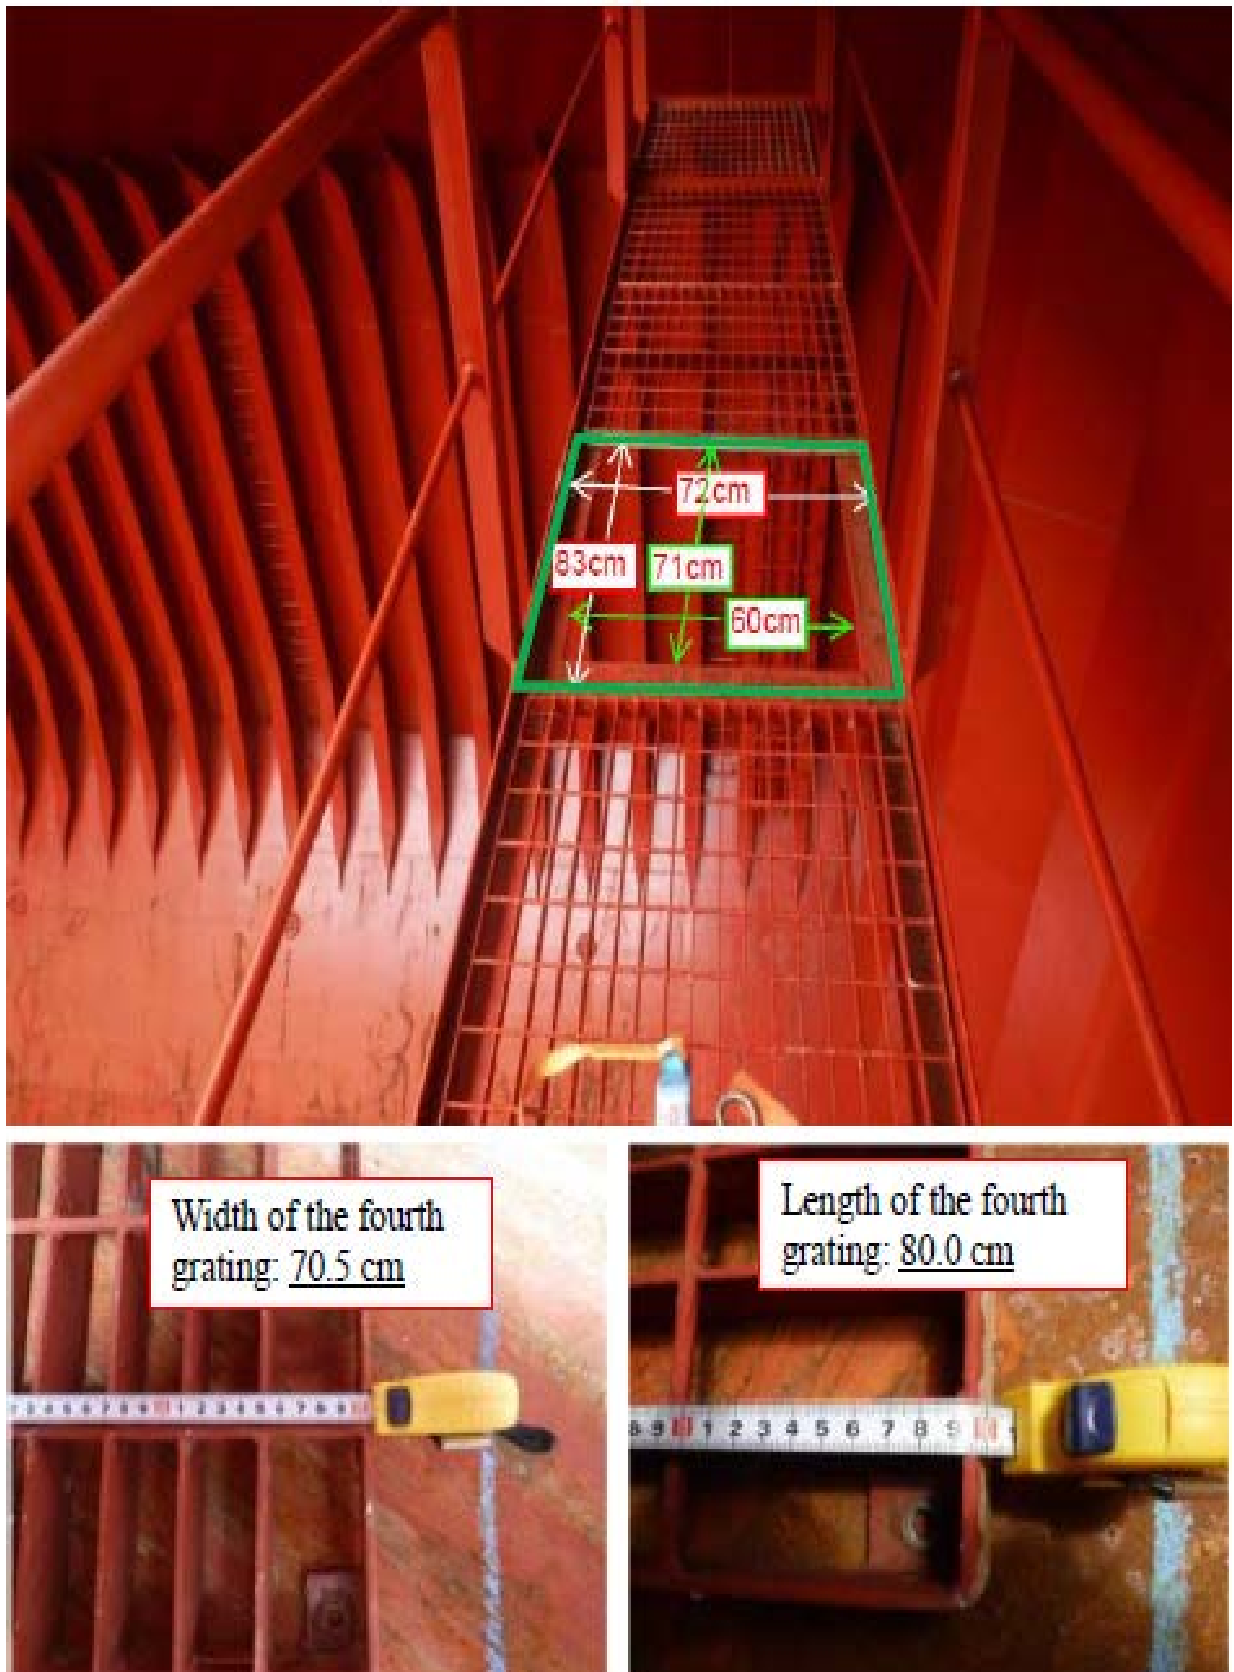
Figure 7 – The measurements of the support frame and the fourth grating

- 5.18 The dimensions of the grating involved in the incident and its support frame and the opening (Figure 7) were as follows:

Length (cm)	Width (cm)	Length of Diagonal (cm)
Grating	<b><u>80.0</u></b>	<u>70.5</u>	106.6
The opening	<u>71.0</u>	60.0	<b><u>93.0</u></b>
Support frame	83.0	72.0	109.8

- 5.19 The design and the securing method of the gratings were in order. However, once the grating is dislocated due to missing of all its bolts and nuts, it might fall down through the opening of the supporting frame or the side edge of the frame.
- 5.20 After the incident, a detailed inspection was conducted to examine all PMA platforms

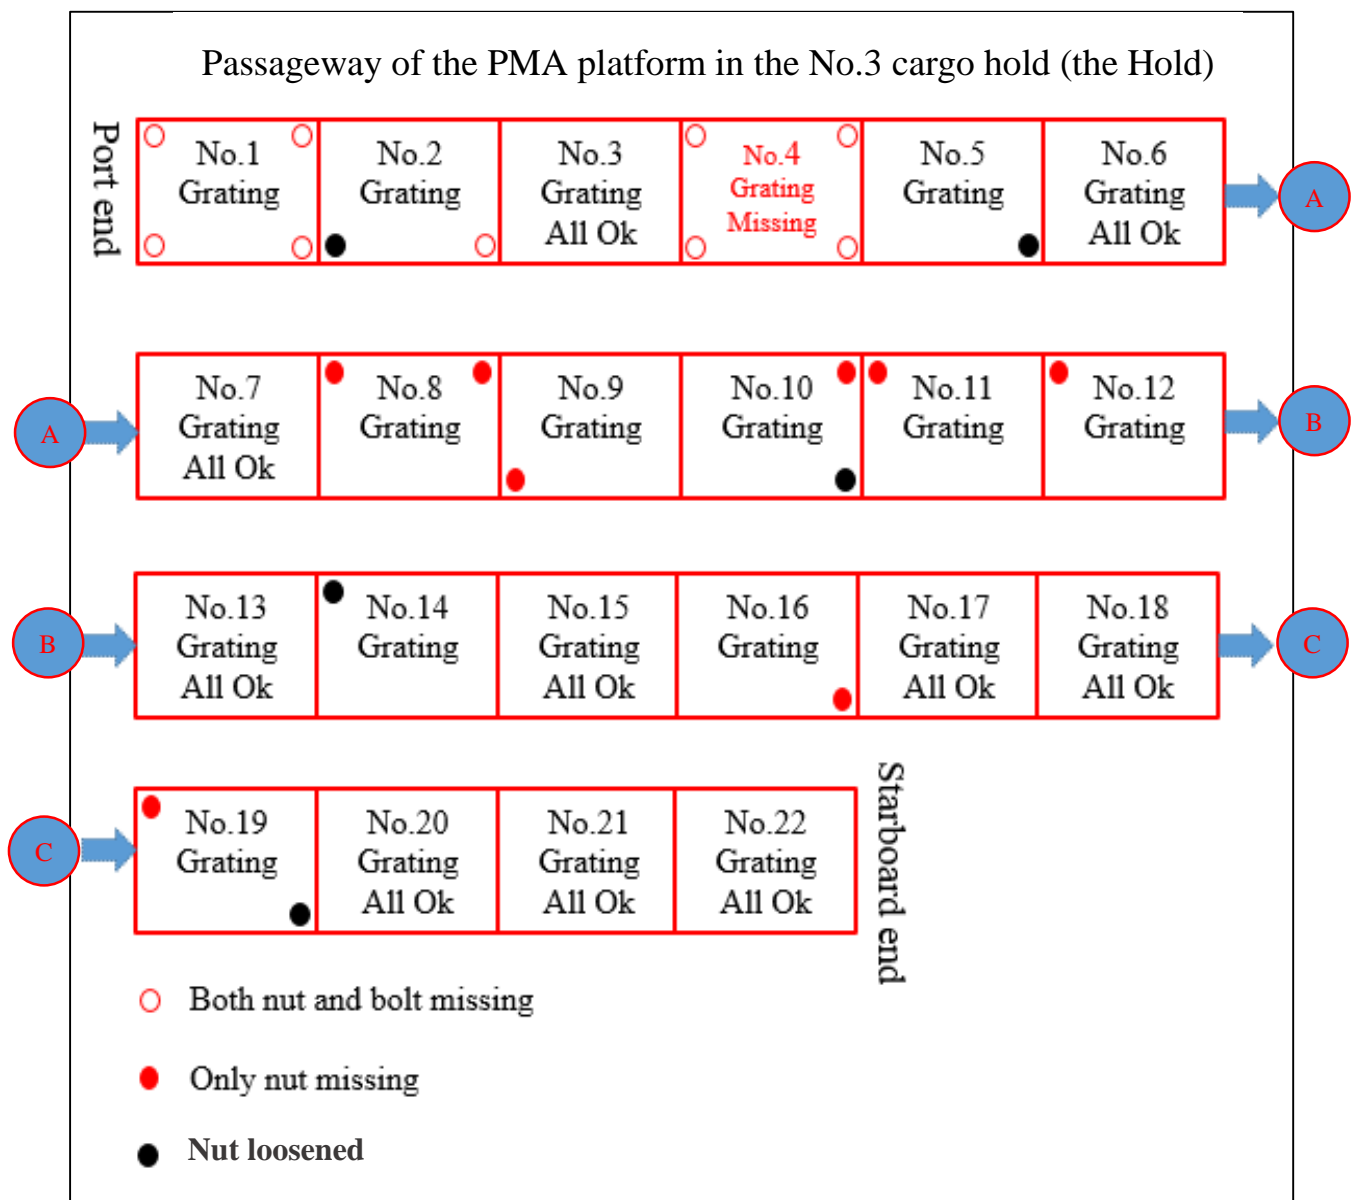
Figure 8 – Sketch to show the condition of the securing bolts and nuts of the gratings on the passageway in No. 3 cargo hold.

in cargo holds. Structural construction of all PMA were found in good condition, but securing bolts and nuts of some gratings were loosened or missing. Figure 8 shows their conditions in the fore end of the Hold and the following table shows the overall inspection results.

Passageway in cargo hold	Number of gratings	Number of nut missing (pcs)	Number of nut loosened (pcs)	Number of both nut and bolt missing (pcs)
No.1 fore	14	3	4	1
No.1 aft	21	1	0	0
No.2 fore	21	13	3	0
No.2 aft	22	1	7	0
<b>No.3 fore</b> (Figure 9)	<b>22</b>	<b>8</b>	<b>5</b>	<b>9 (two gratings with all 4 pieces missing)</b>
No.3 aft	22	10	1	1
No.4 fore	22	1	2	0
No.4 aft	22	0	4	0
No.5 fore	22	0	5	0
No.5 aft	15	0	2	1

- 5.21 From the table shown above, the missing or loosening of grating's securing bolts and nuts of the PMAs in the cargo holds were common, especially in No. 2 and No. 3 cargo holds which were in the midship section of *the vessel*. It could be deduced that the bolts and nuts might be missing or loosening due to ship's vibration. Furthermore, the sea water loaded in the Hold might also slosh over the PMA platform and the gratings during the ballast voyage. These sloshing forces could cause the loosening and missing of the secured bolts and nuts, resulting in the dislocation of the grating from its original position and/or the falling down of the grating from the support frames.

a) establish a procedure in the ship's safety management system manual to ensure that all means of access arrangements including securing devices are regularly inspected and maintained in serviceable condition, especially after loading with ballast water in cargo hold; and
