**Report of the investigation into  
a fatal accident on board  
*“Seaspan Expeditor”*  
at Western Anchorage No.3,  
Hong Kong  
on 17 August 2016.**

The Hong Kong Special Administrative  
Region  
Marine Department  
Marine Accident Investigation Section

15 November 2018

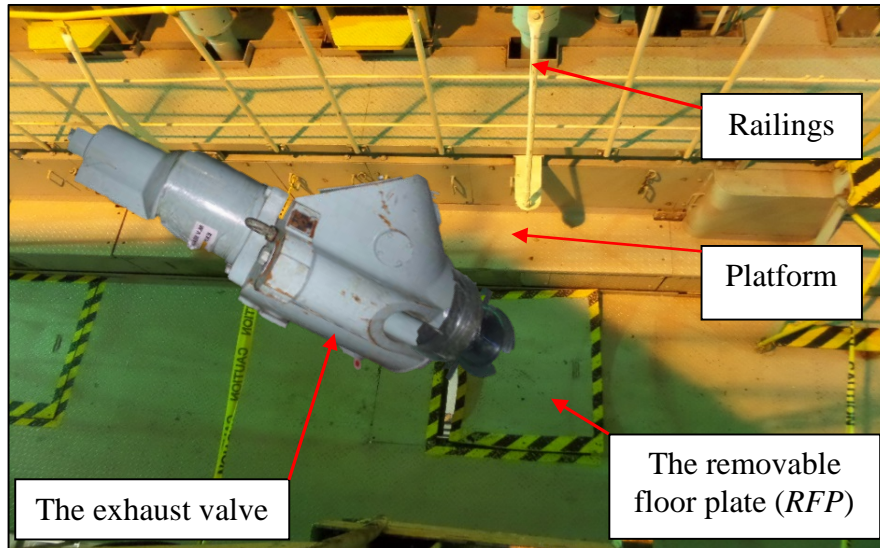
Figure 2: Illustration of the toppled exhaust valve

- 4.7 The fitter guided the second exhaust valve to land on a *RFP* and then released the hoisting hook. Upon the hoisting hook was released, the *RFP* was deformed and the exhaust valve toppled, striking the fitter at his left abdomen causing serious injury (Figure 2).

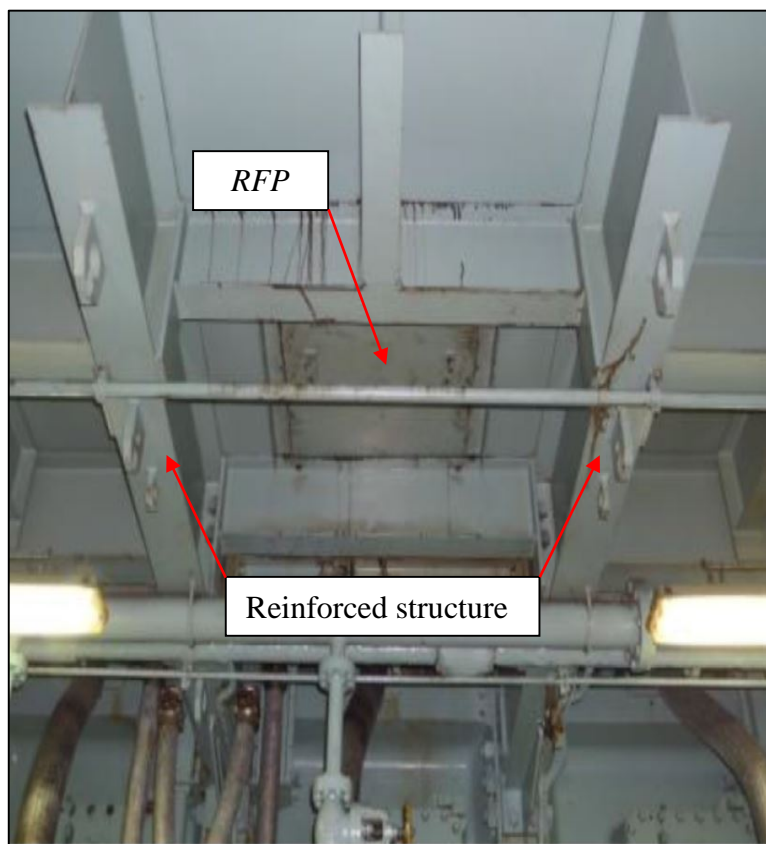
Figure 3: Supporting framework underneath the *RFP* (looking upward)

- 5.7 A box-shaped reinforced structure platform (Figure 3) was provided in the engine room to stow cylinder heads and piston rod complete. A *RFP* with size about 800 mm in square length and 6 mm thick plating was fitted on the platform as the access for the piston rod complete to pass through (Figure 4). The *RFP* should have been fixed to the underneath supporting framework of the platform by securing screws but these securing screws were missing at the time of the incident. Warning stripe around the *RFP* was marked in conspicuous color and pattern to distinguish it from the surrounding floor plates (Figure 5).

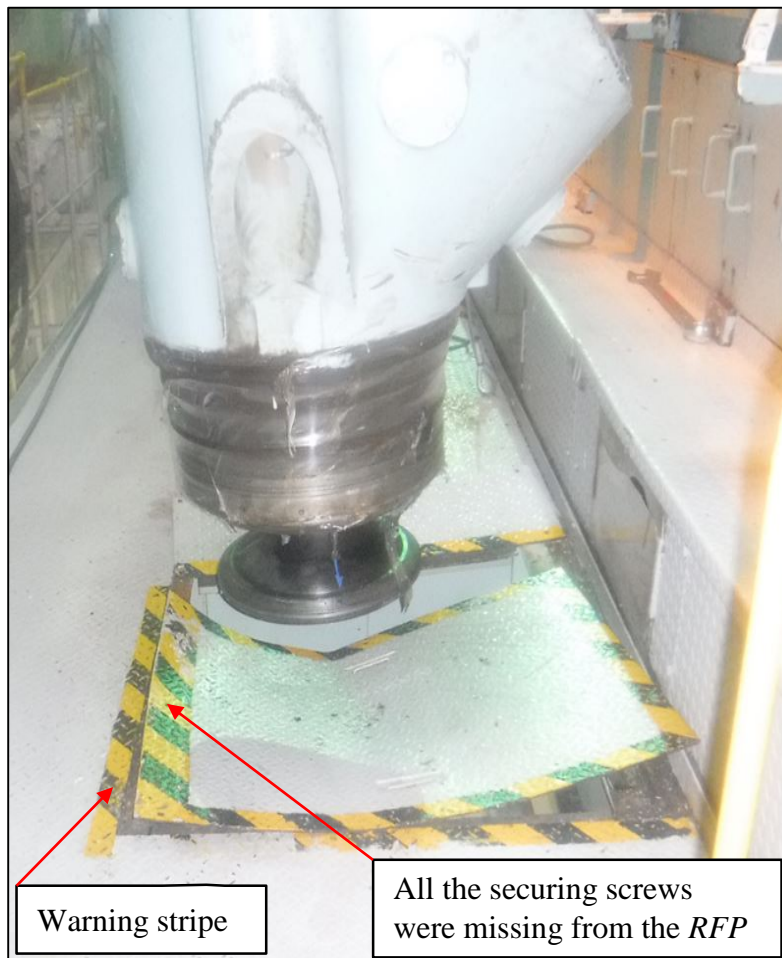
Figure 5: The deformed *RFP* with exhaust valve illustrated on it

- 5.8 As stated in the above paragraph, the *RFP* was the access for the piston rod complete to pass through but was not meant for the use as a landing place to support heavy object such as the exhaust valve which was about 3 tonnes in weight. Placing the exhaust valve on the *RFP* would undoubtedly deform the *RFP* causing the exhaust valve overbalanced and toppled.

- 6.3 The investigation identified that the main contributory factor to this incident was due to the *RFP* being overloaded by the exhaust valve. The 6 mm thick *RFP* was designed as an access cover for piston rod complete and was not meant for the use as a landing platform to support an exhaust valve of 3-tonne weight. As a result of the overloading, the *RFP* deformed thus toppled the exhaust valve crushing the fitter to death.

- 7.1 The management company of *the vessel* should issue a safety circular to inform all masters, officers and crew of the findings of this investigation, and remind them : -
- (a) to carry out proper risk assessment and / or toolbox talk in order to identify any potential safety hazards and implement appropriate safety measures to eliminate the risk of dangers when handling heavy machinery parts; and
  - (b) to maintain good housekeeping of the engine room in accordance with the “*Code of Safe Working Practice for Merchant Seafarers*”, i.e. floor plates or gratings should be properly secured.
- 7.2 A Hong Kong Merchant Shipping Information Note should be issued to promulgate the lessons learnt from the incident.

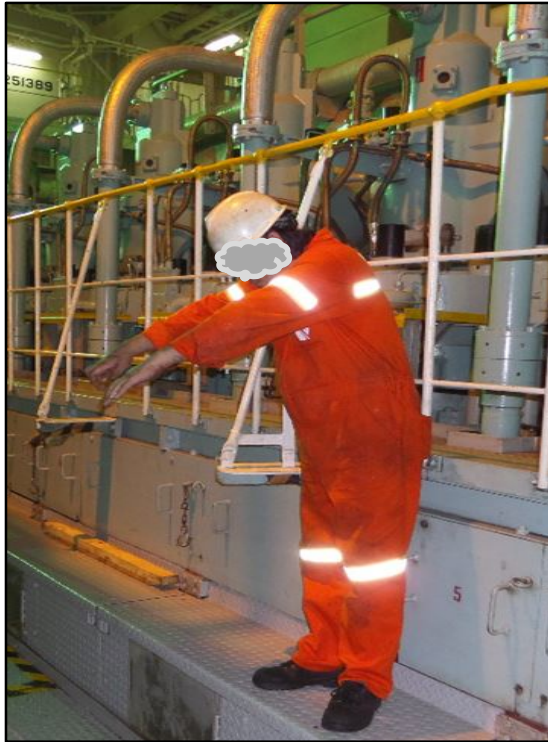
Figure 6: Illustration of the standing position of the fitter

- 5.11 The investigation also revealed that when the exhaust valve was landing onto the engine room platform, the fitter was standing at a position without much room to retreat in emergency (Figure 6). Should the fitter work in group with the second engineer, he might be given with prior warning of not standing at a position with limited room to escape in emergency.
