**Report of investigation into  
the fire accident on board Hong  
Kong registered bulk carrier  
*“Fortune Harmony”*  
at Montevideo anchorage,  
Uruguay on 22 September 2016**

The Hong Kong Special Administrative Region  
Marine Department  
Marine Accident Investigation Section

28 October 2019

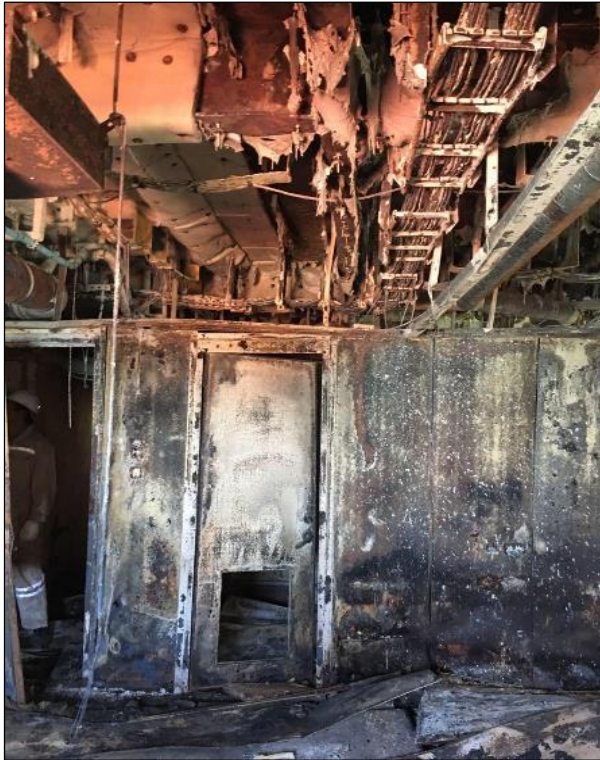
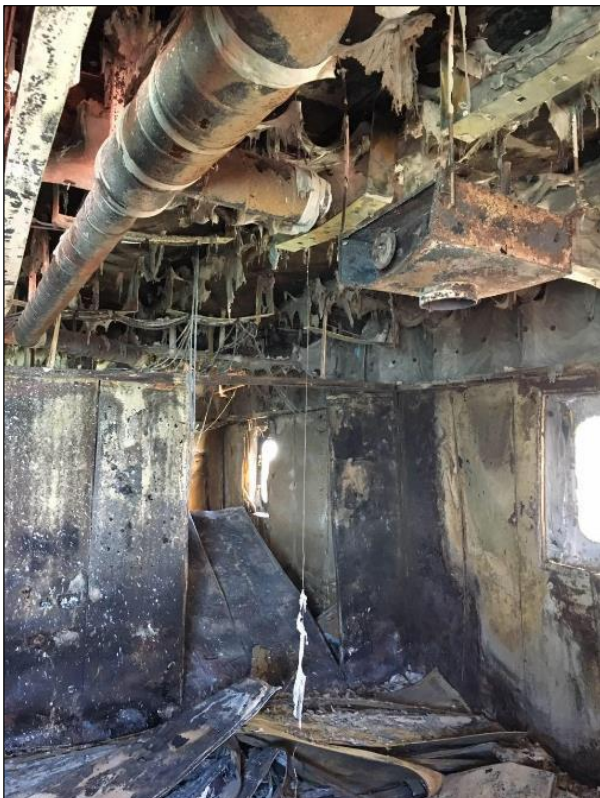
- (a) All the cabins on D-deck including the cable trunks, cable wirings, electrical distribution boxes and air vent ducting were burnt out (Figure 4).

D-deck officer cabin

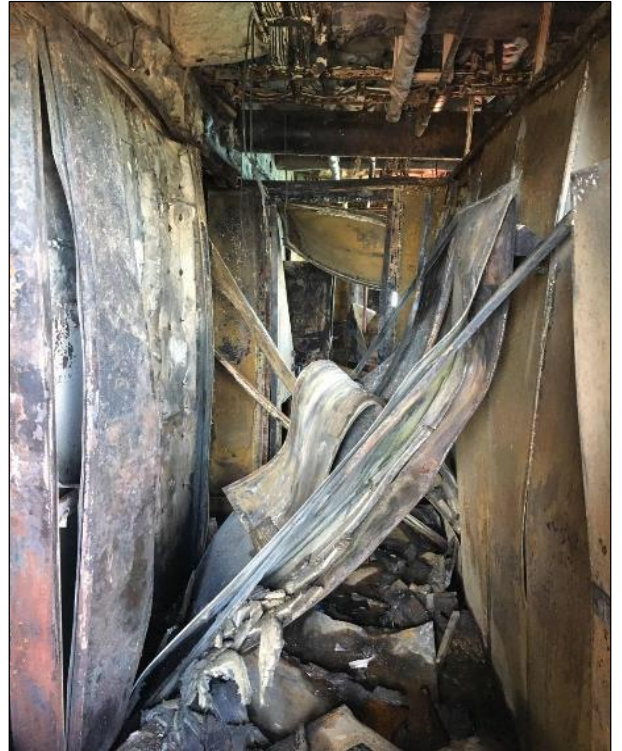
D-deck corridor

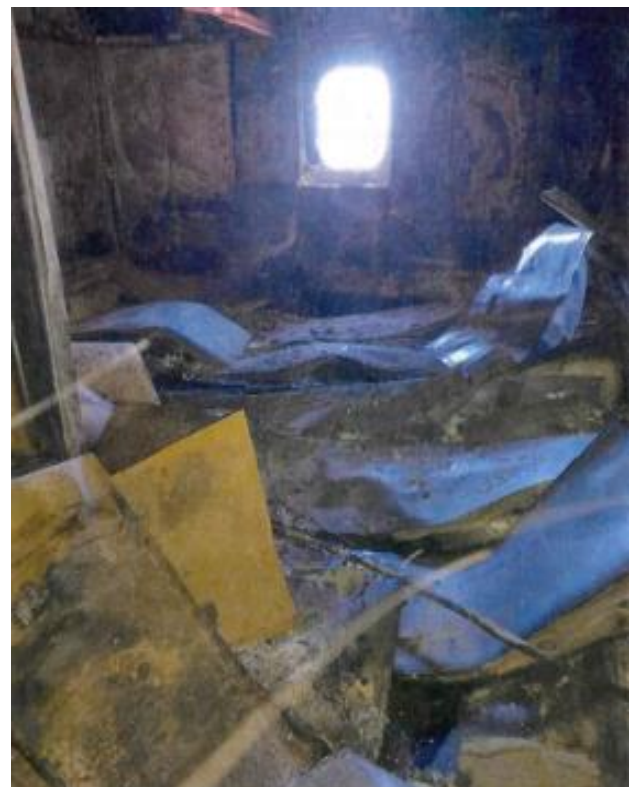
3/E Cabin

- 5.2 The investigation revealed that the fire was most probably caused by faulty electrical equipment/device or its accessories in 3/E's cabin which caused short circuit, heat and sparks to ignite the materials beside it.

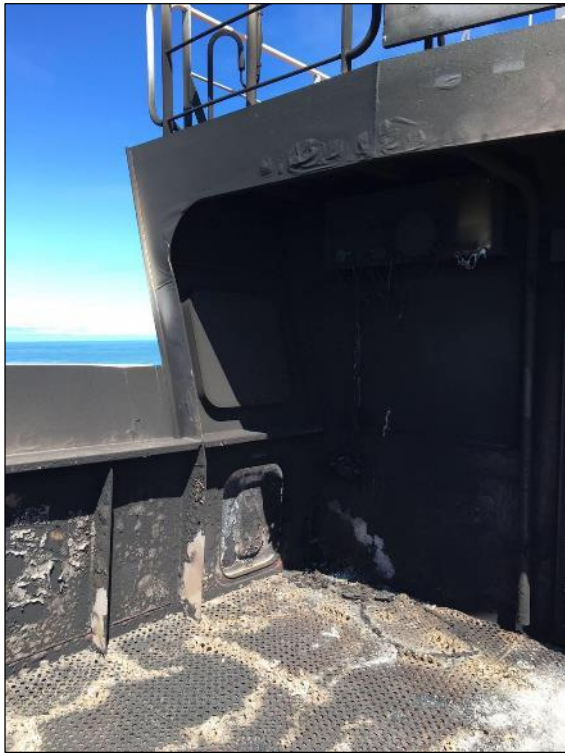
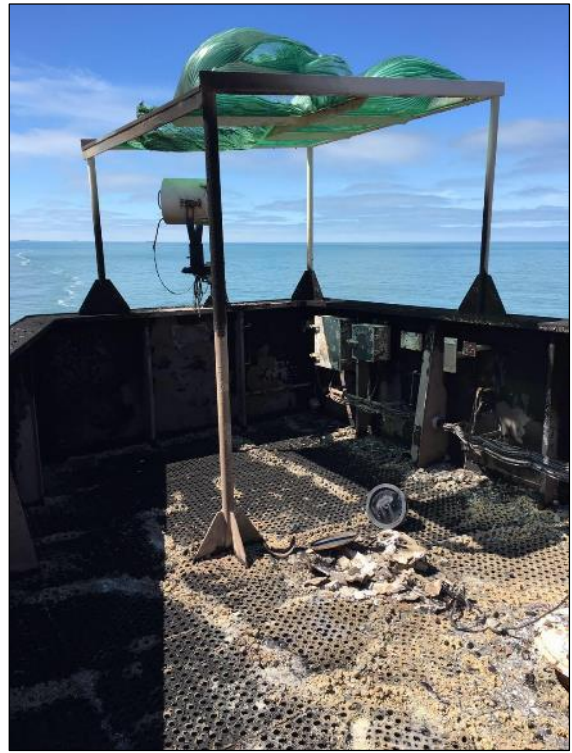
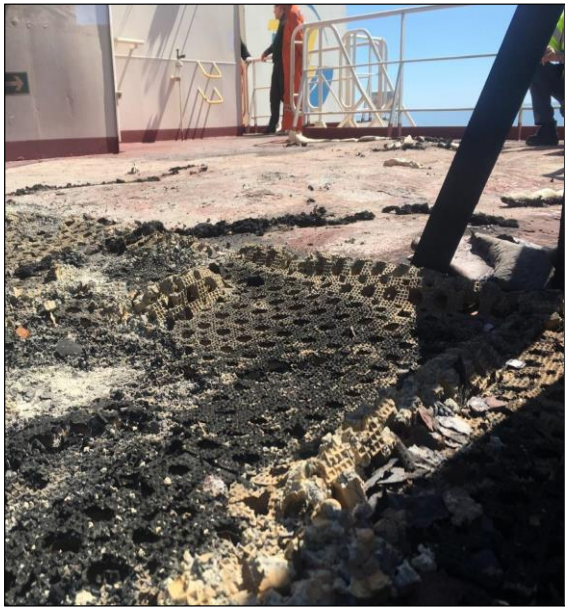
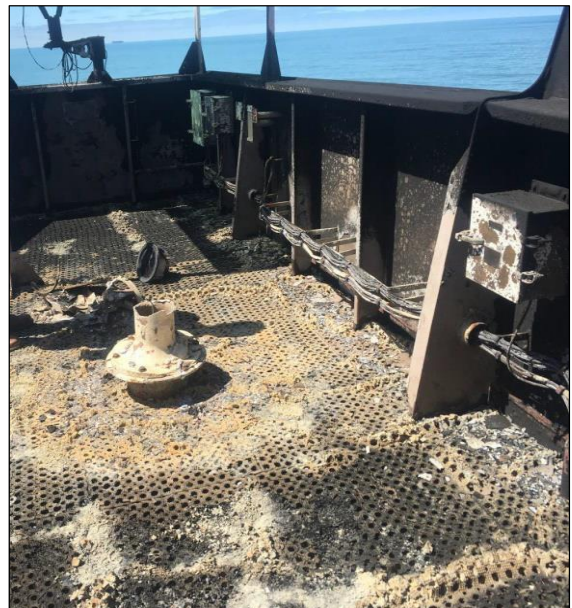
Figure 5 Burnt out of bridge wings

- (b) The bridge wings were affected (Figure 5). The gyro repeaters, rpm indicators for main engine, rudder indicators, EPIRB, MOB lifebuoys and VHF radio, ALDES light socket etc. installed on the wings were damaged.

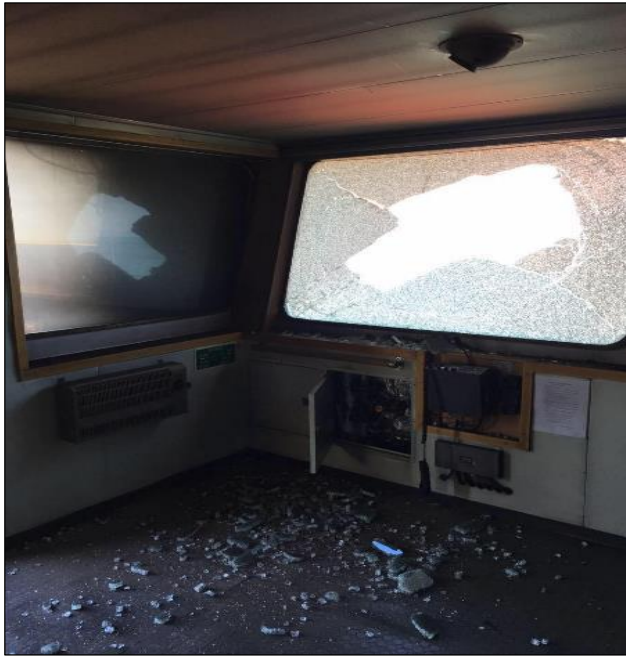
- (c) Two Inmarsat-C printers and a facsimile machine in the bridge near the bridge side doors were affected by the radiation of fire through the side doors. Some of the forward windows were broken or deformed (Figure 6).

Damage of front window

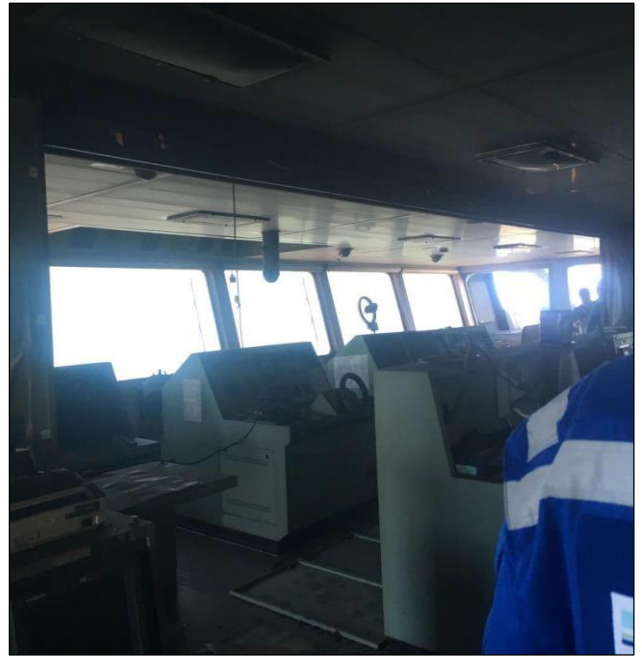
Fume smoke navigation bridge

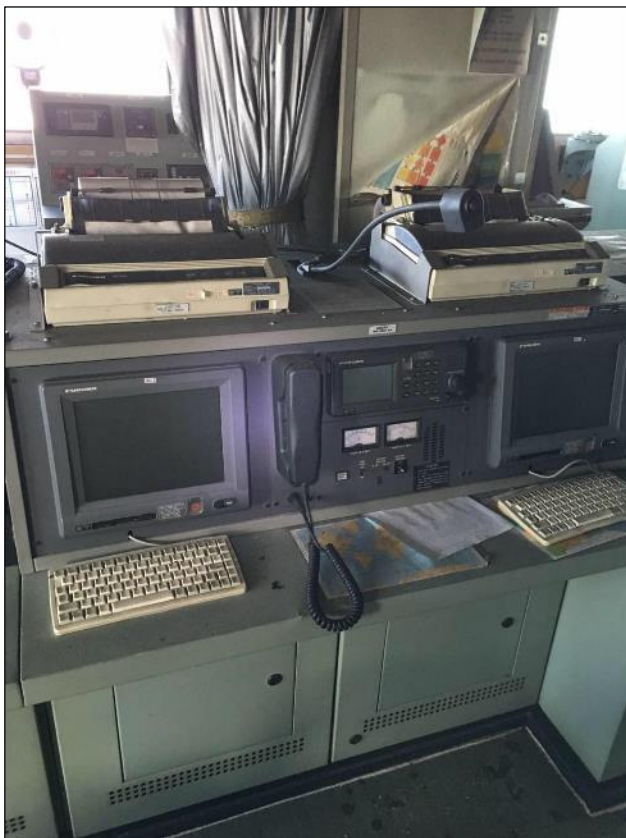
Fume smoke printer

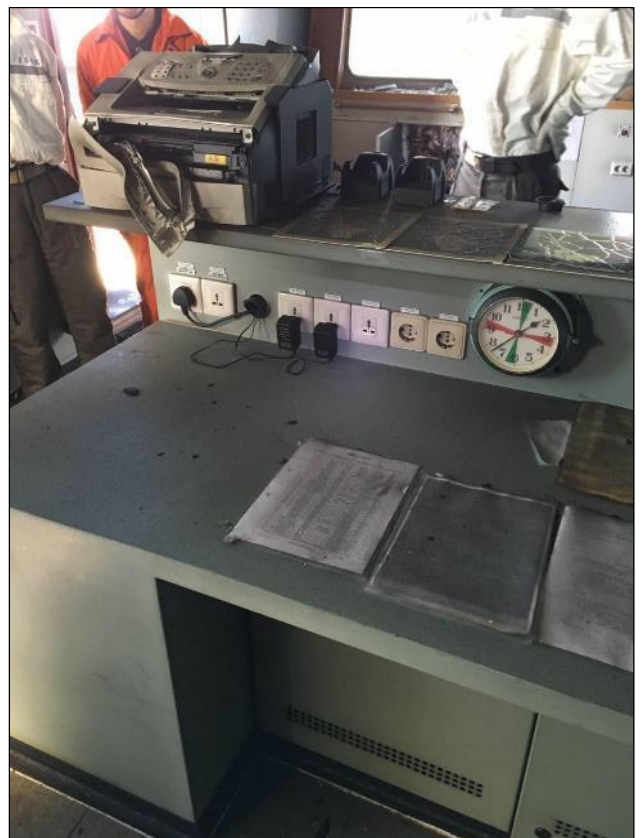
Damage of fax machine

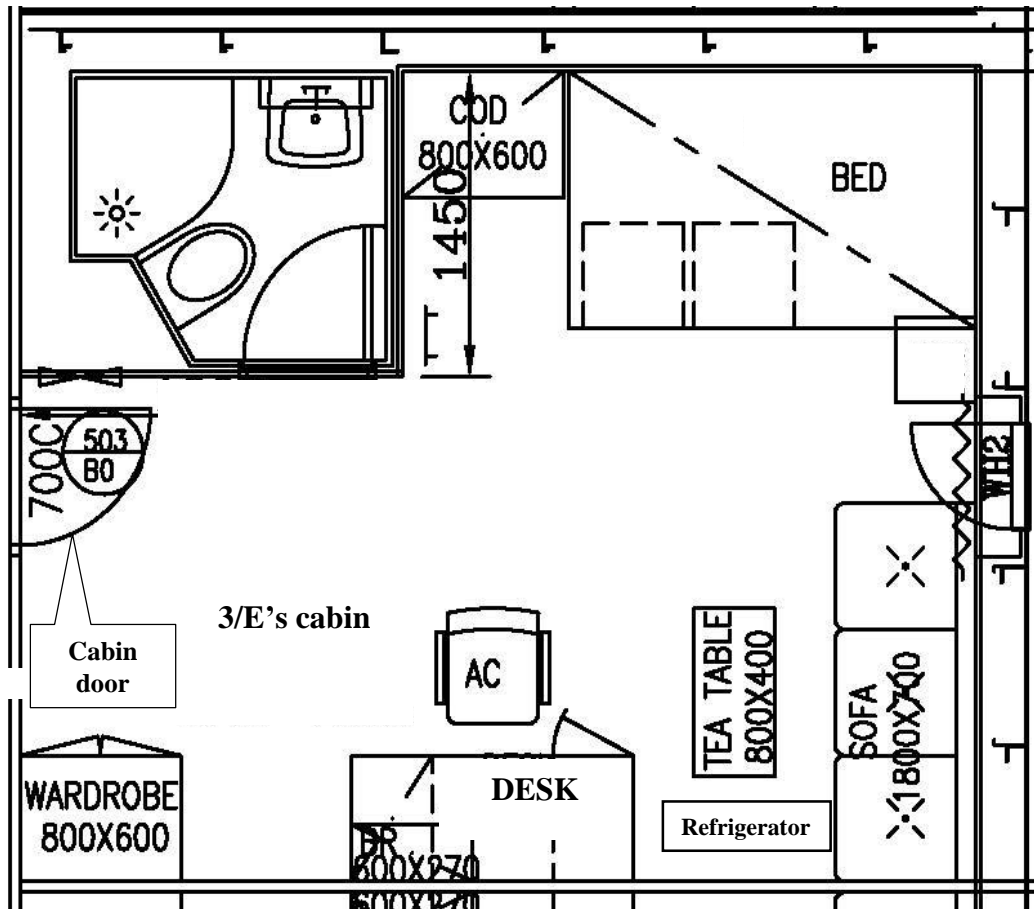
Figure 7 Layout of 3/E's cabin

- 4.4 There was little discernible evidence on source of ignition left due to extensive damage of the 3/E's cabin. 3/E did not smoke and there were not many electrical fittings and device in his cabin. It was also reported that, apart from the cabin lighting and the refrigerator, a laptop computer was being charged and there was no electrical equipment left switched on in the cabin. The layout of 3/E's cabin is shown in Figure 7.

- 4.5 When 3/E entered his cabin trying to combat the fire, the smoke and fire were already too big for him to stay inside to put out the fire with a portable fire extinguisher. He could only vaguely saw flames from the direction of sofa. As 3/E's cabin was burnt out extensively, it was difficult to tell the exact source of the fire. When the fire broke out, 3/E left his laptop battery unattended in charging state. Short circuit of electrical equipment generating heat and spark igniting household stuff beside it might be a possible cause of the fire.
