**Report of investigation  
into the fatal accident on board  
Hong Kong registered cargo ship  
“*SPRING SALIM*”  
on 25 October 2016**

**The Hong Kong Special Administrative Region  
Marine Department  
Marine Accident Investigation Section**

19 March 2019

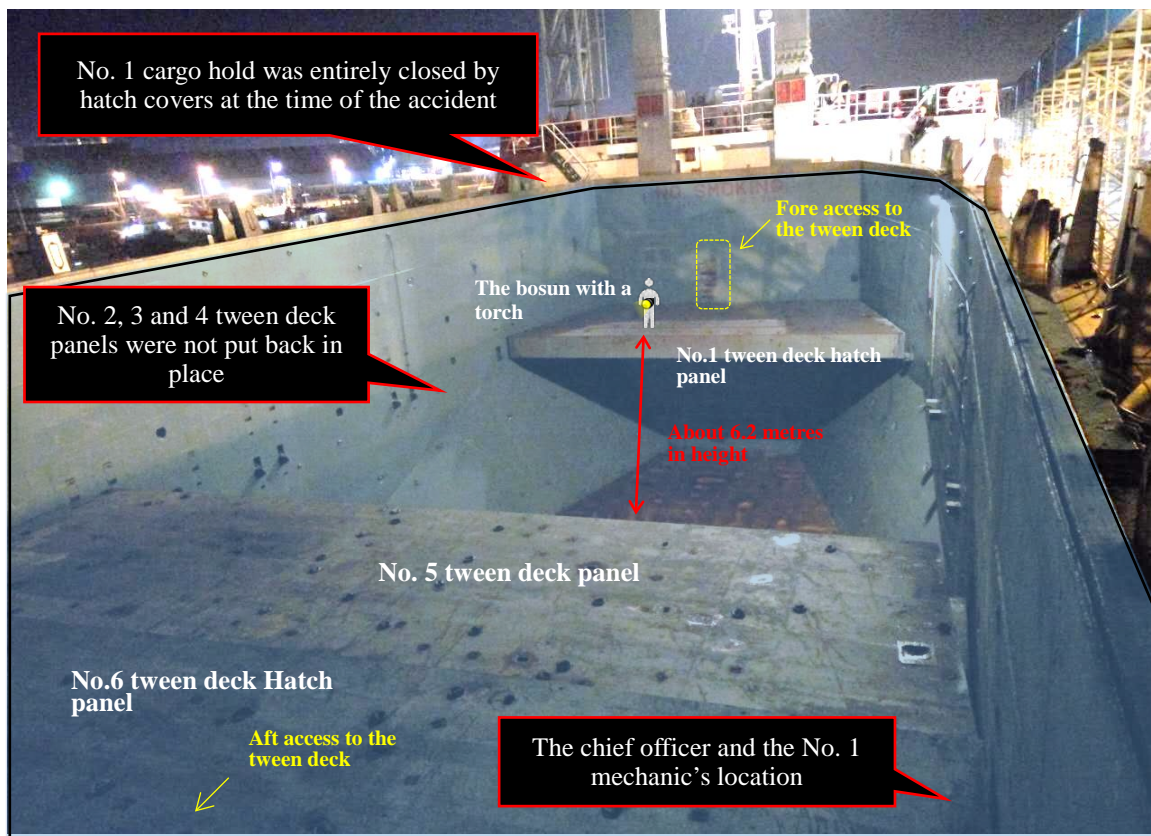
Figure 2 No. 1 cargo hold

- 4.1 On 24 October 2016 at 1000 hours, *the vessel* finished the discharge of cargo at the port of Kendari, Indonesia. For cleaning and sweeping purposes, the No. 2, No. 3 and No. 4 tween deck hatch panels of the No. 1 cargo hold were not put back in place thus leaving a big opening in the middle section of the tween deck (Figure 2).

- 5.9 The tween deck of the No. 1 cargo hold was partly covered by the No. 1, No. 5 and No. 6 tween deck hatch panels only (Figure 2). As the remaining three tween deck hatch panels were removed and placed on top of No. 5 and 6 tween deck panels, the tween deck was left with a big opening at its middle section. The master stated that it was a general practice to leave an opening in the tween deck in order to facilitate loading and unloading of cargoes as well as lifting garbage out of the cargo hold after cleaning operation. The hazard of fall from the tween deck opening existed. However, there was no safety measure in place to prevent person from falling from such opening.

- 6.2 The investigation revealed that there was a safety hazard of fall from height in case the opening of the tween deck was formed when some of the tween deck hatch panels were not put back in place. The risk of fall would further be increased when the No. 1 upper deck cargo hold hatch covers were put in place and the tween deck environment would be in total darkness.

- (c) restrict entry into the tween deck spaces when some of their hatch panels have been removed. If it is really necessary to work in such spaces, safety measures must be in place before work begins; and

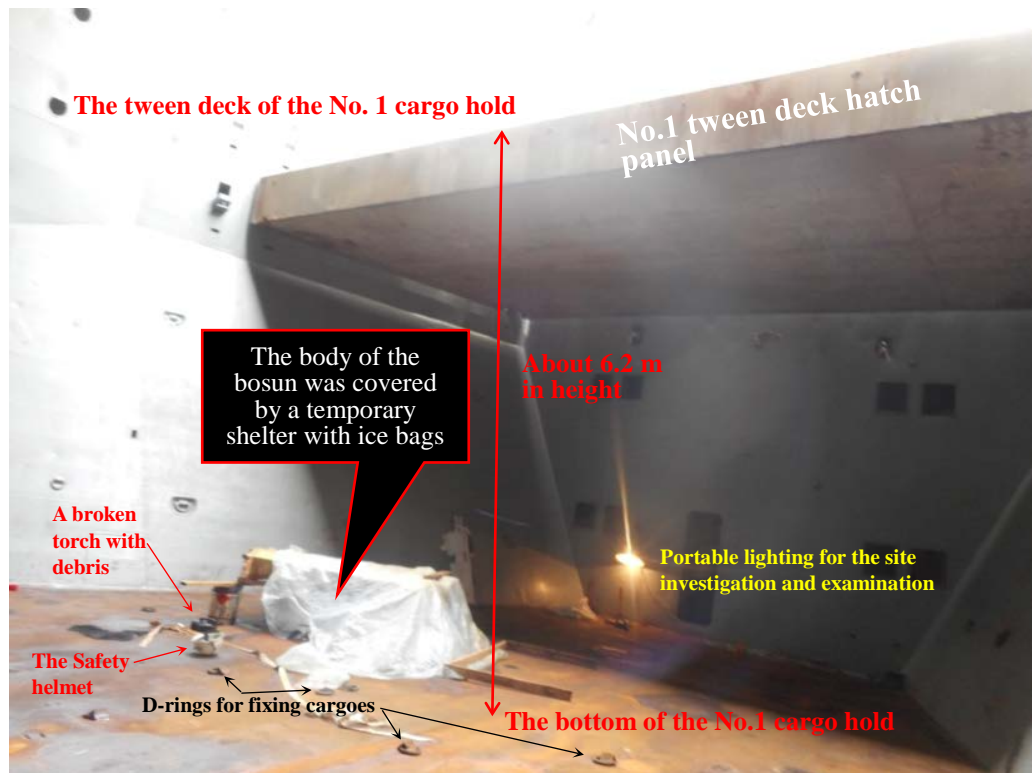
Figure 3 The scene of the accident

- 4.12 At 0740 hours on 26 October 2017, *the vessel* dropped anchor at the inner anchorage of Baubau. The local agent and officers from the relevant local port authority boarded *the vessel* and visited the scene of the accident for investigation (Figure 3).

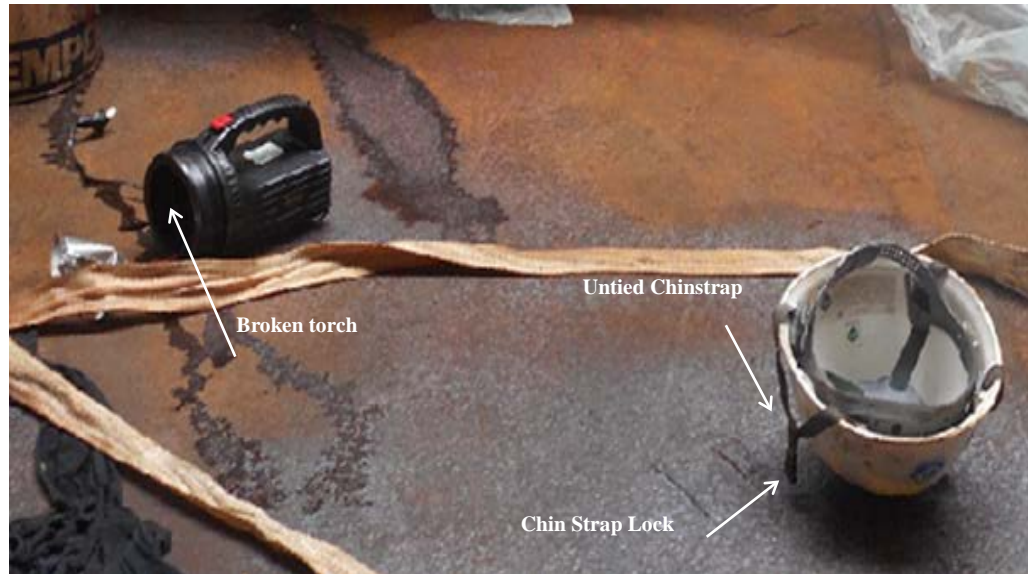
Figure 4 The safety helmet and torch of the bosun

- 5.10 The bosun worn an overall and a raincoat, a safety helmet and working shoes, as well as wearing gloves. He entered from the fore access to the No. 1 cargo hold and stepped on the No. 1 tween deck hatch panel with the intention to inspect water leakage. He walked on the No. 1 tween deck hatch panel to the aft but fell from the opening onto the cargo hold bottom. At the accident scene, a safety helmet with chin strap plastic buckle opened and a broken torch were found (Figure 4).

- 5.11 At the time of the accident, No. 1 cargo hold was in total darkness. It might not be easy for the bosun to discover the opening adjacent to the No. 1 tween deck hatch panel by torchlight. Subsequently, he fell from a vertical height of about 6.2 metres onto the bottom of the cargo hold through the opening. As his safety helmet was found intact without sign of the chin strap being torn apart, it could be deduced that the safety helmet had not been properly worn resulting in the helmet being dropped off from the bosun during the fall thus failing to protect the bosun from suffering severe head injury when hitting the bottom floor of the cargo hold.
