**Report of investigation  
into the fatal accident on board  
Hong Kong registered container ship  
“MCC Chittagong” at the south of  
Chittagong port, Bangladesh  
on 16 December 2016**

**The Hong Kong Special Administrative Region  
Marine Department  
Marine Accident Investigation Section**

24 October 2019

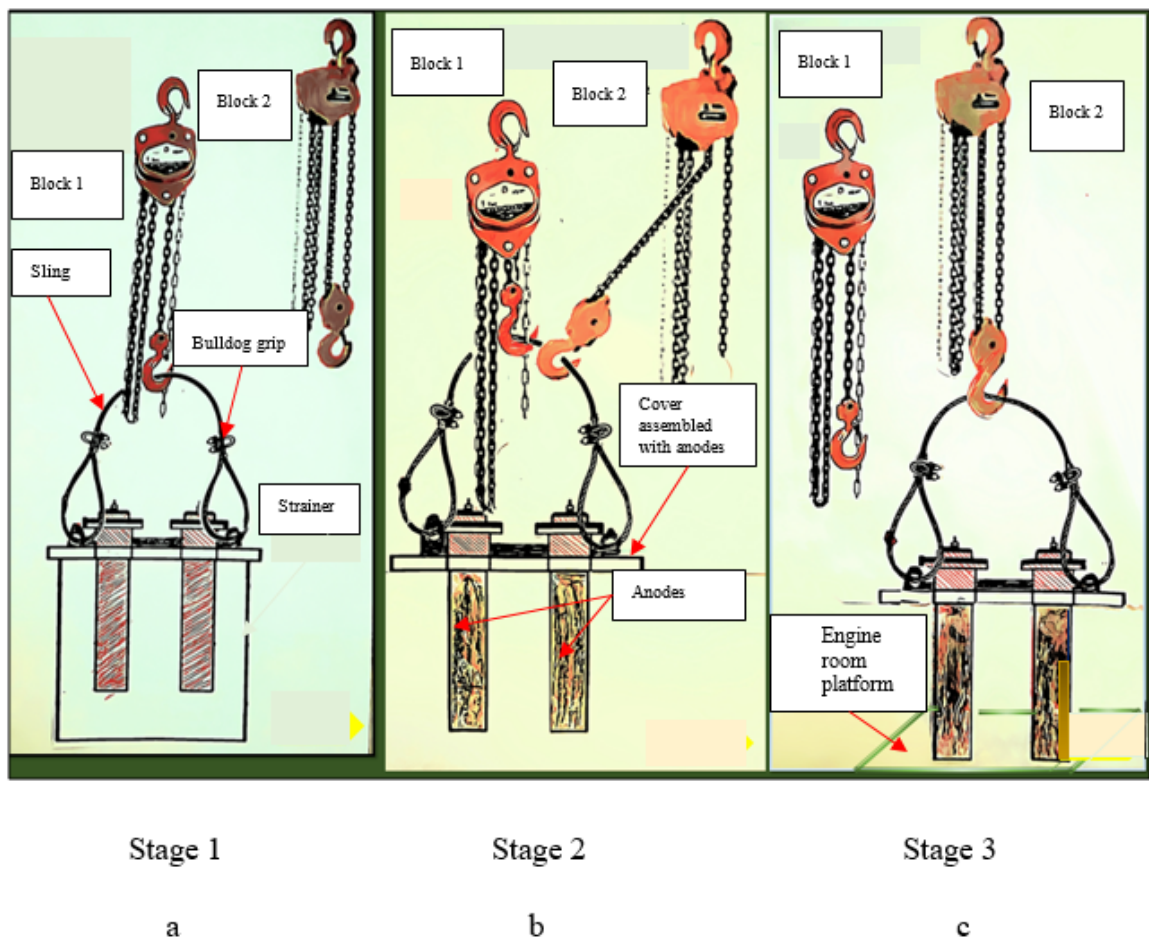
Figure 2 Lifting of the cover assembled with anodes

- 3.3 At about 1307 hours, after removal of all the bolts of the strainer's cover, the cover was lifted by a chain block (Block 1) with a sling (Figure 2a). After the strainer was cleared, the cover was then shifted aside by another chain block (Block 2) (Figure 2b). While dangled loosely by Block 2, the cover was rested on the engine room platform at a position of about 2 metres away from the strainer (Figure 2c). The sling was made by using a plastic coated wire with an "eye" formed at each end by a bulldog grip (Figure 3).

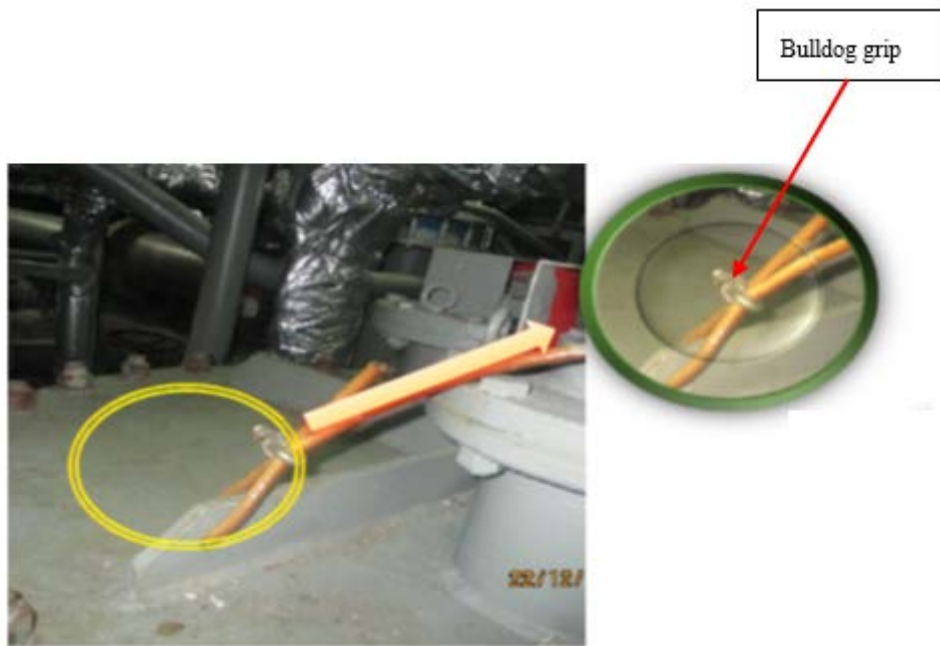
Figure 3 The sling

- 4.12 The sling used for lifting the cover in this accident did not comply with *the Guidance*. As shown in Figure 3, the “U” bolt was fitted at the “live” end instead of the “dead” end. Furthermore, only one bulldog grip, instead of a minimum of three, was used and the PVC coating was not removed prior to the use of the grip.

- b) the sling assembly including the fitted bulldog grips did not conform to the recommendations detailed in *the Code*, as follows:
    - (i) the sling assembly used only one bulldog grip at “eye” end instead of a minimum of three;

- (ii) the bulldog grip was tied in a wrong direction; and
    - (iii) the wire used for forming the sling was plastic coated and was not suitable for lifting operation.

- 6.1 The management company of *the vessel* is recommended to:
- a) issue notice/circular to draw attention of their masters, officers and crew to the findings of the investigation;
  - b) promulgate the company's procedures and Technical Operation Manual for lifting gears and lifting practices, in particular the application of bulldog grips; and
  - c) consider conducting internal audit to ensure that the company's procedures and instructions for lifting equipment are strictly followed by ship crew on board their fleet.
- 6.2 A Hong Kong Merchant Shipping Information Note should be issued to promulgate the lessons learnt from the accident.

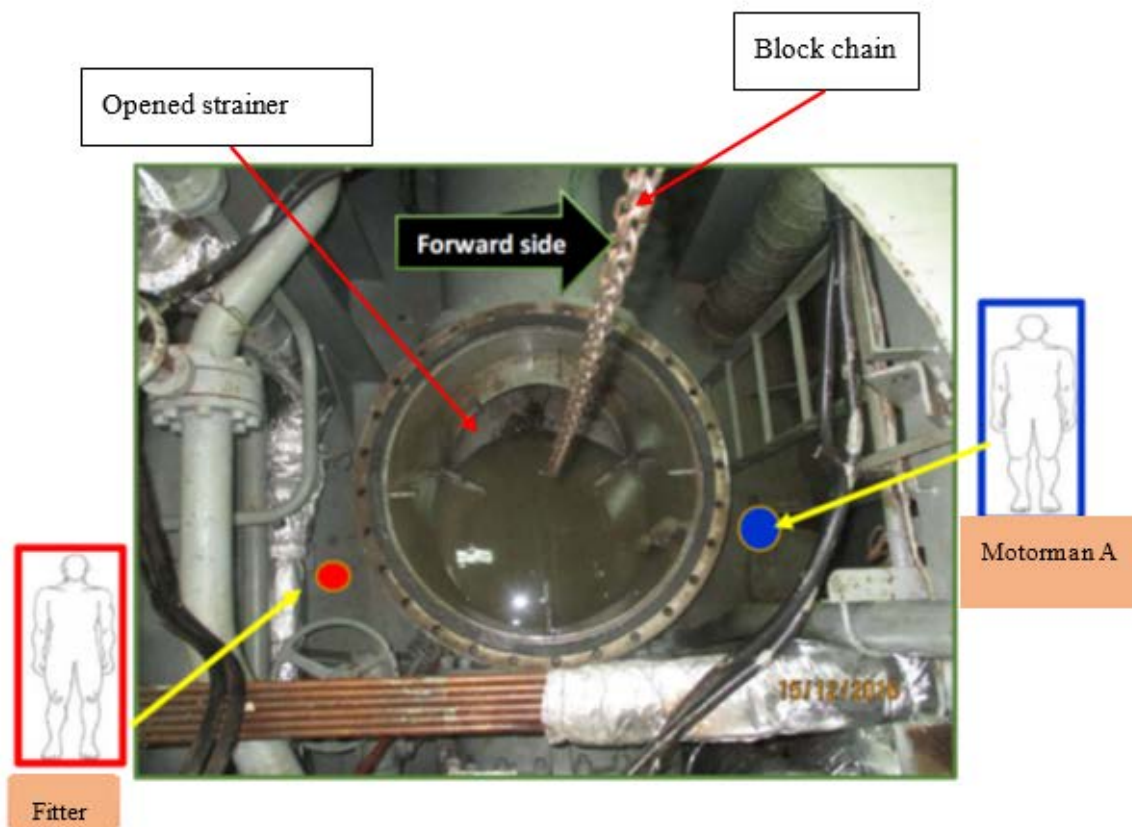
Figure 4 Positions of the fitter and Motorman A at the time of the accident

- 3.4 At about 1315 hours, the fitter and Motorman A standing next to the strainer were trying to loosen the filter by using a crow bar (Figure 4). Suddenly the wire forming an "eye" at one end of the sling slid out of the bulldog grip causing the cover to topple over and fell towards the strainer (Figure 5).

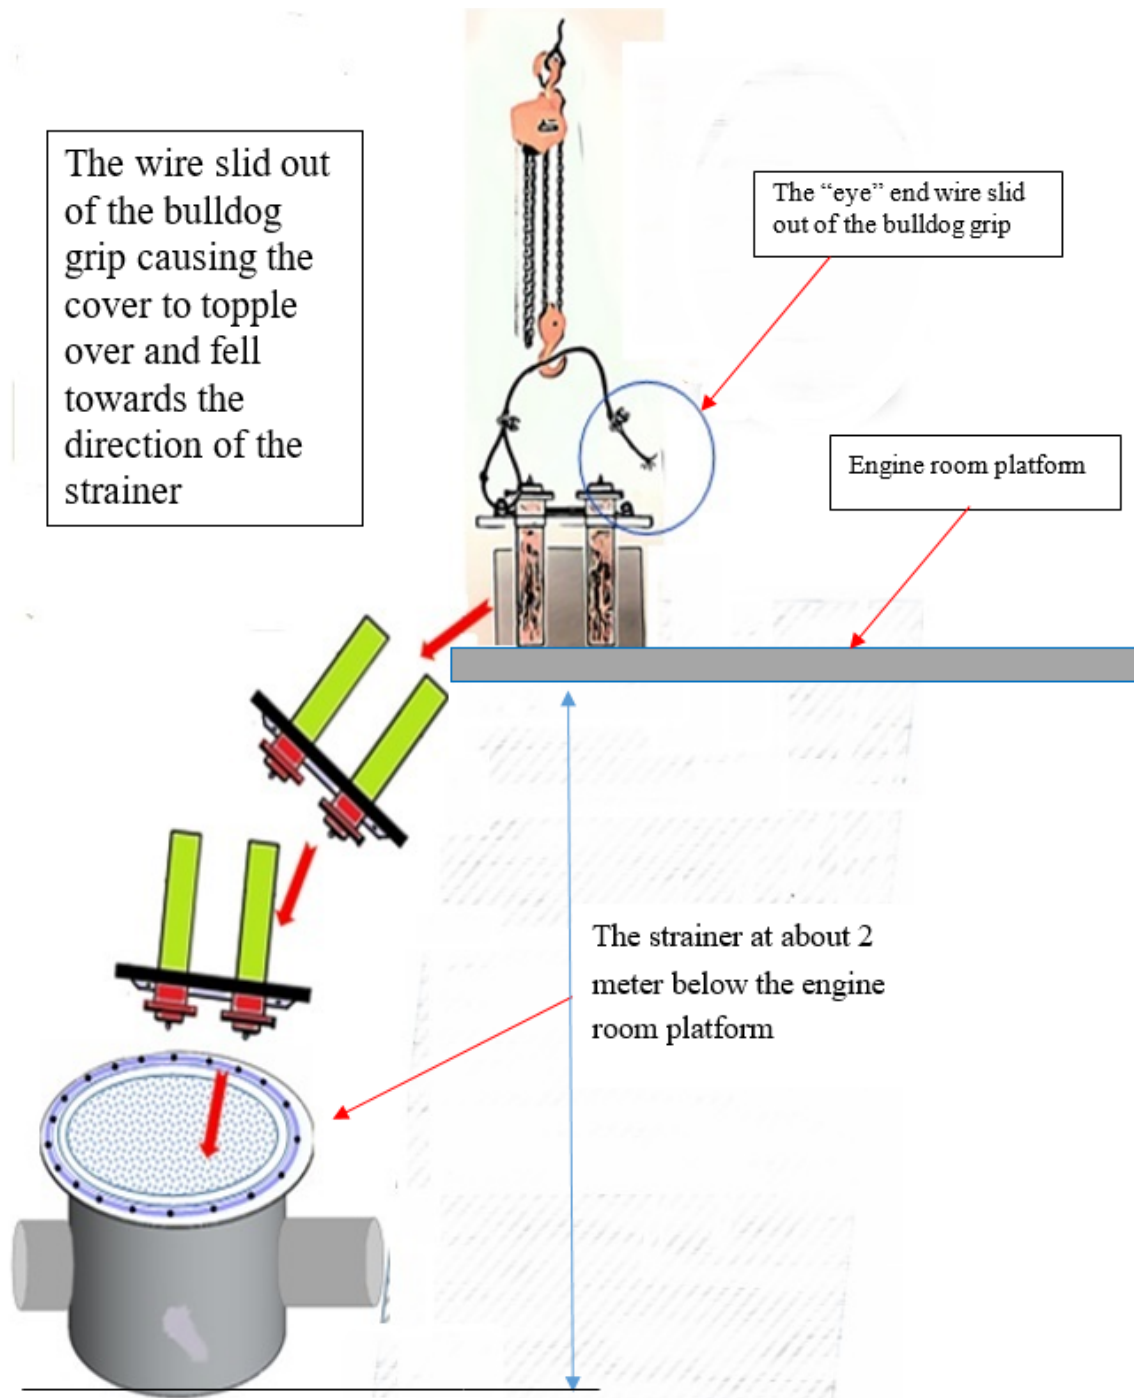
Figure 5 The wire slid out of the bulldog grip

- 4.17 It is apparent that the second engineer, as a senior officer and the leader of the lifting team, had inadequate knowledge of lifting methods, the use of lifting gears and insufficient safety awareness. He had wrongly accepted to use a sling formed by plastic coated wire with only one bulldog fitted at each end and tied in wrong direction, not to mention that the wire should not be used in the first place.

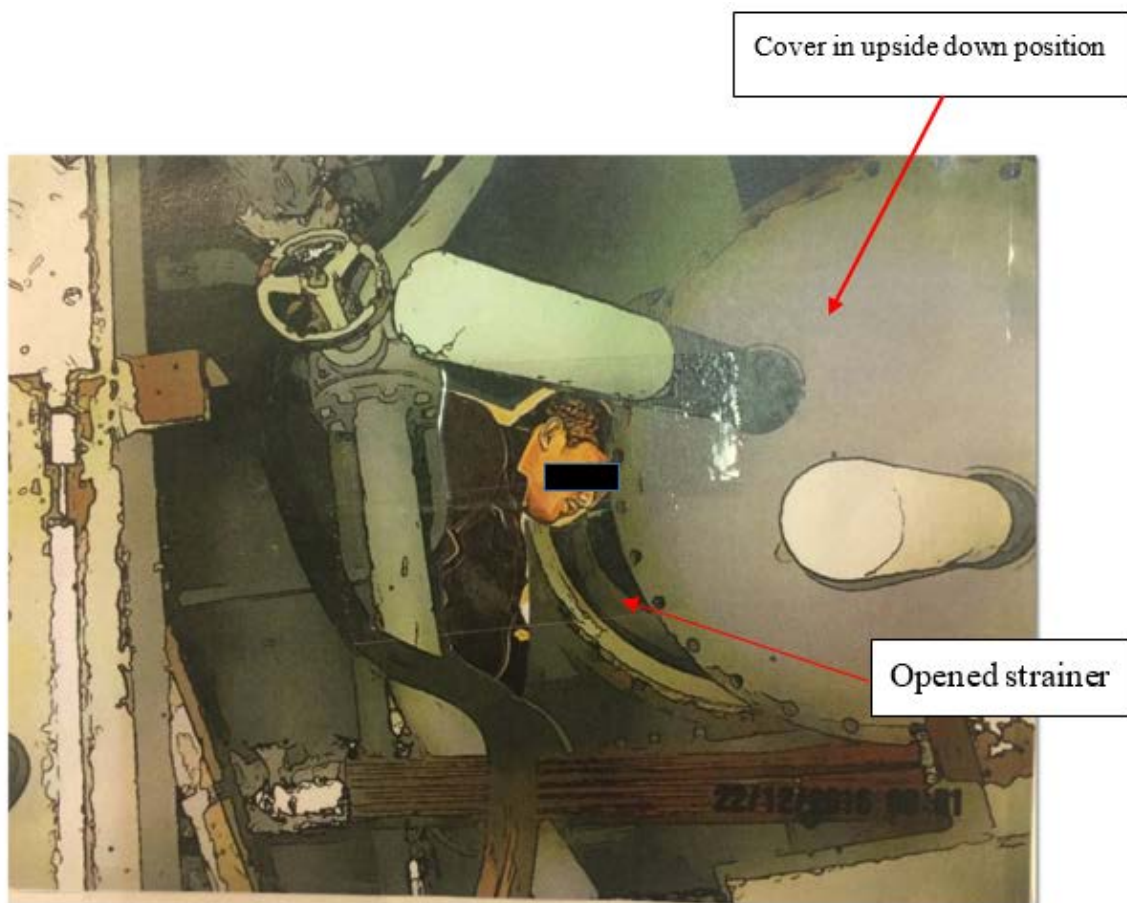
Figure 6 Illustration of the cover which hit and crushed the fitter's head

- 3.5 Upon landing on the strainer, the cover hit and crushed the fitter's head (Figure 6). Motorman A moved the cover away immediately and, together with the second engineer, carried the fitter to the deck floor.

- 4.9 The post mortem report stated that there was no disease being detected morphologically. The injuries were ante-mortem in nature and were caused by either falling on hard projecting substance or falling of similar substance on the face and the head. The cause of death was due to injuries of head and face leading to injury of vital organ (brain) which was ante-mortem and consistent with the accident.
