Report of investigation into the
collision between the Hong Kong
registered bulk carrier “*Inspiration
Lake*” and the Republic of Korea
registered fishing vessel “209
Juyoung” in position 36°05.48’N
130°01.40’E on 10 January 2017

The Hong Kong Special Administrative Region
Marine Department
Marine Accident Investigation Section

3 June 2019

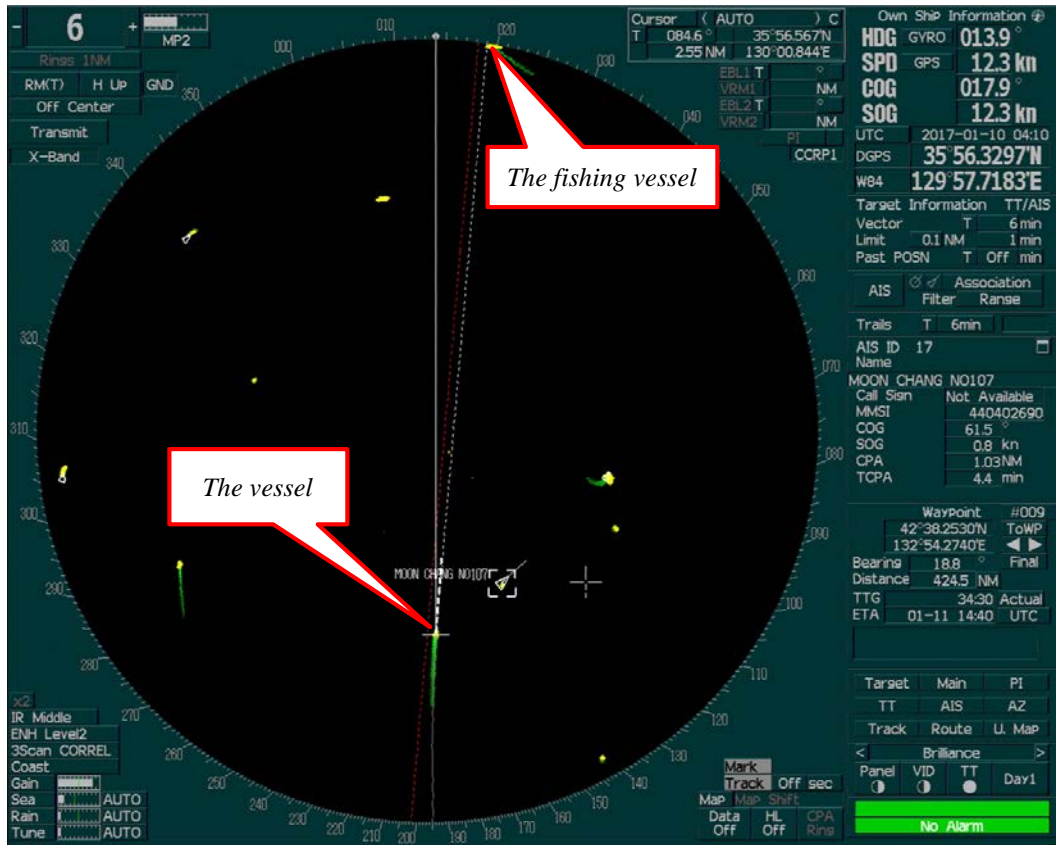
- 3.4 At about 1310 hours, when *the vessel* was at position 35°56.3'N, 129°57.7'E on a course of 018° and at a speed of about 12 knots, the target of *the fishing vessel* was detected and appeared on the radar screen at a distance of about 9.78 n.ms and a bearing of 019.5°. However, the second officer failed to observe the target of *the fishing vessel* on the radar. At 1324 hours, the master left the bridge to distribute the voyage instructions to the chief engineer and chief officer for their follow-up actions.

Figure 3 - The Radar screen at 1310 hours when *the fishing vessel* was first detected and displayed on the radar

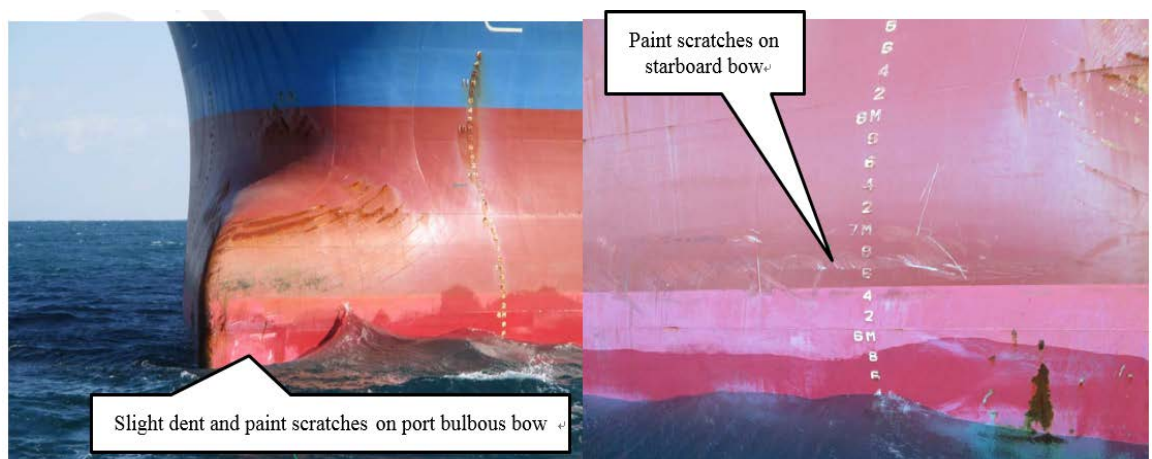
- 4.9 External and internal inspections of *the vessel* were conducted by Class NK and P & I (Protection and Indemnity) club surveyors at Pohang Anchorage. Slight dent with a size of approximately 1 metre x 1 metre and paint scratches over an area about 2 metres x 1.5 metres were found at the port side shell plating of the bulbous bow. Paint scratches were also found on the starboard bow plating (Figure 6). The internal structure of the fore peak tank was intact. The seaworthiness of *the vessel* had not been affected. No repair was needed according to Class NK's survey report.

Figure 6 – Damage conditions of *the vessel*

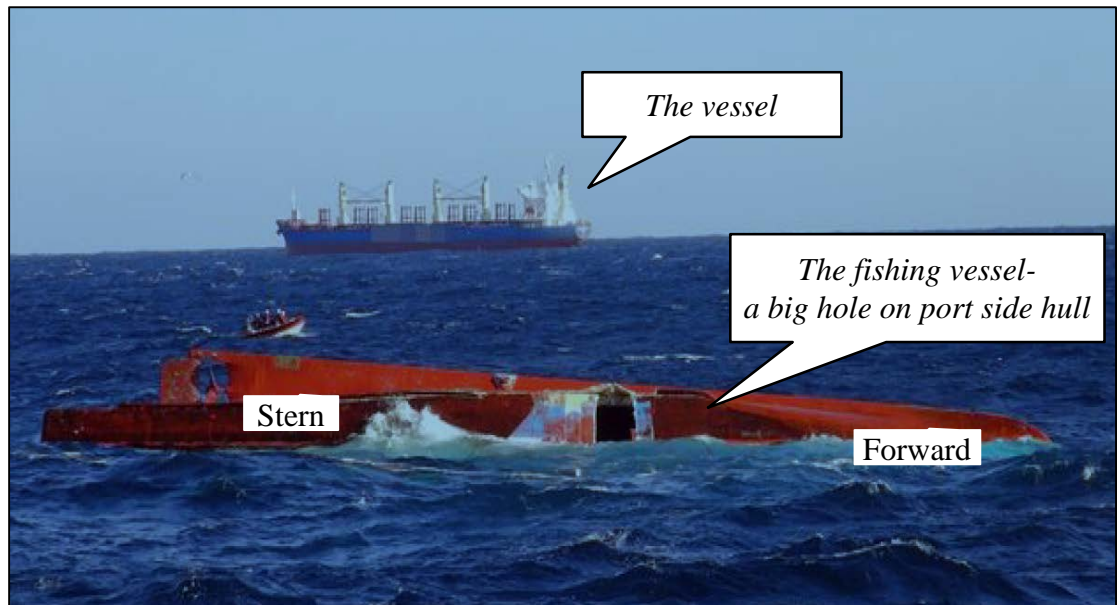
- 4.10 After the collision, *the fishing vessel* turned upside down and was floating on the sea surface. As struck by *the vessel*, the port side hull of *the fishing vessel* was holed (Figure 7).

Figure 7 - *The fishing vessel* floating upside down on the sea surface
