**Report of investigation into the fatal
accident of a sailor fell overboard a
local dumb lighter “*Kwong Fei 38*”
and drowned in the waters east of
Round Island on 13 January 2017**

Marine Accident Investigation Section
Marine Department
The Hong Kong Special Administrative Region

20 July 2018

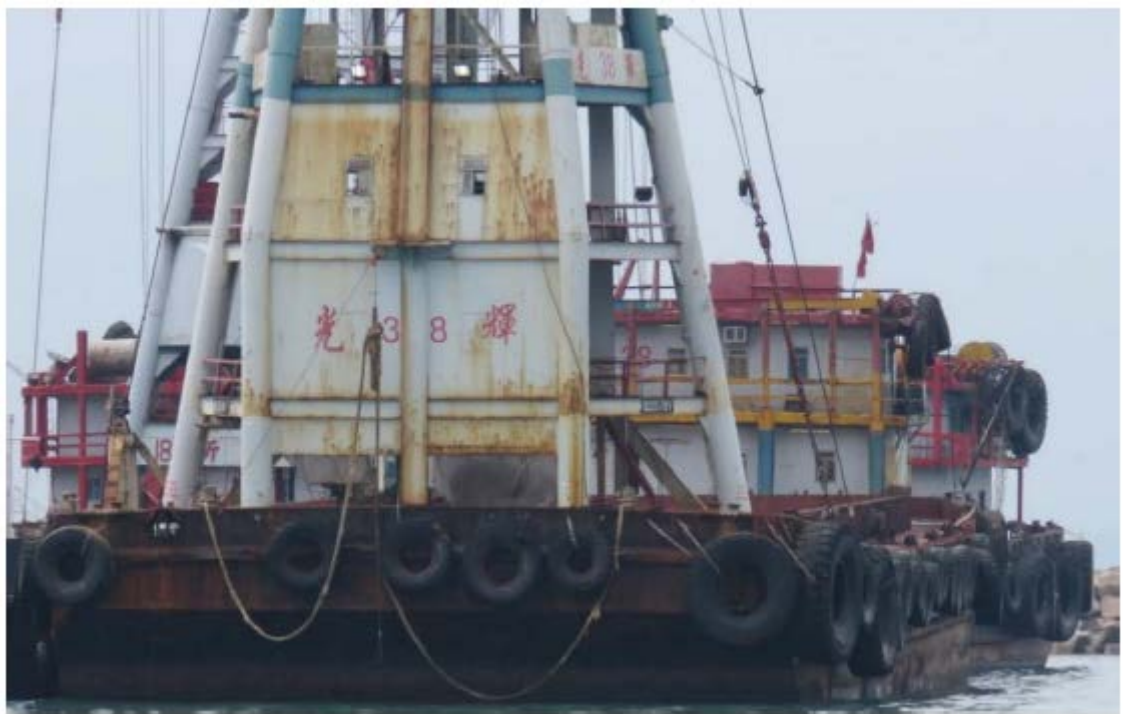
Figure 1: “Kwong Fei 38”

2.2 “Kwong Fei 38” (Figure 1)

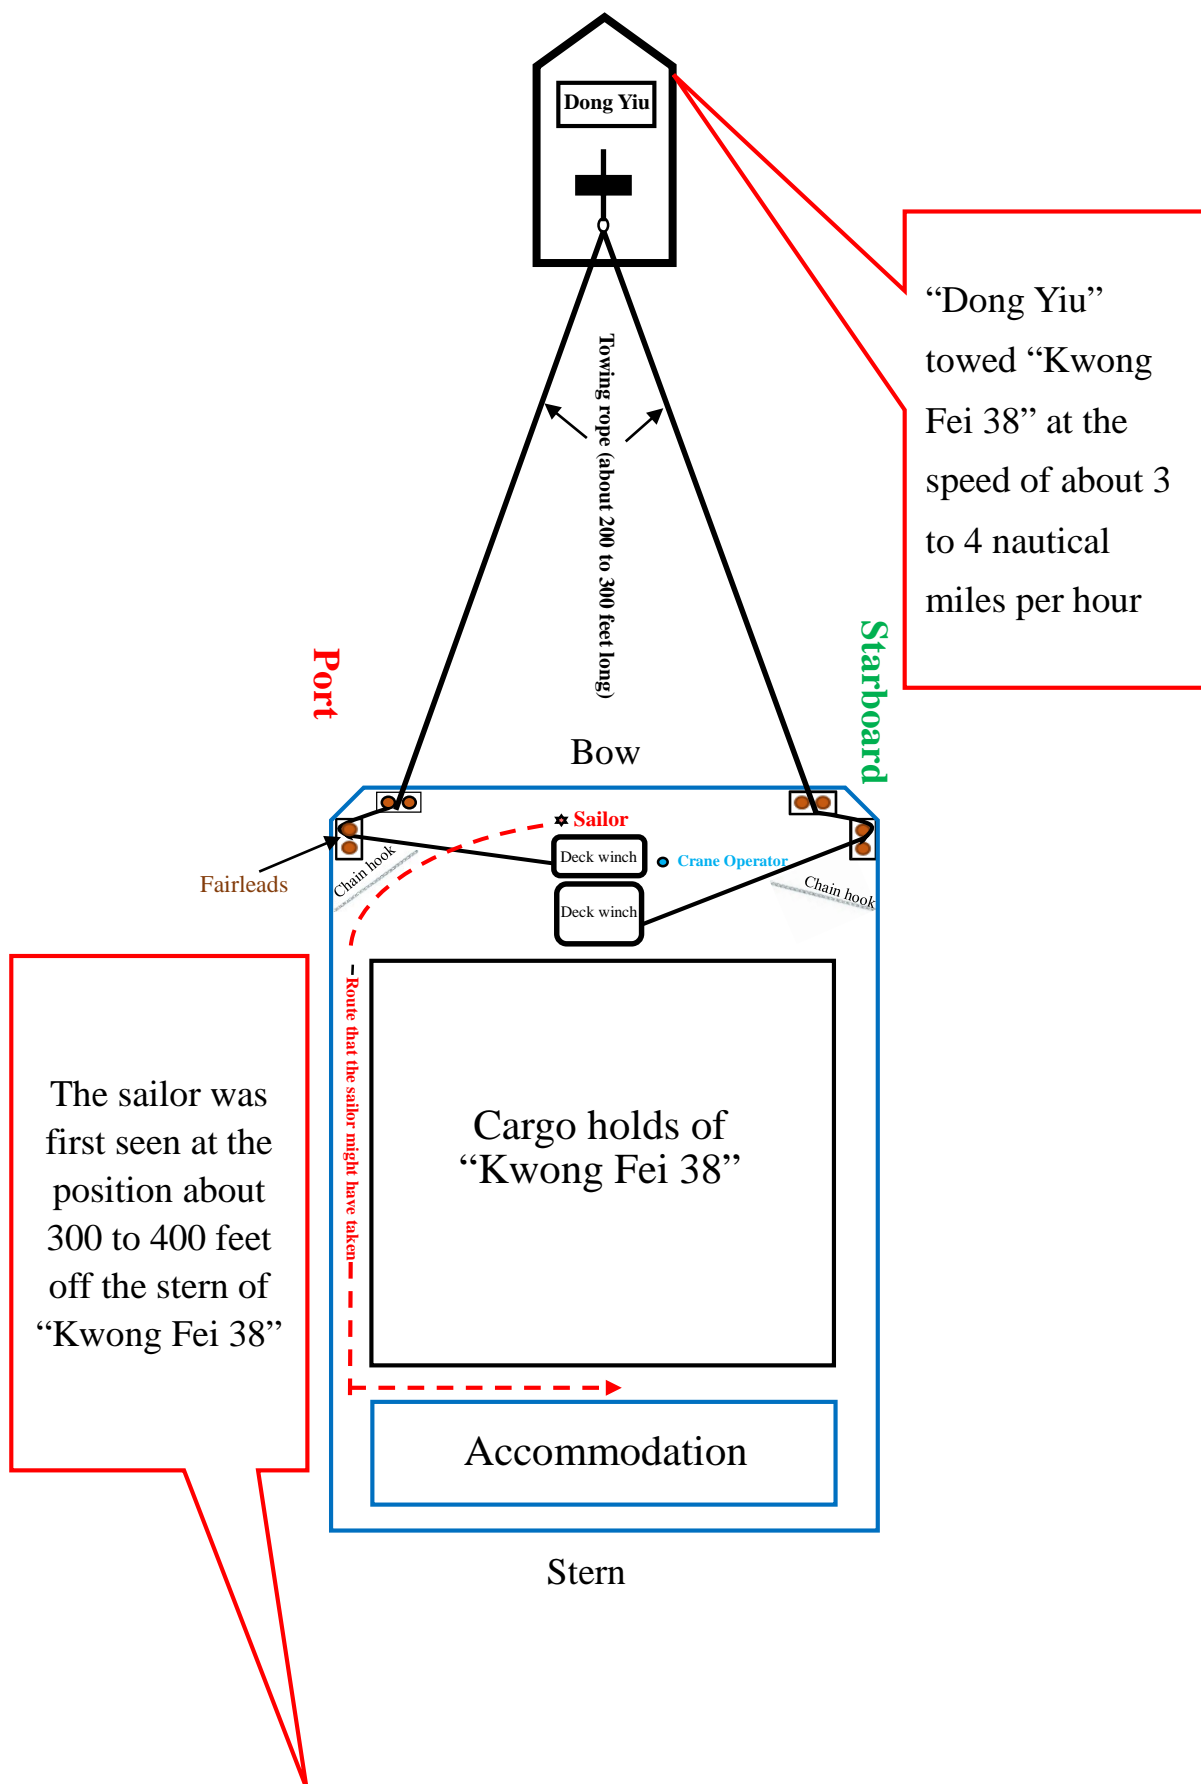
Figure 2 Vessels involved in the incident

- 4.4 At around 1630 hours, the **Crane Operator** saw the **Sailor** leave the bow after finishing his work. The **Crane Operator** assumed that the **Sailor** had returned to the accommodation through the port side deck at that time (Figure 2).

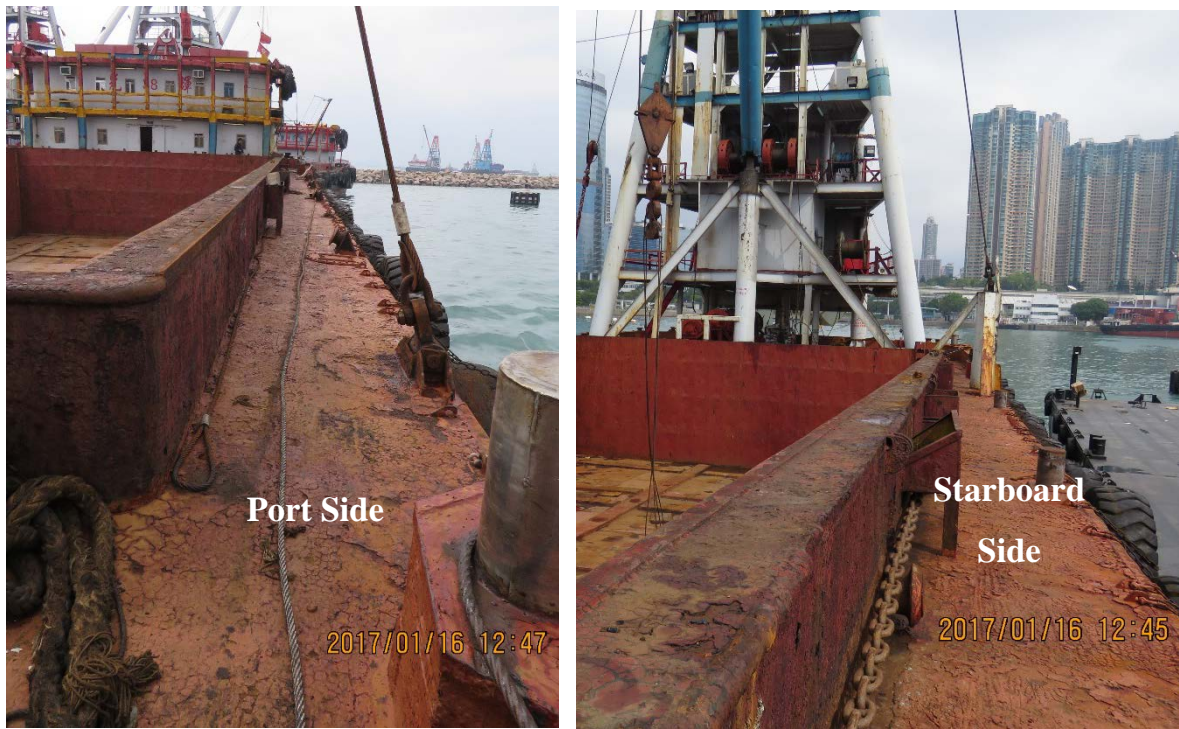
Figure 3 The access areas of the port and starboard decks of “Kwong Fei 38”

- 5.9 The starboard deck of “Kwong Fei 38” was clear and free from obstruction. However, there were two steel cables on the port deck. One of which, extending from bow to stern, was for berthing at piers and a considerable length of it laid in the middle of the access area of the port deck. There was also a slightly raised void space manhole cover at the midship section in the access area of the port deck, and further back stacked a small pile of chains which extended to the middle of the access area. Hence, the personnel were more prone to trip when walking in the access area of the port deck (Figure 3).

- 5.10 “Kwong Fei 38” is a dumb lighter. It is not required to have bulwarks or guardrails installed along its deck. Since the accident took place on 13 January 2017, the lighter did not have any suitable warning plate displayed to alert the personnel on board to the absence of bulwarks and guardrails along the deck for the purpose of enhancing their awareness. However, according to the Code of Practice – Safety Standards for Class II Vessels which came into effect on 3 March 2017, any non-mechanically propelled vessel on which bulwarks or guardrails are not fitted at main deck ship side, there shall be displayed in a conspicuous location on board a suitable warning plate indicating that no bulwarks or guardrails have been fitted at the position.

- 5.11 Since the **Sailor** returned to the accommodation by himself, no one witnessed how he fell overboard and drowned.
- 5.12 It kept raining during the material time of the accident. The paint on the deck surface of the access area, which had not undergone special anti-slip treatment, was wet and slippery, and the **Sailor** was wearing white cloth shoes without any anti-slip property. Based on the information available, it is deduced that the most possible causes of the accident are as follows:

- (i) the **Sailor**, who walked on the wet and slippery deck surface of the

- access area wearing white cloth shoes without any anti-slip property, was very likely to have fallen overboard because he slipped or tripped over the steel cables, chains or manhole cover on the deck and lost his footing; and
- (ii) the **Sailor** drowned after falling overboard as he was not donning a lifejacket.

- (i) comply with the requirements of the Code of Practice on Safety Standards for Class II Vessels by displaying in a conspicuous location on board a suitable warning plate indicating that no bulwarks or guardrails have been fitted at the position, and reminding all workers of the dumb lighter under tow that they are allowed to walk or work near the ship sides without any guardrails only if necessary and when appropriate safety or protective measures (wearing suitable working dress, slip resistant safety shoes¹, life jackets and fastening seat belts, etc.) have been adopted. Extreme care should be exercised during rainy days in particular to avoid falling overboard due to slippery deck; and

- (ii) keep good housekeeping of the material on deck, such as the steel cables and chains, to eliminate any potential tripping hazard on board.
- 7.2 A Marine Department Notice should be issued to report on lessons learned from this accident.
