**Report of investigation
into the fatal accident on board the
Hong Kong registered bulk carrier
“*Golden Taurus*” at sea
on 5 February 2017**

**The Hong Kong Special Administrative Region
Marine Department
Marine Accident Investigation Section**

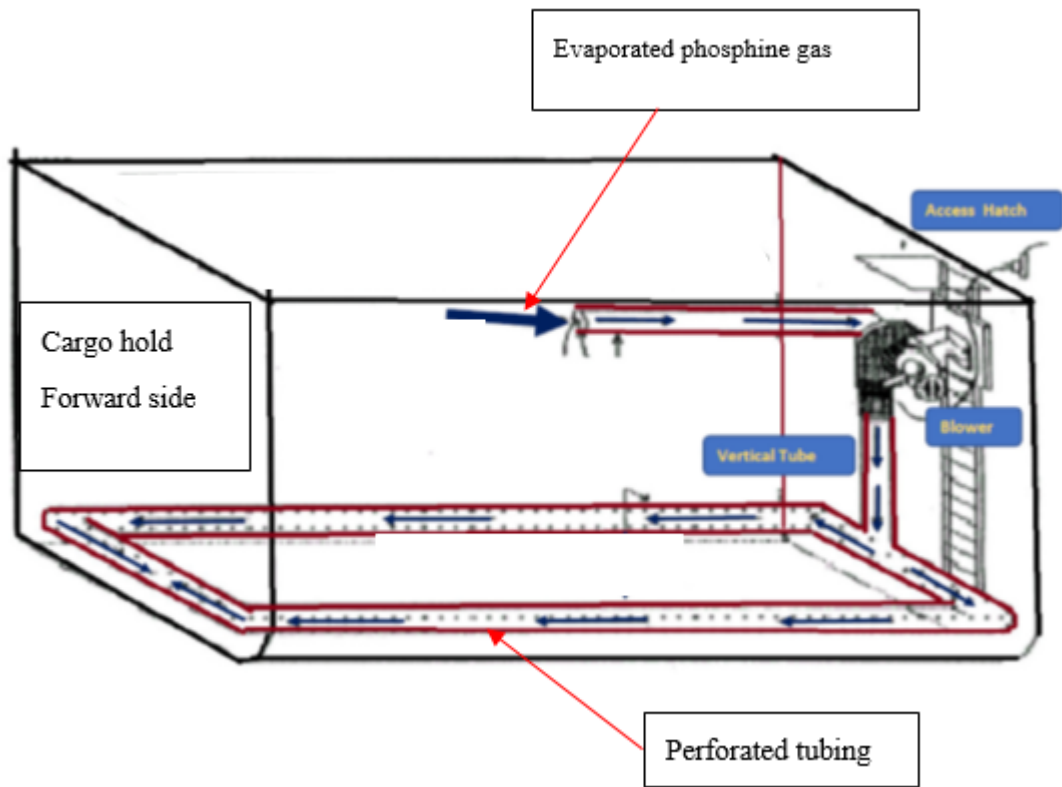
Figure 2 Fumigation of the cargo hold

- 4.7 Recirculation method prescribed by the United States Federal Grain Inspection Services Rules was used for cargo hold fumigation. A local contractor approved by the United States Department of Agriculture (USDA) carried out the job and the arrangement was shown in Figure 2. The fumigants were tablets containing aluminium phosphide, ammonium carbamate and covered with paraffin. The tablets were spread on top of the wheat. A blower was used to suck the phosphine gas evaporated from the tablets accumulated above the wheat through vertical tube to cargo hold bottom. Phosphine gas would pass through the perforated tubing to

circulate around the cargo hold bottom and make its way up running through the wheat so as to fumigate the wheat evenly.

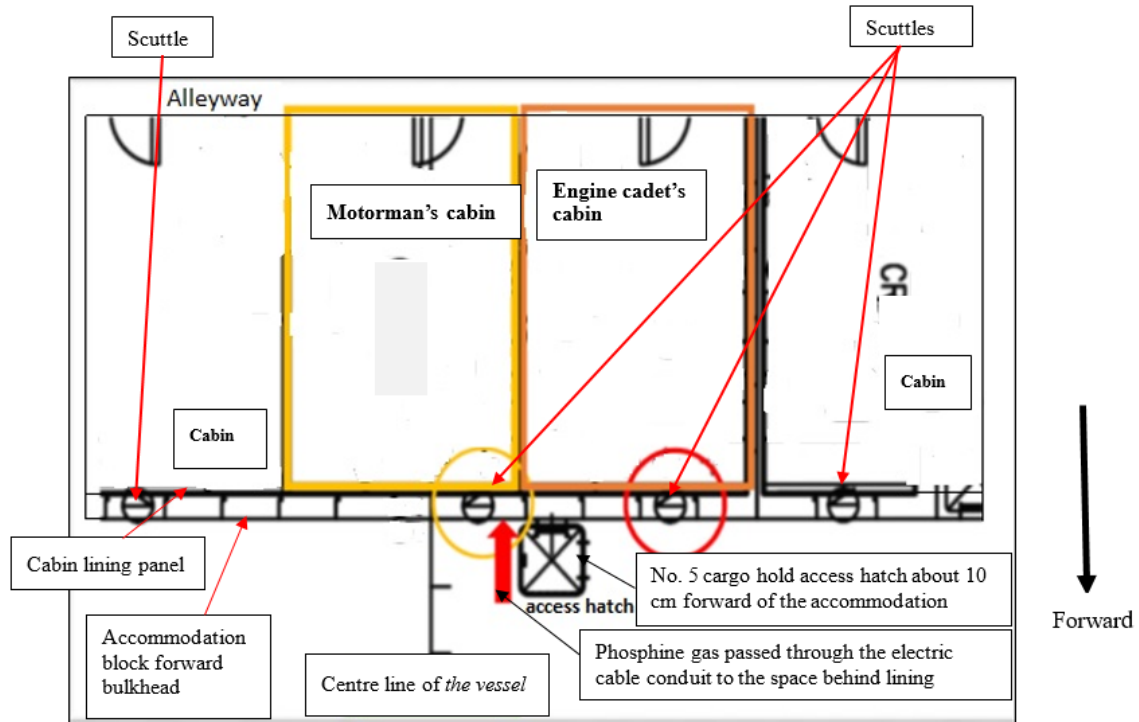
Figure 3 Layout of the crew cabins

- 4.16 *The vessel* was built at Chengxi Shipyard Company Limited, China in 2015. When she was under construction, the owner requested an additional work to fit a permanent access light for the aft access ladder of No. 5 cargo hold which was located about 10 cm forward of the accommodation bulkhead. A 60 mm diameter conduit was used to run an electric cable between the accommodation and No. 5 cargo hold (Figures 3 and 4).

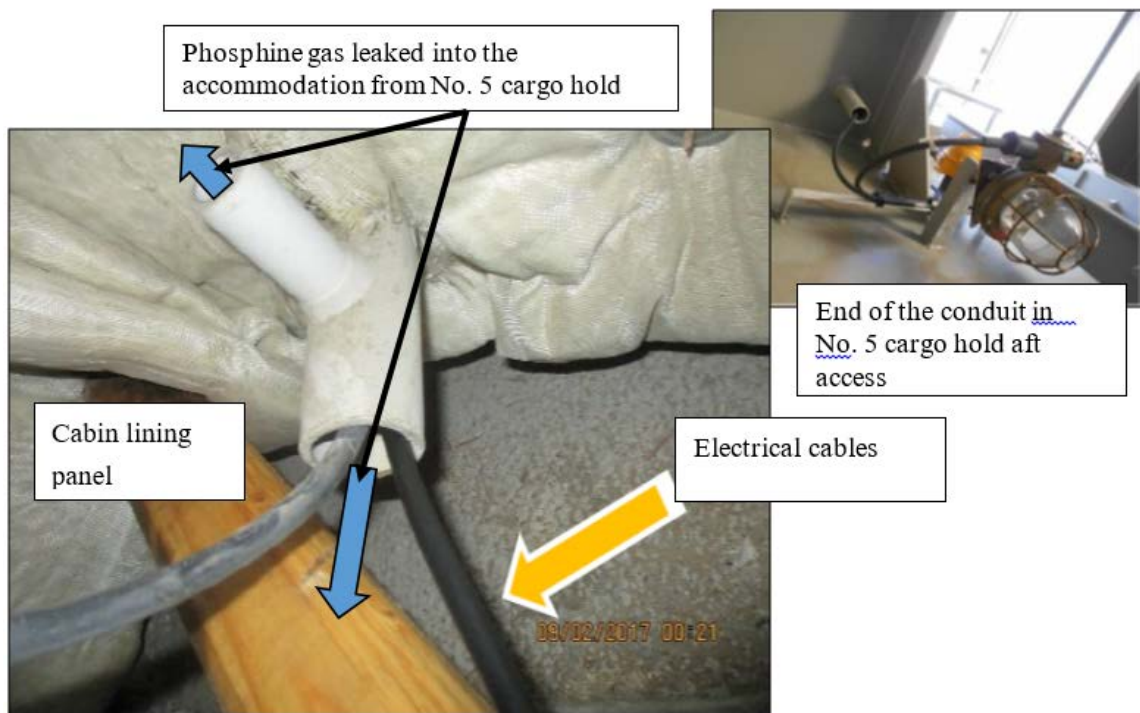
- 4.17 The investigation revealed that both ends of the electric cable conduit were not sealed (Figure 5). Under the action of the blower, the phosphine gas was circulated throughout No. 5 cargo hold under relatively more positive pressure. It was apparent that the effect of pressure gradient between the cargo hold and the accommodation had sufficiently forced the poisonous gas to leak into the crew cabins via the unsealed conduit (Figure 6).
- 4.18 The CS of *the vessel* confirmed that the installation of the conduit was not completed in accordance with the applicable classification rules. The CS followed up this fatal accident case and reported that the electrical cable and the conduit had been removed and the openings were sealed.

Figure 5 Gas leaking into the accommodation space through the unsealed conduit

- 5.2 The investigation reveals the following contributory factors leading to the accident:
- a) When *the vessel* was built, an electric cable conduit connecting No. 5 cargo hold and the accommodation was added at the request of the shipowner. This additional work had not been checked against the relevant rules and regulations of the classification society of *the vessel*. Both ends of the cable conduit were not sealed thus allowing the passage of phosphine gas from No. 5 cargo hold into the accommodation; and

- 6.1 The owner/management company of *the vessel* is recommended to:
- a) issue notice/circular to draw the attention of their masters, officers and crew of the findings of the investigation, and to conduct internal audit to ensure that the company's procedures and instructions for fumigation are strictly followed by their ships' crew;
 - b) ensure strict compliance with the company's procedures and guidelines on fumigation of its fleet; and
 - c) enhance the education and training for senior officers in relation to risk assessment and awareness of toxic gas.
- 6.2 A Hong Kong Merchant Shipping Information Note will be issued to promulgate the lessons learnt from this accident.

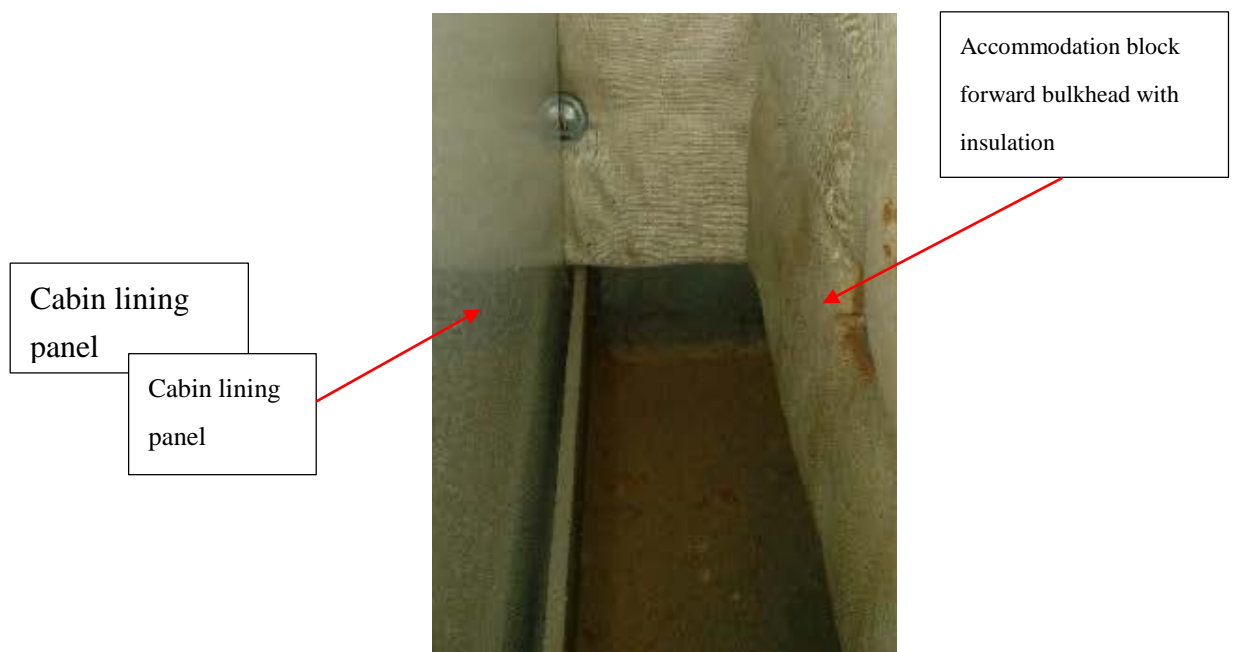
Figure 6 Accommodation space between the forward bulkhead and the cabin lining panel
