**Report of investigation
into the fatal accident
on board the Hong Kong registered
bulk carrier “*GREAT FLUENCY*”
at Liepaja, Latvia
on 16 February 2017**

**The Hong Kong Special Administrative Region
Marine Department
Marine Accident Investigation Section**

3 June 2019

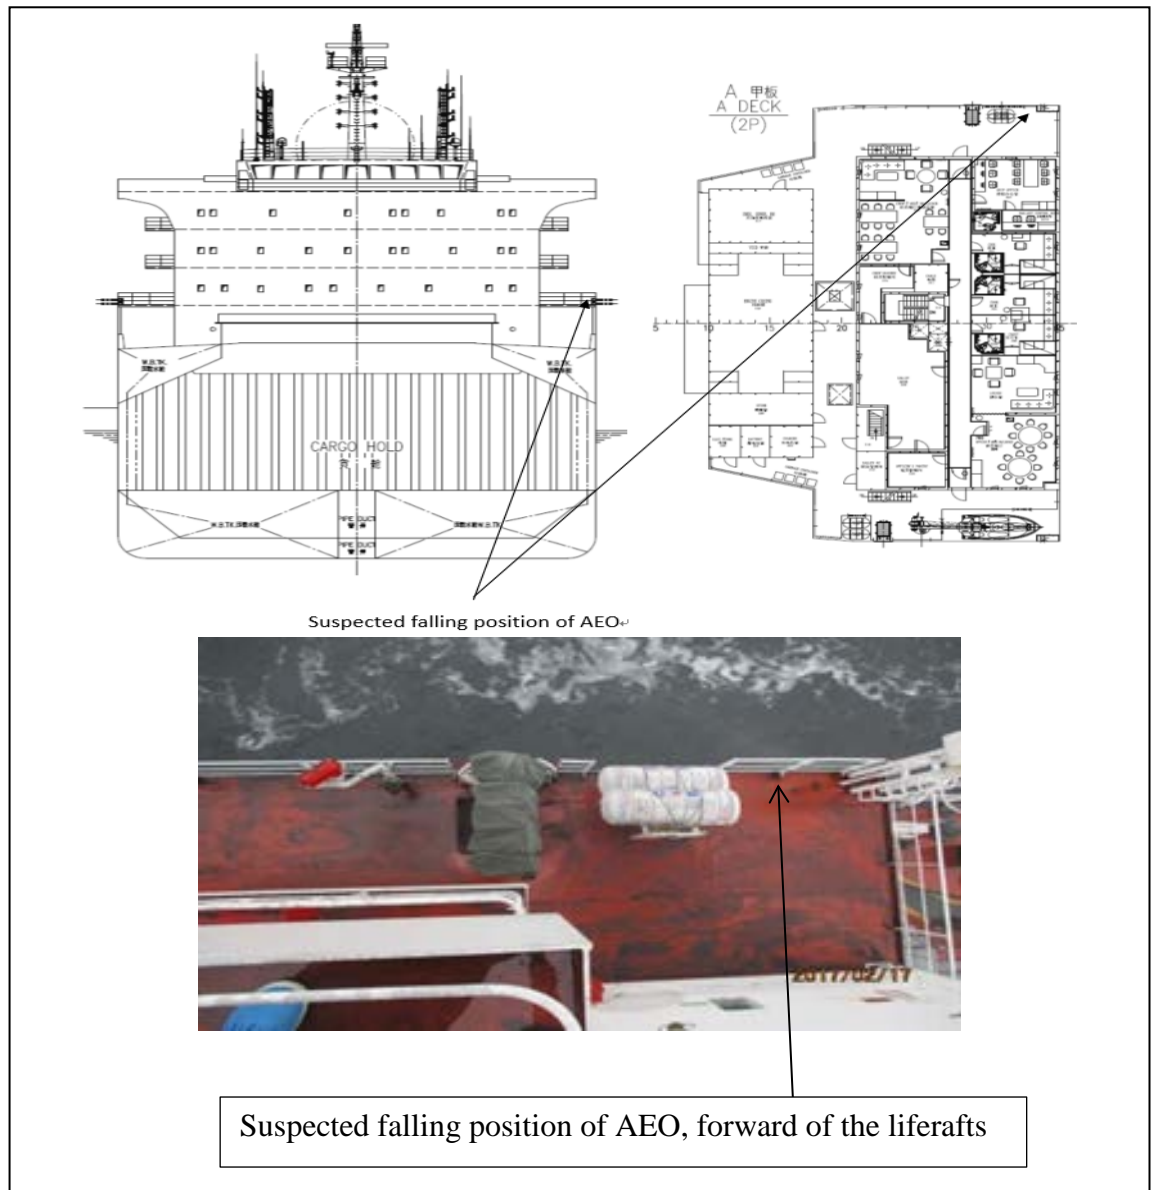
- 5.10 None of the crew witnessed the falling overboard of the AEO. However, it was suspected that the AEO might have lost his balance under the influence of alcohol and accidentally fell overboard into the water from the "A" Deck outside the accommodation block on the port side. The height of the fall was about 12 metres above the sea level.
- 5.11 Due to the loading of coal cargo, all handrails and stanchions were covered with coal dust. As the coal dust on the handrail at the forward of the liferafts on the port side of "A" deck had been rubbed off, it was believed that the AEO might have fallen overboard from this location as shown in Figure 2 below.

Figure 2 The suspected falling position on the port side “A” deck outside the accommodation block

- 7.1 The owner / management company of *the vessel* should issue a safety circular to inform all masters, officers and crew on board their vessels the findings of the accident investigation and instruct its vessels to strictly follow the alcohol policy set by the company.
- 7.2 A Hong Kong Merchant Shipping Information Notice is to be issued to promulgate the lessons learnt from the accident.
