**Report of investigation into
the fatal accident on board
the Portugal registered
container vessel
“Northern Jupiter”
at Yiu Lian Dockyards,
Tsing Yi, Hong Kong
on 29 June 2017**

The Hong Kong Special Administrative Region
Marine Department
Marine Accident Investigation Section

26 April 2019

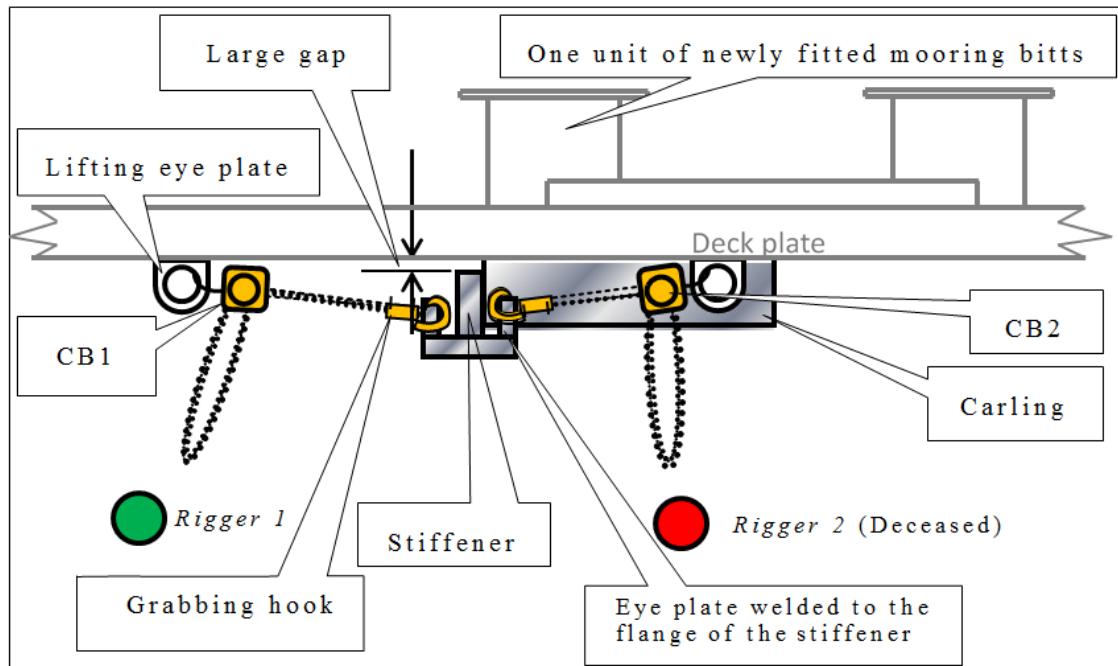
Figure 4: The initial hoisting arrangement of the stiffener by using CB1 and CB2

- 3.7 When CB1 and CB2 reached their extreme stops, however, the stiffener still fell short of reaching the deck plate with a large gap in between (Figure 4). *Rigger 1* and *Rigger 2* then decided to adjust the hoisting arrangement with the intention to lift the stiffener further up to close the gap.
- 3.8 The intended adjustment was that with CB2 still holding the stiffener in position, the grabbing hook of CB1 would be repositioned to the anchor point of CB2. In doing so, the chain of CB1 would run past the bottom of the stiffener. By tensioning the chain, it would then be expected that the lifting force created would lift the stiffener up further (Figure 5).

- 4.5 Without any supervision and safety instruction given and without any work plan in advance, the two riggers were left alone to handle their work. As a result, the initial hoisting arrangement had failed to position the stiffener to its fitting position (Figure 4 and para.3.7). In the attempt to adjust the hoisting arrangement, both riggers did not comprehend the situation that CB2 alone was not strong enough to hold the stiffener at its mid-air position (Figure 6 and para.3.9).
- 4.6 In order to prevent the risk of fall of the stiffener, an additional chain block or the use of an additional wire sling to secure the stiffener at its mid-air position should be ascertained before the release of the grabbing hook of CB1.

- (a) to instruct their frontline staff to be vigilant about hoisting operation of heavy object;
- (b) to carry out work plan in advance by conducting risk assessment of heavy lifting to identify all potential hazards; and
- (c) to issue lifting plan for every heavy lifting operation to show the lifting method, safety instruction, equipment arranged and the number of people involved, handling of emergencies etc. A safety officer should be deployed as supervisor to ensure the safety of the lift.

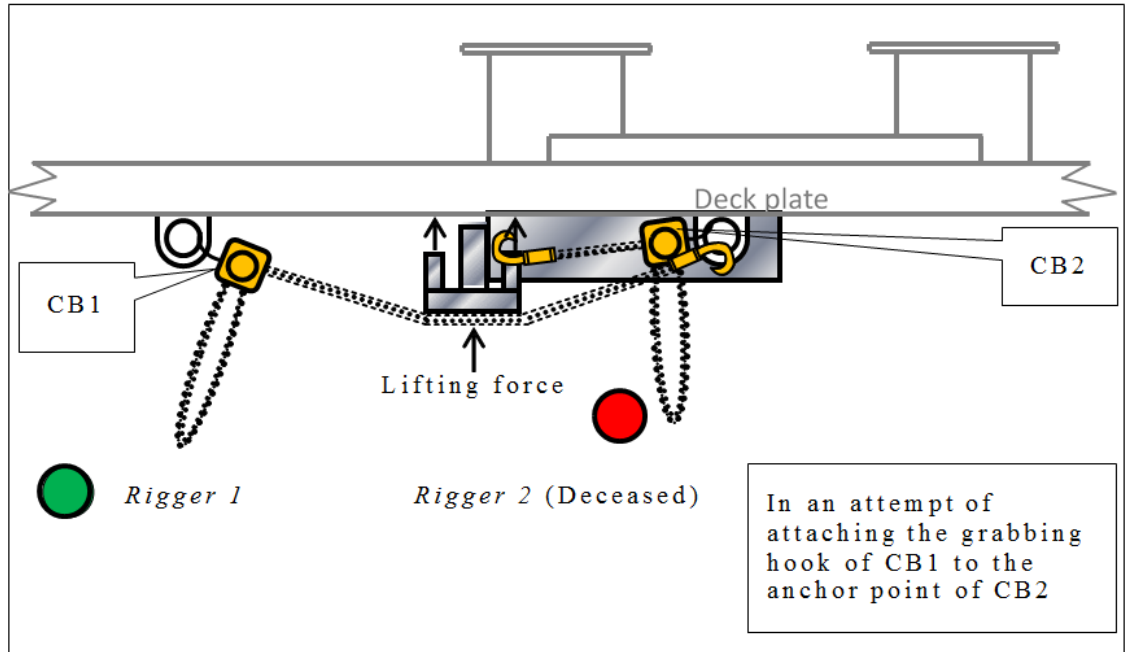
Figure 5: An illustration of the two riggers' attempt to change the hoisting arrangement with the intention to lift up the stiffener further

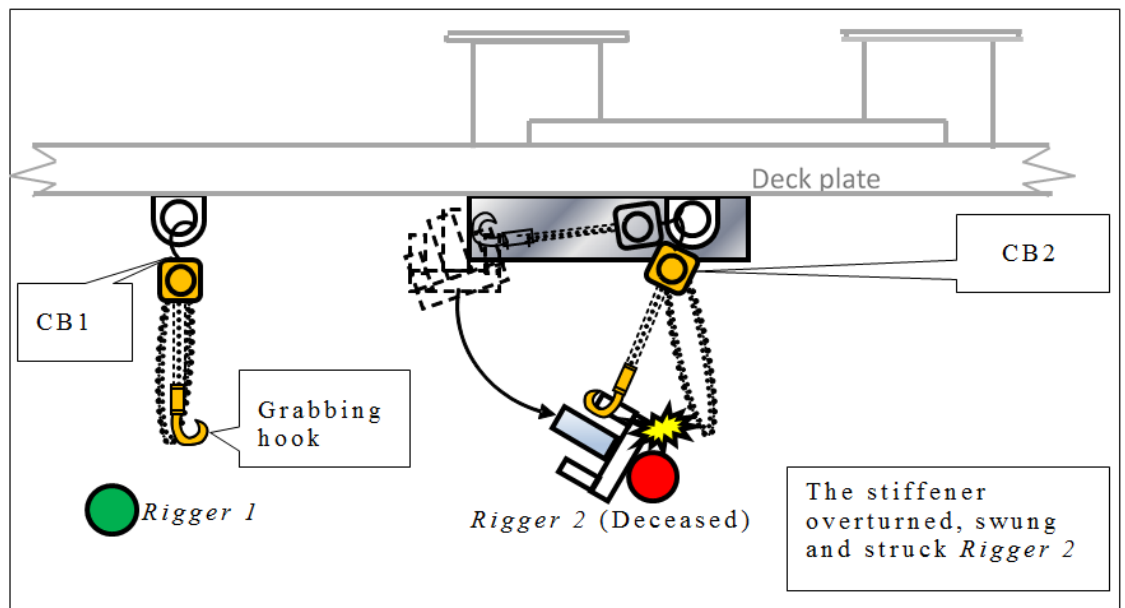
- 3.9 When the grabbing hook of CB1 was released, however, CB2 failed to hold the stiffener in position and the latter overturned, swung and struck the head of *Rigger 2* (Figure 6).

Figure 6: An illustration of the stiffener's movement when the grabbing hook of CB1 was released
