**Report of investigation  
into the man overboard  
accident on the Hong Kong  
registered bulk carrier  
“*SUNNY HORIZON*” in  
position 21°29.8’N 123°17.0’E  
on 11 August 2017**

The Hong Kong Special Administrative Region  
Marine Department  
Marine Accident Investigation Section

9 January 2020

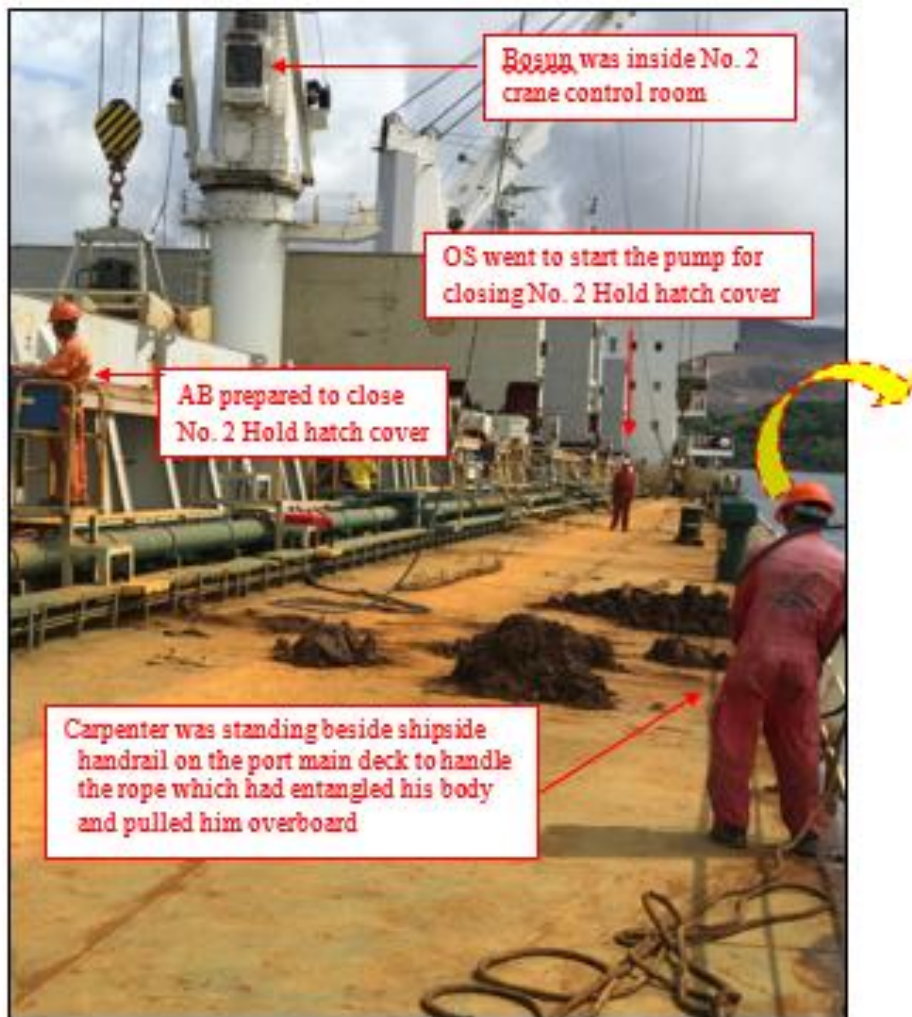
- 3.5 *The vessel* began to roll moderately again, causing the crane hook to swing heavily. The bosun stopped the crane and shouted to the carpenter to warn him to hold the rope firmly as well as to keep his position safely. However, the carpenter was not aware of the bosun's warning and tried to fasten the rope to the nearby shipside handrail. Before the rope was fastened to the shipside handrail, the heavy swinging of the crane hook caused the rope to entangle the carpenter and the carpenter was pulled overboard (Figure 2). The AB heard the bosun's yell and ran to catch the carpenter but in vain.

Figure 2 – Reconstruction diagram showing the locations of the deck crew and the carpenter entangled by the rope

- 5.2 When the carpenter was assisting to place No. 2 crane hook back to its designated stowage position on the port main deck, he was accidentally tangled with the rope attached to the crane hook. Subsequently, he was pulled overboard and fell into the sea at about 140 nautical miles east of Taiwan (21°29.8’N 123°17.0’E). After 53 hours of search and rescue operation, the carpenter still went missing.

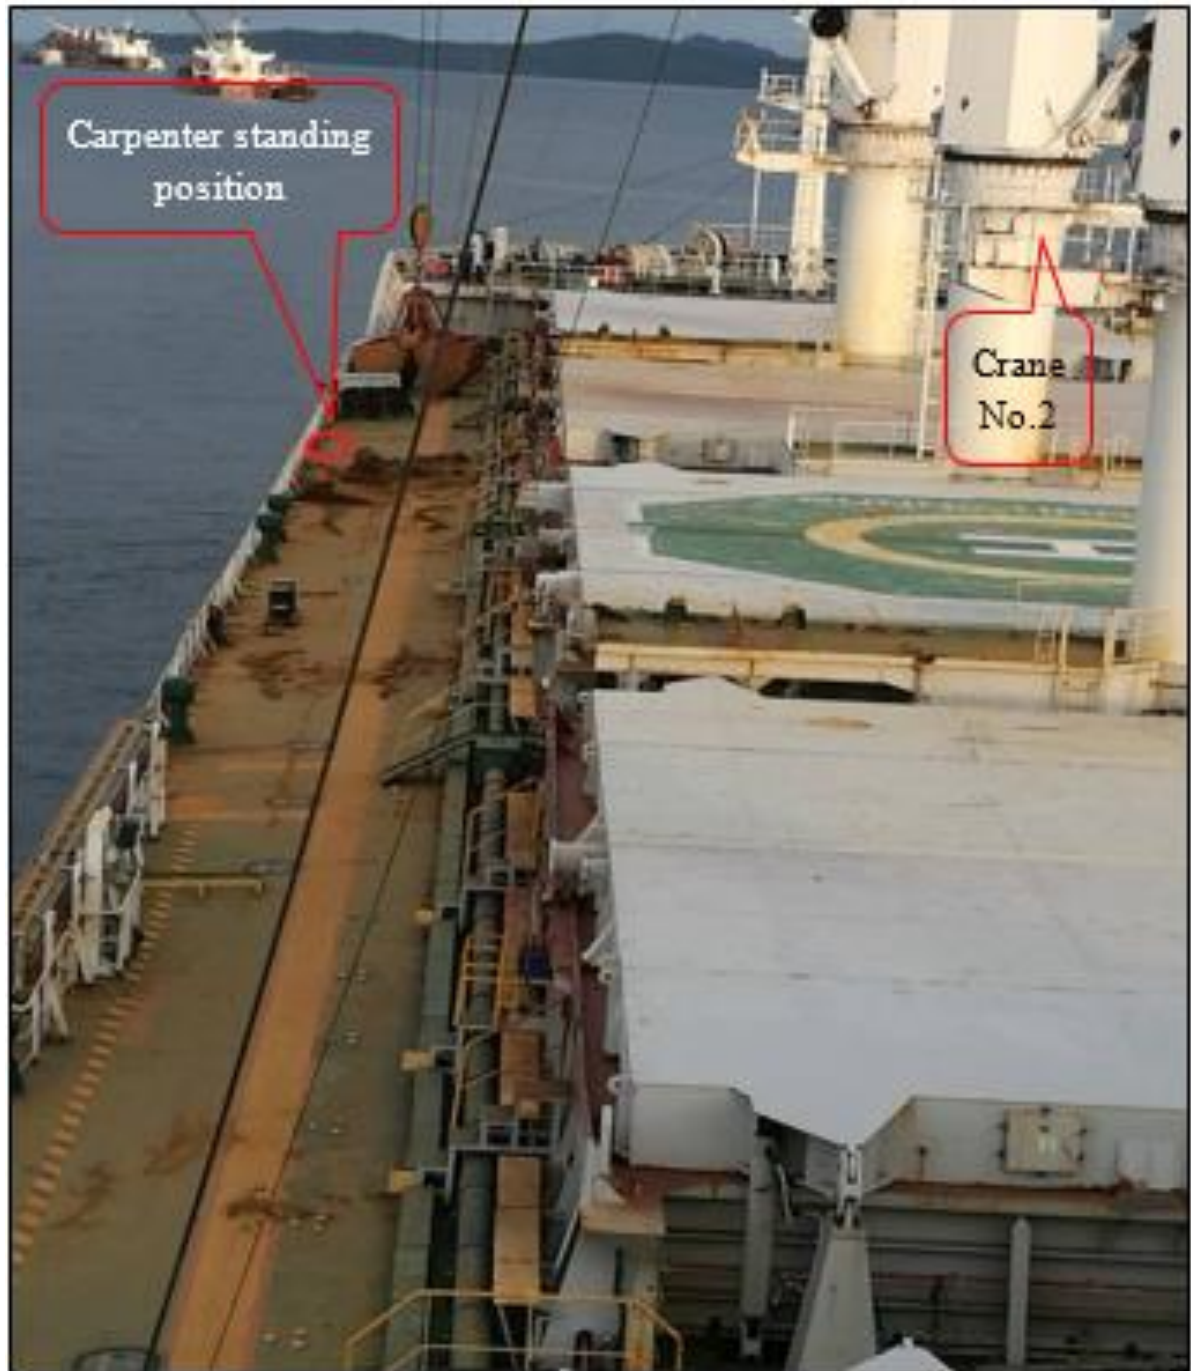
### **The lifting operation (Figure 3)**

- 4.12 Paragraph 19.11.6 of Chapter 19 “Lifting Plant and Operations” of the Code of Safe working Practices for Merchant Seafarers (the Code) <sup>1</sup> states that “Weather conditions can play a significant part in lifting operations. High winds or wave action may cause suspended loads to swing dangerously or mobile equipment to topple. Consideration should be given to the effects of weather conditions on all lifting operations, whether inside the ship or outside on deck, and such operations should be suspended before conditions deteriorate to the extent that lifting becomes dangerous.”. The Code also states that all lifting operations must be properly planned after risk assessment and the operation must be appropriately supervised and carried out to protect the crew.

- 4.13 In this accident, the deck crew did not adhere to the above guideline. Although the lifting operation was suspended for a short while due to heavy rolling of *the vessel*, the bosun considered the condition suitable for resuming the operation after the adjustment of the ship’s heading. It appeared that proper consideration or planning had not been made in advance by conducting an appropriate risk assessment for the lifting operation under *the vessel*’s rolling condition.

Figure 3 – Overview of the port main deck of No.2 cargo hold

- 5.3 The investigation into the accident found that:
  - (i) heavy swinging of the crane hook caused by the rolling and pitching of *the vessel* in rough sea was the main contributory factor to the accident;

- under adverse weather, any lifting operation should be avoided. If the lifting operation is unavoidable, a full risk assessment should be conducted before the operation. The risk assessment should include the factors such as the weather and sea conditions, measures of downgrading the risk level of the lifting operation and measures to be taken to avoid dangerous swinging of the crane hook and/or the lifting object.
